Sensor malfunction

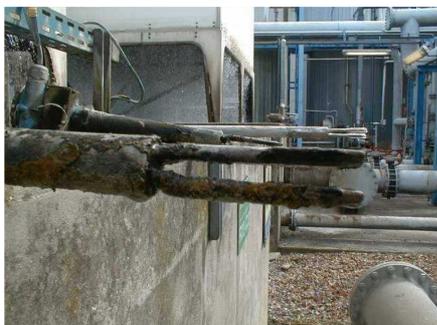
Fig. 4: The fouling of vibrating fork level probes caused a runaway reaction (ARIA 18339, Source: DREAL)
