Risk analysis and works projects

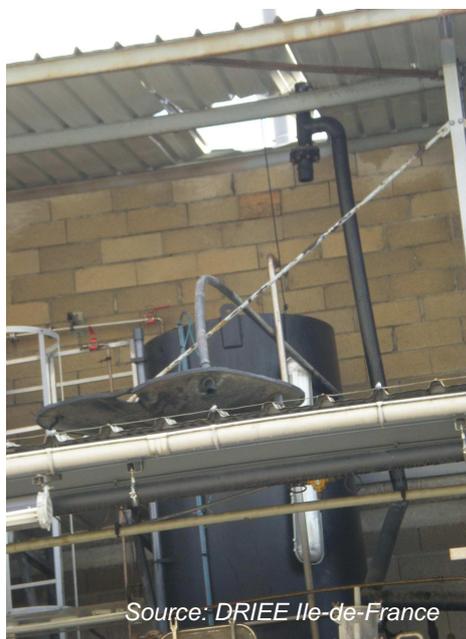
on a stepladder. This repair job, requiring a gas tungsten arc welding (GTAW) station, was intended to connect a pipe used to inert a temporary solvent storage tank to the plant's nitrogen supply line. **This weld was undertaken following a quick nitrogen flush performed by the employee.** At 4:45 pm, just a few seconds after completing the operation, as the welder was climbing down from the stepladder and exiting the zone, the 10-m³ polypropylene tank burst, sending its plug through the roof of the hangar housing the storage tanks. The worker and two other subcontractors in the zone were not injured. The classified facilities inspectorate was duly notified. A level sensor installed on the tank plug was ejected onto the roof and fell to the ground; the manhole, filling tap and pressure relief valve were also found on the hangar roof.

The damaged tank had been drained 3 months prior and degassed. **All of the damaged pipe had previously been verified by running water through it.** No combustion traces, combined with the fact that the damaged tank had been the only one capable of receiving nitrogen on the day of the accident (i.e. its shut-off valve had remained open), led to the hypothesis of a pneumatic explosion inside the tank. Despite being set at 30 mbar (strength threshold of the tank), the nitrogen expansion valve was capable of supplying a maximum pressure of 37 mbar and moreover, its good working order had not been assured. In contrast, the tank's pressure switch found on the floor indicated a pressure of 27 mbar. The accident might also have been caused by the rapid dilatation of nitrogen subsequent to its reheating when passing through the pipe segment nearest the weld (the GTAW weld had reached 1,000°C), though the level of the tank's liquid seal had not varied (it should have risen and overflowed in the event of a pressure increase).

observed findings. The programme was suspended until a determination could be provided of the specific accident causes. **An analysis of potential hazards had been primarily focused on risks tied to the presence of petroleum solvents.** The Classified Facilities Inspectorate noted that in addition to the lack of tank isolation, **these works had not been carried out within the scope of the SGS installation maintenance procedure and furthermore displayed an insufficient risk analysis** (regarding the risk of equipment subjected to a pressure surge or drop). In a span of 5 months, this accident was the 3rd on the site and the 2nd pertaining to works assigned to subcontractors.
