Anticipating fire and explosion risks in wood silos

Over the past 3 years, more than 40 fires involving silos containing wood chips or sawdust have been recorded in the ARIA database. In such instances, operational difficulties are commonly encountered by emergency services (lengthy interventions, vulnerability of storage structures, etc.). Each response is therefore unique and requires comprehensive knowledge of all potential risks.

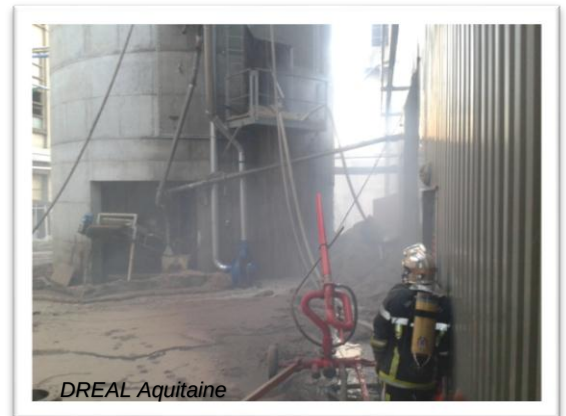
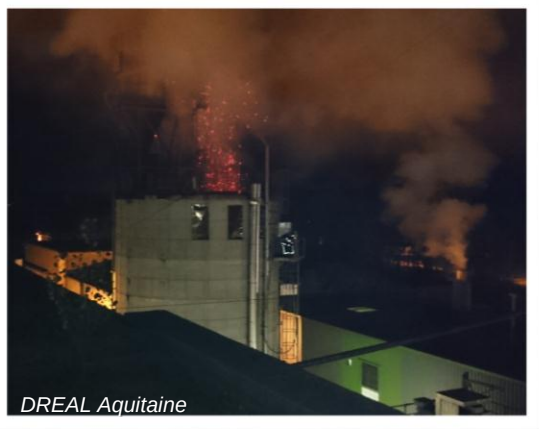
Fire broke out at a wood board factory around 5 pm in an **800-m³ concrete silo** (height: 26 m, diameter: 8 m) containing 240 tonnes of sawdust feeding a biomass boiler. Both the internal emergency plan and the **silo's sprinkling system** were activated. Temperature in the silo was

estimated at 250°C. **First responders decided to drain the silo from its lower part using an auger.**

On 30th Oct at 3 am, the sawdust ignited. **Falling blocks of sawdust caused several heat flashes.** Fire-fighters proceeded by **flushing the inside of the silo in order to contain the flames.** At 6:30 pm, the situation deteriorated with: **the silo engulfed in flames over its entire height, destruction of the drain screw, and the appearance of cracks at the top of the silo.** Given the risk of silo collapse, a 60-m safety perimeter was set up.

Sprinkling inside the silo resumed. Emergency responders cooled the silo from the outside, as **several explosions were occurring in the cell.** **Holes were drilled so as to discharge the accumulated sawdust.**

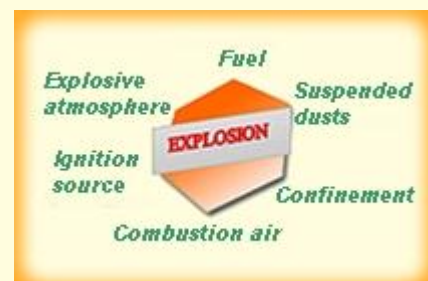
While **fires** are the most frequent of the hazardous phenomena, **explosions** should be feared most.

The mechanical effects induced lead to the **spraying of fragments, structural collapse** and a **blast wave**; moreover, such effects can **injure or kill** first responders.

Large volumes of extinction water might, in some cases, be generated; it would be highly useful to capture these volumes within a suitable basin and then treat them in order to avoid **polluting the natural environment.**
