## Seal boxes: Not to be mistaken as a cure for ageing

Commonly used to plug leaks on pipelines, seal boxes serve to stop discharge flows without entirely shutting down production. Despite this advantage, several accidents have shown that this type of remedial action is not sustainable and moreover necessitates regular monitoring during operations while awaiting definitive repairs.

**1st case, date: 19th Nov 2013 - Fatal accident at Antwerp refinery in Belgium (ARIA 44781):**

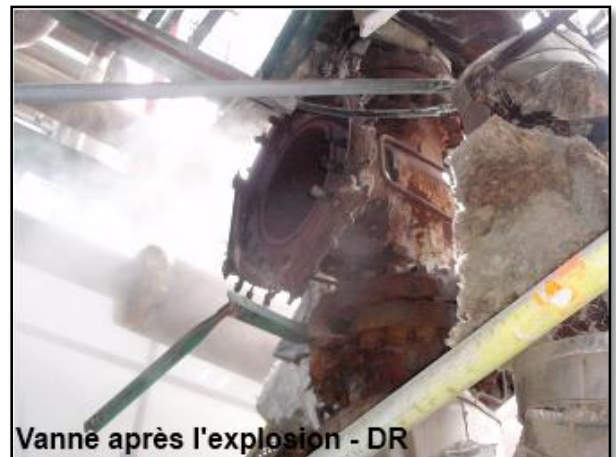
**Both of these (subcontractor) victims had been re-injecting resin into a seal box on a flange when the fastening rods broke.** The release of boiler water (pressure: 70 bar, temperature: 290°C) caused a steam explosion.

A metallurgical analysis of the failed rods revealed that they had been subjected to stress corrosion cracking.

- the **valve displayed a design or manufacturing flaw**: the throat diameter of the joint inside the cap was too small. This flaw caused non-alignment in the vicinity of the flange, along with additional mechanical stresses;
- the seal box (installed in 2011) attached to the valve was turned off for 6 weeks in 2012, during which time it was **maintained under pressure although at low temperature**. In this condition, boiler water made its way to the flange-seal box connection and formed a corrosive medium;
- **the additional mechanical stresses, produced at the time of re-injection, were sufficient to cause the corroded rods to fail**;
- **the seal box had not been designed to withstand the additional axial force resulting from broken rods.**

- **a visual inspection of rod condition does not offer an adequate level of certainty**;
- **if resin is to be re-injected into the seal box, the condition of the bolts would need to be determined**;
- **both an inventory and a log of operations performed** on the various seal boxes are valuable records.

Moreover, the seal boxes must be considered as **a temporary and non-definitive repair**.
