OECD Special Session « Ageing of hazardous installations »

Lessons learnt from accidents involving ageing of industrial facilities

Pauline ARAMA
French Bureau for Analysis of Industrial Risks and Pollutions

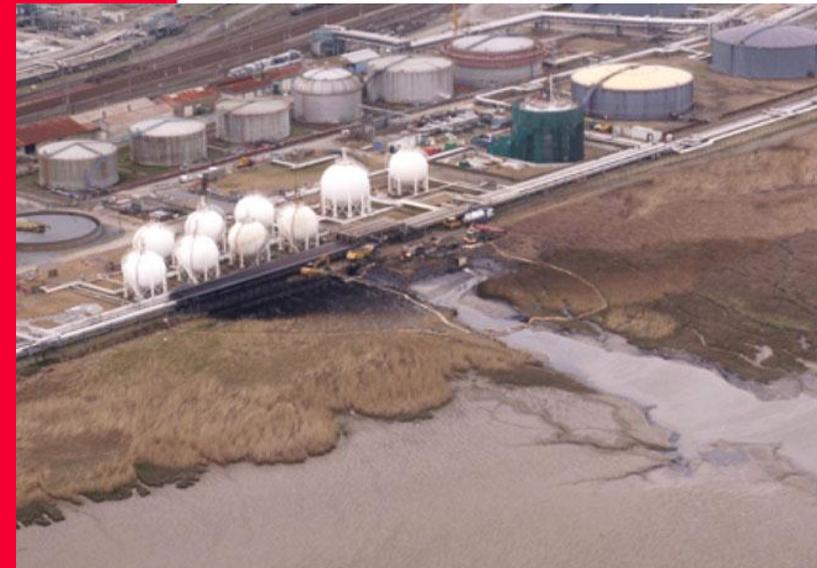
ARIA 34351 – 13/03/2008 – 44 – DONGES

During the loading of 31,000 m³ of fuel oil into a ship at a refinery site, a leak on a pipe caused spreading in the Loire River Estuary.

The fuel oil pipeline showed a longitudinal opening, due to localised corrosion in the thermal insulation that was related to a water leak on a pipe running directly overhead.

Despite the **previous detection of several anomalies on this rack**, the operator failed to implement the measures made necessary by the river's proximity.

A number of **remedial measures** were imposed including : inspections on the site's other pipelines, permanent monitoring accompanied by a leak detection system and alarm relay for the pipelines running closest to the river.

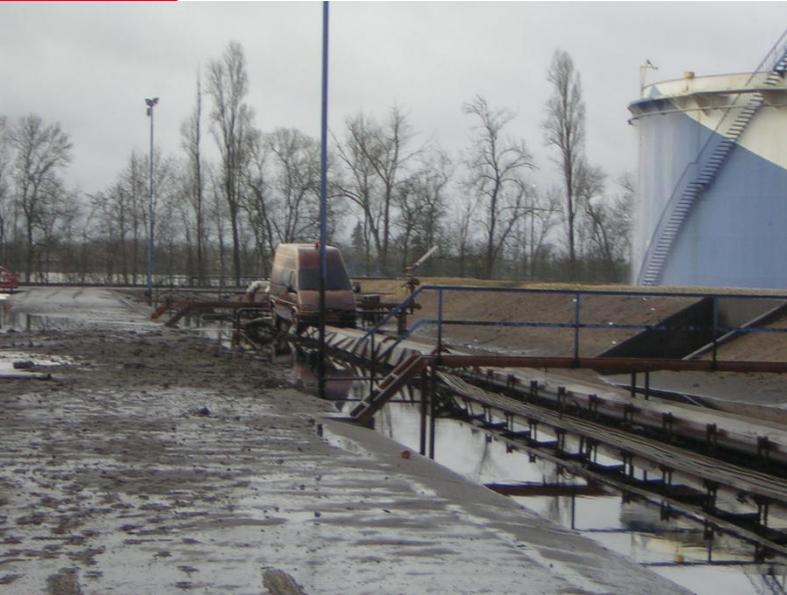
ARIA 32675 – 12/01/2007 – 33 – AMBES

The bottom of a tank containing 12,000 m³ of light crude oil opened. The retention basin withstood the effect of the ensuing wave, but 2,000 m³ of fuel still spilled out of the basin. 50 m³ of oil polluted 2 km of marshland ditches, infiltrating the surface water and flowing into the Garonne River. **In all, 40 km of riverbanks on the Gironde, Dordogne and Garonne were polluted.** The site operator pumped 6,000 m³ of product, proceeded with pollution cleanup steps in the vicinity and treated water fouled by the spill. Operating losses were estimated at €50 million.

A slight leak on the tank had been detected the day before around 5 pm. No procedure had been planned to deal with an emergency situation of this type. The operator had postponed until the next day the tank drainage step due to the risks potentially incurred by employees when having to block the floating roof seal on the tank at night. During this wait, water had been injected into the bottom of the tank.

In 2006, an inspection of the tank bottom had revealed corrosion and thickness losses of up to 80%. Repair work had been performed and followed up with an inspection.

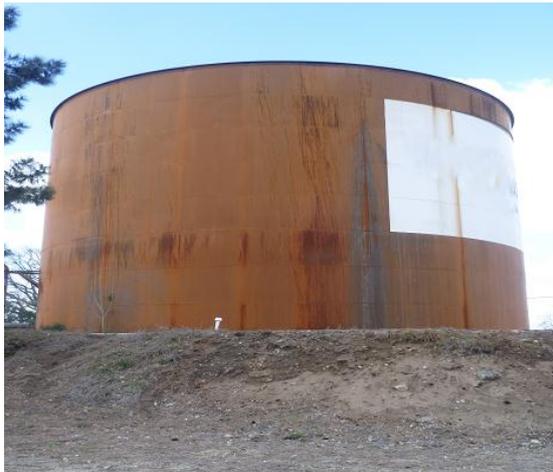
ARIA 42401 - 05/07/2012 - 33 - BIGANOS

At 2:30 pm, inside a paper mill located 5 km east of Arcachon Bay, **a 5,000-m³ black liquor tank ruptured**. 4,000 m³ of this product at 85°C spilled over a 2 to 3-ha area within the mill. After destroying a low retaining wall, **100 m³ of product overflowed into the LACANAU and then the LEYRE Rivers**.

The tank showed signs of ageing and corrosion. The mill operator had scheduled complementary inspections on this tank for the end of July 2012 specifically to ensure its suitability for continued service.

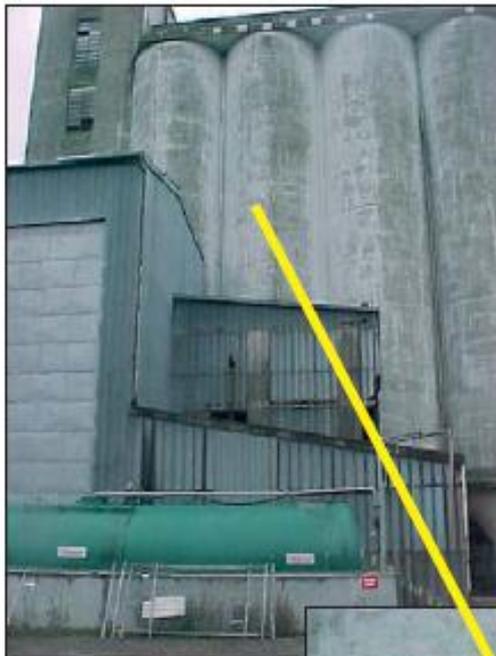
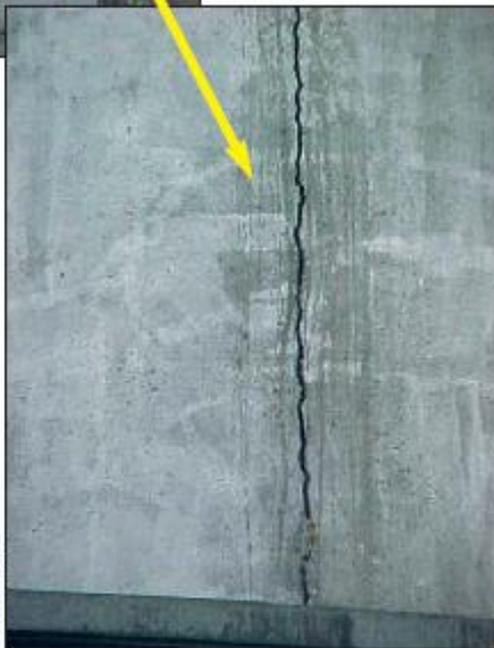
ARIA 23368, 20/10/2002 – 02 - JUSSY

In an agricultural cooperative, the concrete wall of one of the vertical storage cells of a silo built in 1963 cracked throughout a length of 25 m. About 100 tonnes of maize spilled over and destroyed a wall allowing access to the control facilities at ground level.

The inspectorate for classified facilities recommended the prefect to issue an emergency site shutdown order requiring an expert evaluation of the facilities. **Poor ageing of the reinforced concrete, with corrosion of the reinforced steel, is the cause of the accident.**

*Fissure d'un silo
de maïs en béton.
Jussy (02)*

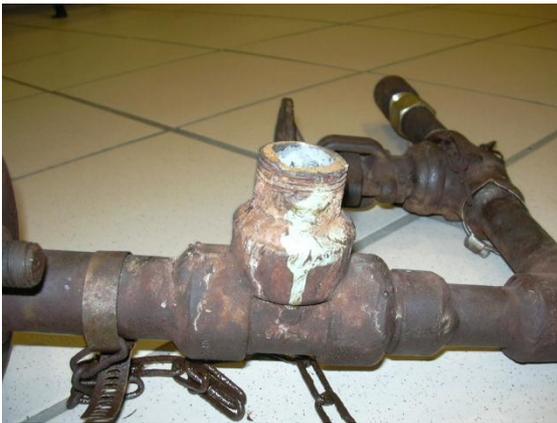
ARIA 32611 - 28/10/2006 - 76 - GONFREVILLE-L'ORCHER

In a plastics manufacturing plant, the **rupture of a 1" branch pipe on the discharge tank of a propylene gas compressor** caused the emission of a cloud of gas.

Examination of the broken branch pipe confirmed that the **rupture was in fact caused by mechanical fatigue**, i.e. by progressive cracking. The examination of the fracture surface showed that an initial cracking phase had occurred several years earlier. Progressive cracking had then continued until total rupture of the branch pipe through ductile fracture. **The blowdown pipe generated continuous mechanical vibration**, with the embossing on the equipment acting as a recess creating a local stress zone which led to generating the fatigue fracture phenomenon.

The design of the pipe was unsuitable for significant exposure to vibrations. The **inspection organised on the pipe was also inappropriate** (inspections of the "small branch pipes" did not take into account fatigue cracking at the thread roots, which is specific to a screwed assembly).

All of the branch pipes subject to vibrations were identified; the screwed assemblies were replaced where possible by a slip-on assembly. Furthermore, the operator modified the compressor so as to eliminate a fixed point that was detrimental in environments subject to vibrations.
