LESSONS LEARNT
from industrial accidents

IMPEL Seminar
Lille, 2 and 3 June 2015

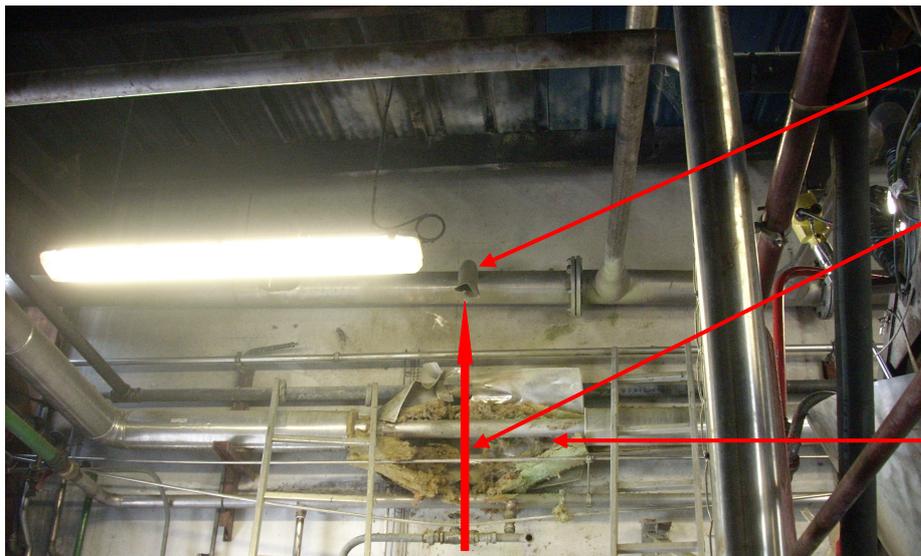
Remainder of the pipe torn off by the explosion

The portion of pipe damaged by the explosion was an "empty" conduit from a larger network responsible for collecting VOC-laden air in various zones of the workshop.

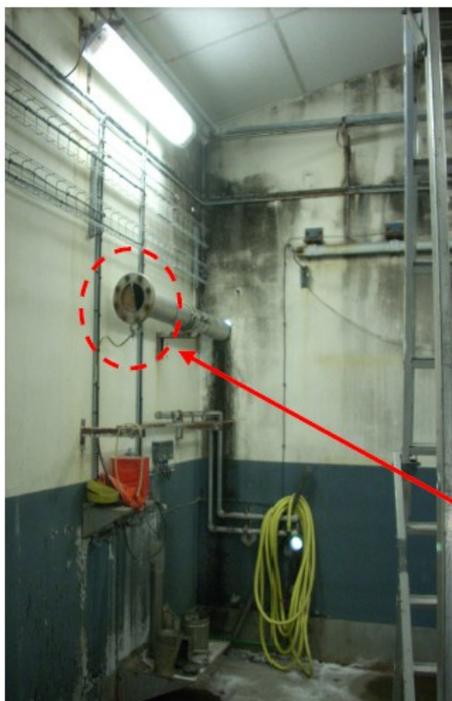
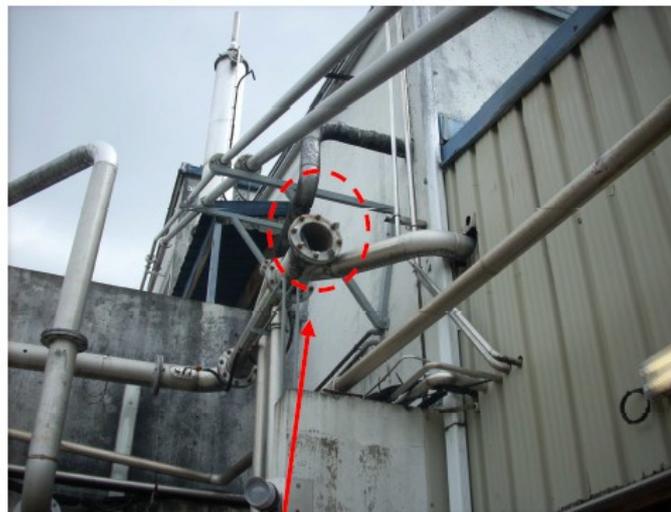
Plugs and/or foil present on the suction network that had opened subsequent to the pressure surge generated by the explosion

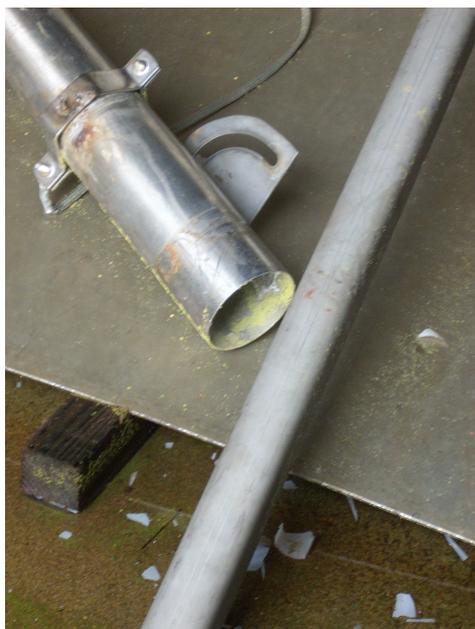
Pyrotechnic dust residue (a yellowish substance with powdery texture) was present on the metal debris of the stripped pipe (found on the floor of the workshop and outside the building, along the path of the foil that had been ripped apart). These observations indicated that **the pipe had not been adequately washed** during preliminary rinsing steps.

Metal debris, from the pipe blasted by the explosion, found on the floor. The picture on the left shows residue from pyrotechnic dust (yellowish) covering the inner pipe wall.

The fire most likely broke out due to ignition of this powder residue and/or pyrotechnic dust accumulated inside the pipe. This build-up was correlated with the **heating produced by friction of the metal saw blade on the stainless steel suction pipe (hotspot).**

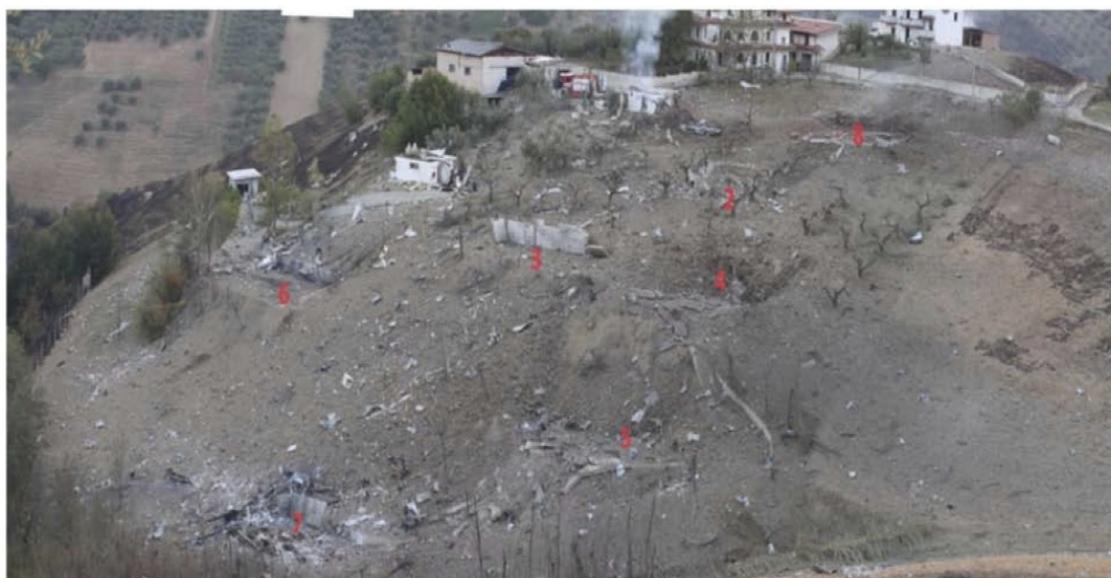
Seven of the eleven buildings of the plant were completely destroyed by the blast combined with the fire : buildings Nr. 2, 3, 4, 5, 6, 7, 8. Buildings 10 and 11 were partly damaged, while buildings 1 and 9 were strongly damaged.

Illustration 2 : The remains of the plant after the accident

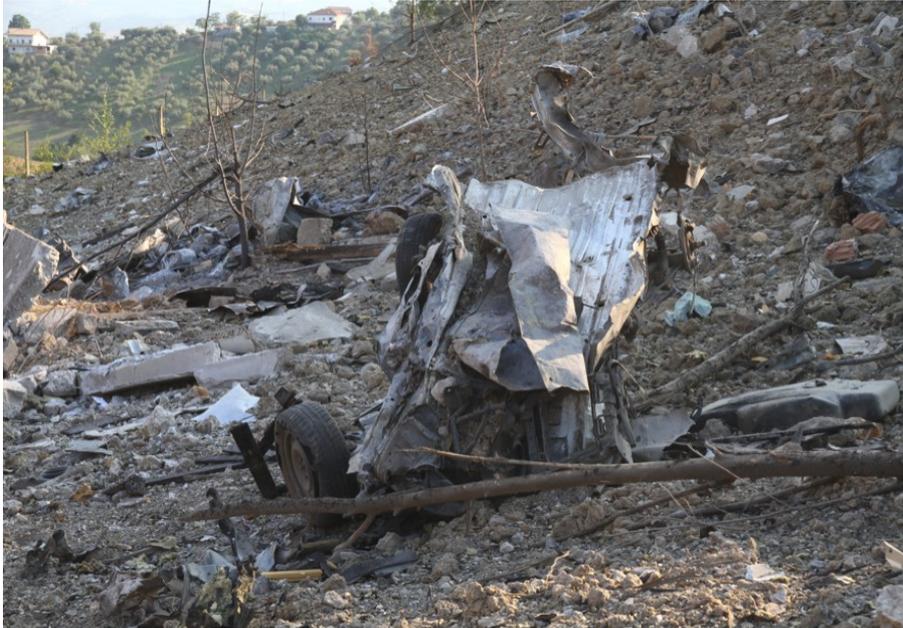
Based on data provided by firefighters, it is supposed that a “pick-up truck” (a small truck with an open body and low sides), normally used for internal explosives transfer, has been involved in the first explosions. The remains of the pick-up were found near the storage buildings Nr. 4 and 5 (illustration 3).

Illustration 3 : The remains of the pick-up truck

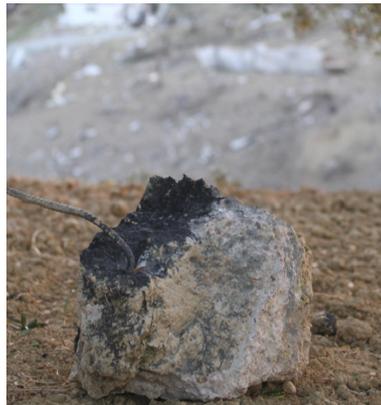
Illustration 4 : Piece of concrete found more than 900 m away from the plant

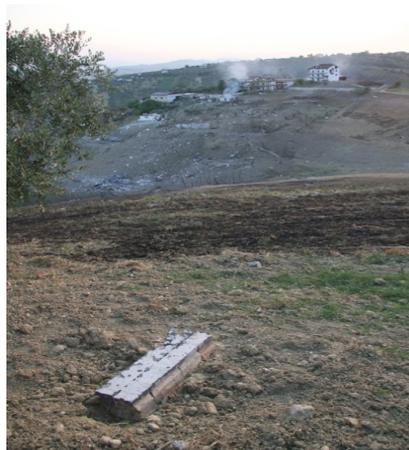
Illustration 5 : Debris projected by the explosions

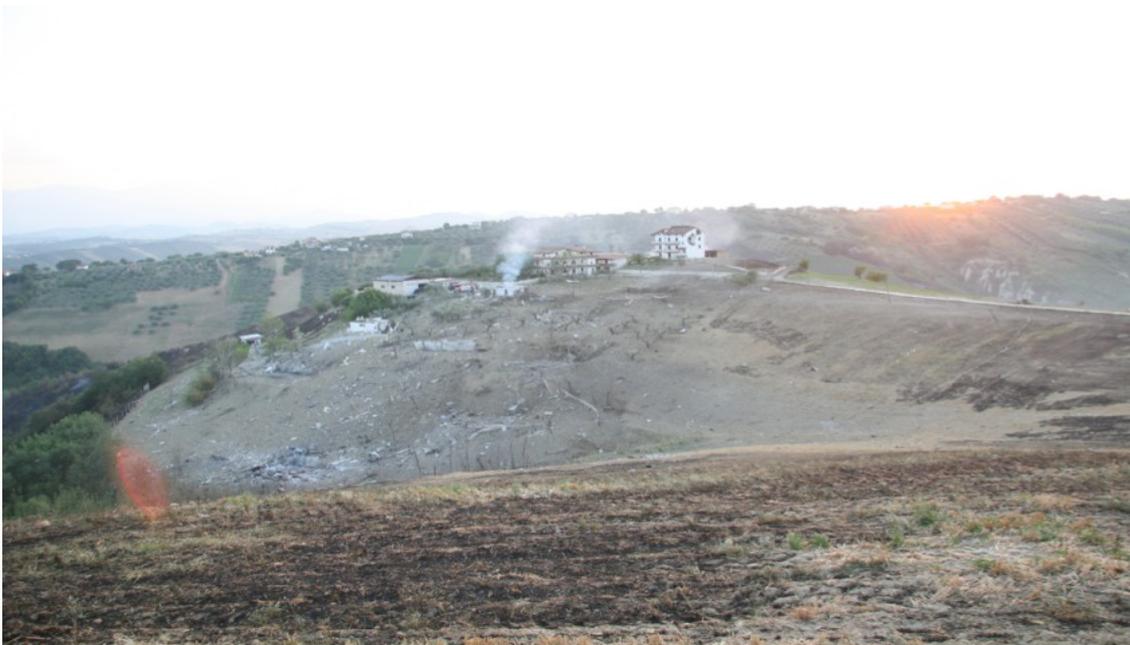
Illustration 6 : Fires in the area around the plant

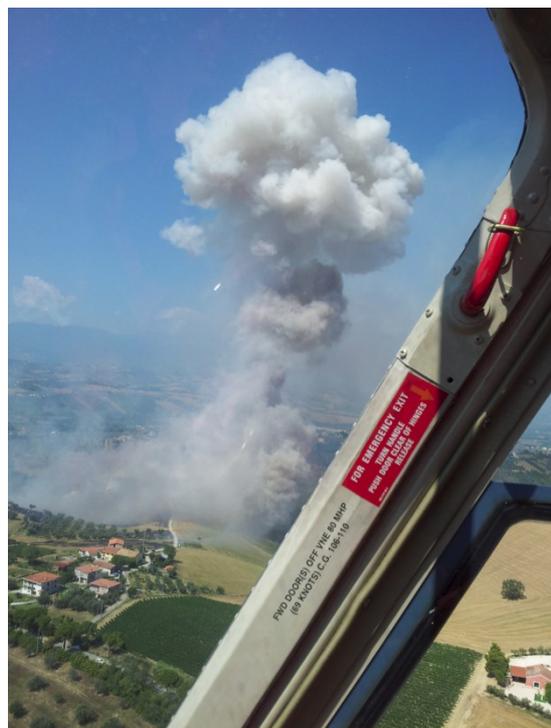
Illustration 7 : Toxic cloud emitted to the atmosphere

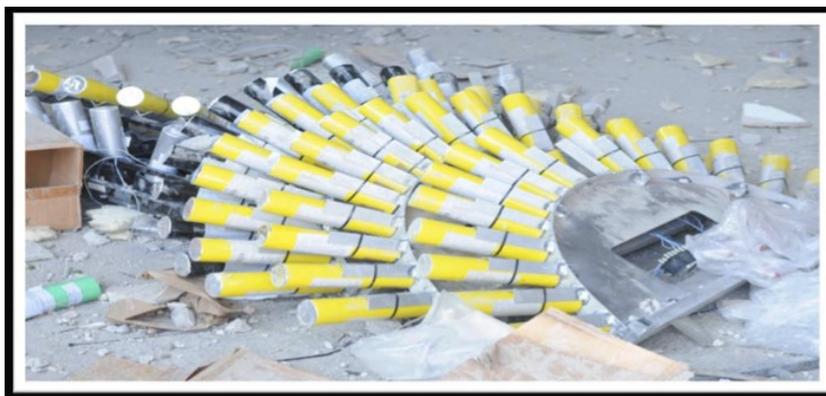
After the accident, explosive products that the plant operator was not allowed to store were found in the remains of the plant. Indeed, fireworks already “armed” with an ignition device were discovered. (illustration 8). Other pre-armed fireworks were found inside the trucks parked just outside the plant, near the operator's house.

Illustration 8 : Pre-armed fireworks

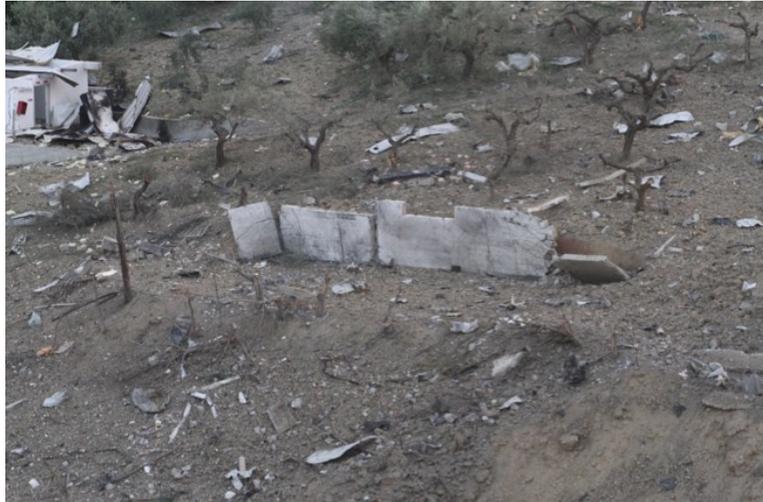
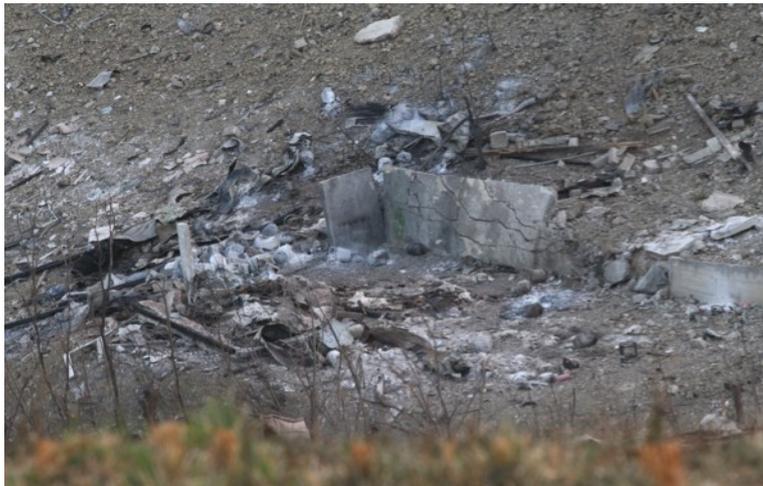
The material damages observed in the storage buildings and their protection walls (illustrations 9, 10) show a real disintegration effect. This is the evidence of a "mass explosion" (the entire explosive amount exploded almost instantaneously). This phenomenon is a further proof of the presence of dangerous pre-assembled explosive products at the time of the accident.

Illustrations 9 and 10 : Damages caused to the buildings and their protection walls

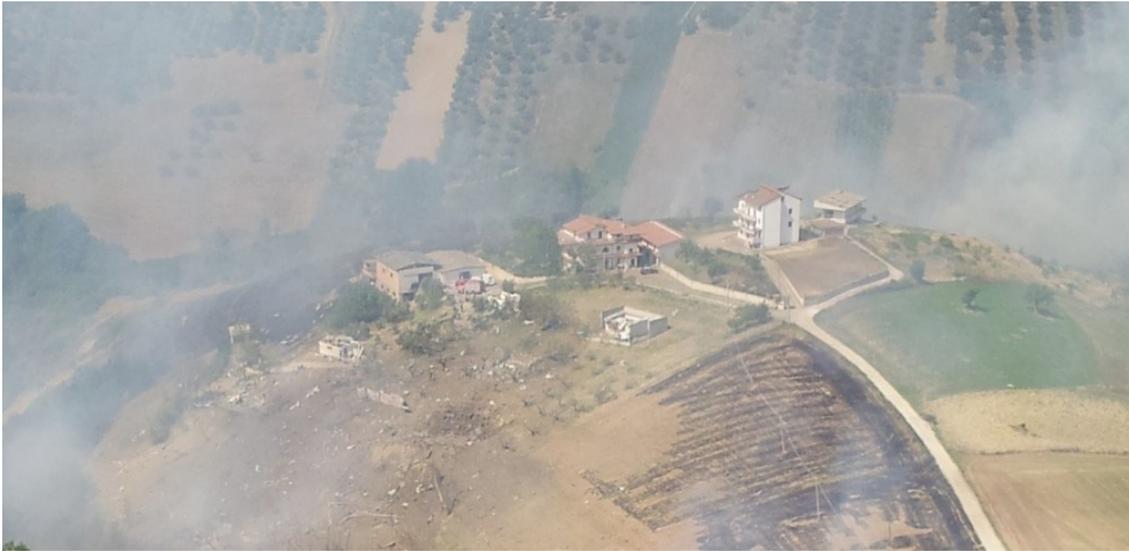
Moreover, a domino effect occurred in building Nr.8 40 minutes after the first explosions. As shown on illustration 11, building Nr. 8 had already been damaged by the first blast wave. The respect of safety distances among the buildings, according to the national regulation, should allow to avoid domino effects. But these safety distances are of course a valid protection method only if the maximum quantities and the authorised typologies of explosives products have been respected (the safety distances are designed based on these parameters). The occurrence of a domino effect leads to conclude that there might have been violations of the regulation in terms of qualities and quantities of explosives stored in the plant.

Illustration 11 : view of the plant after the first series of explosions

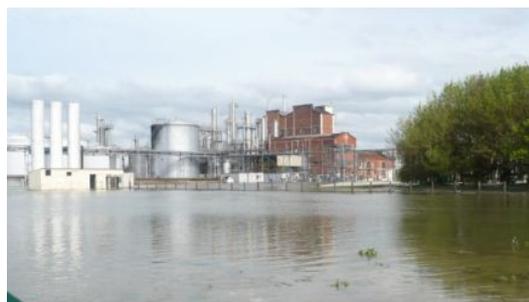
Chemical plant overwhelmed by water
(source: DREAL Champagne-Ardenne)

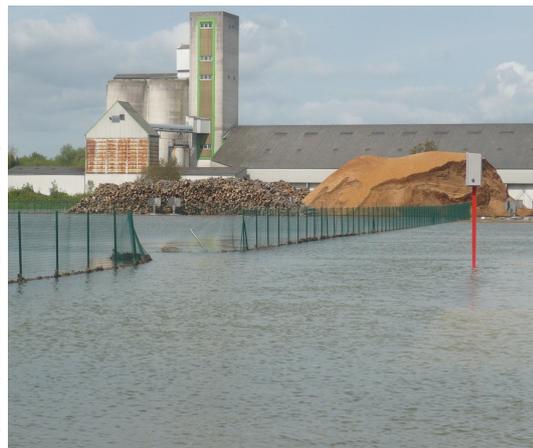
Wood storage at the plant overwhelmed by water
(Source: DREAL Champagne-Ardenne)

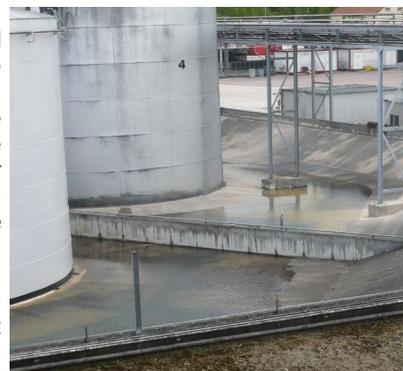
Retention basin for an unsealed tank (Source: DREAL Champagne-Ardenne)

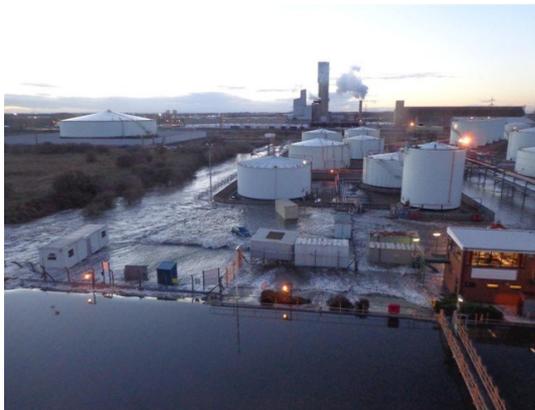
Figure 2 - View of terminal being flooded from ship moored up on jetty, source Cleveland EPU

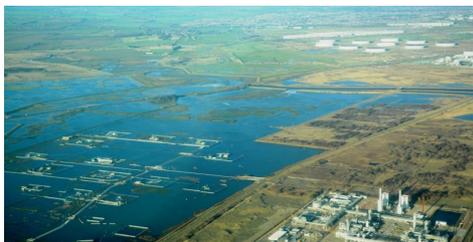
Figure 5 : SABIC Brinefields and the flood defence breach, source Environment Agency

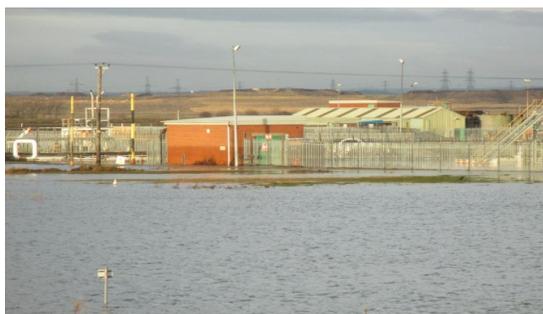
Figure 6 : Control room on the Brinefield – note flood level mark on control room wall, Source Sabic UK Ltd

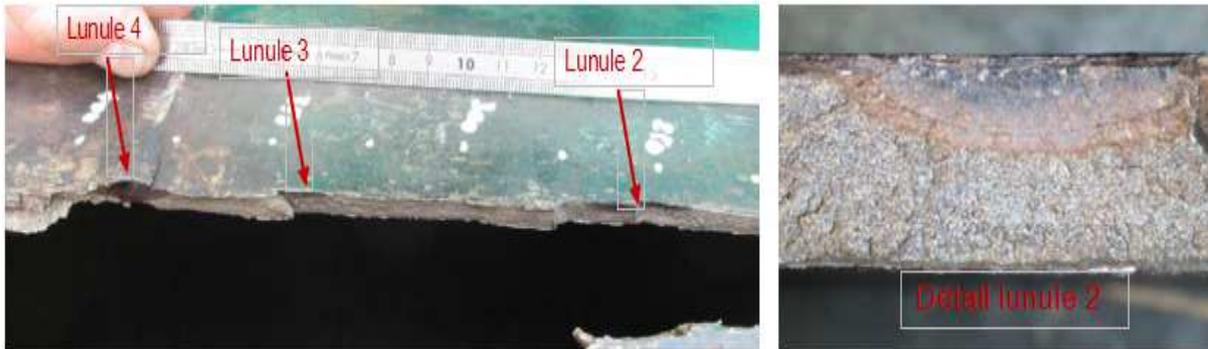
Outside the rupture zone, on the outer surface of the liner and along the upper generatrix, the magnetic particle inspection evaluation revealed the presence of crack-type anomalies associated with the identified mechanical damage that had strain-hardened the metal and caused the tube to flatten over its upper generatrix. Mechanical stresses at the level of the connection with the non-flattened zone had thus formed.

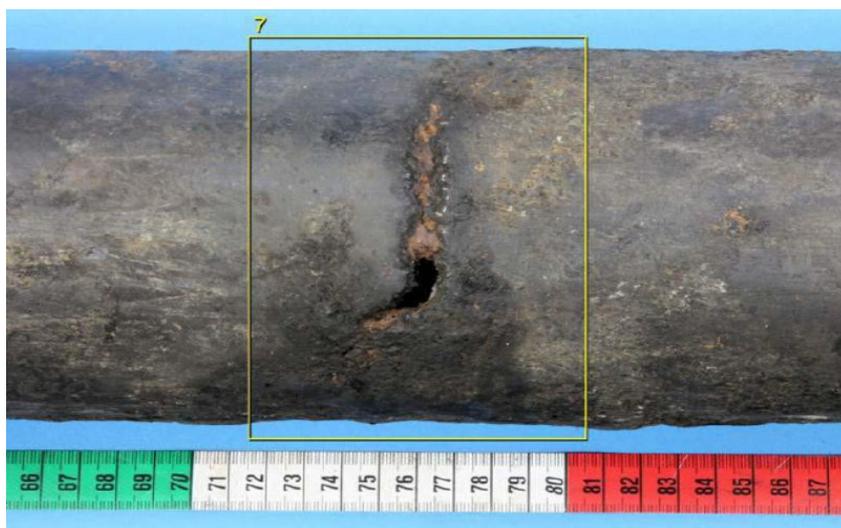
Figure 3: Hole in the steel kerosene pipeline stemming from outside corrosion (copyright: operator)

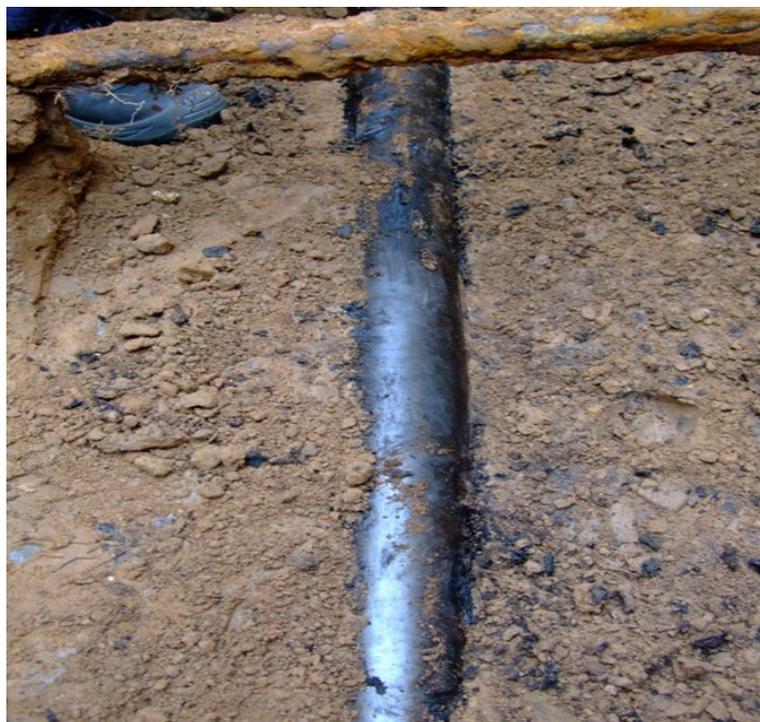
Figure 4: Water pipe (at the top of the picture) crossing the kerosene pipeline (copyright: operator)
