Overview of accident statistics on waste management facilities

- October 2016 -

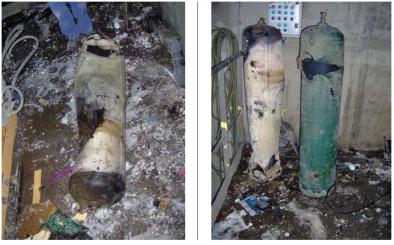
Propane bottles found mixed to the waste in a shredder

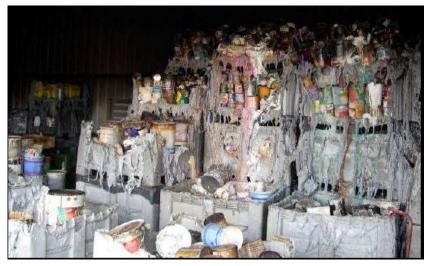
Fire of hazardous waste following and incompatibility reaction

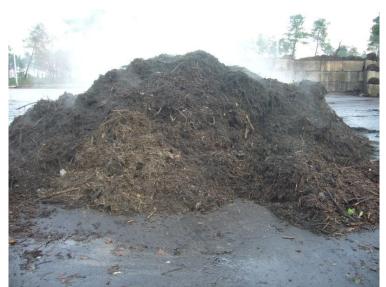
Self-heating of a stockpile of screening refuse (ARIA 35496)

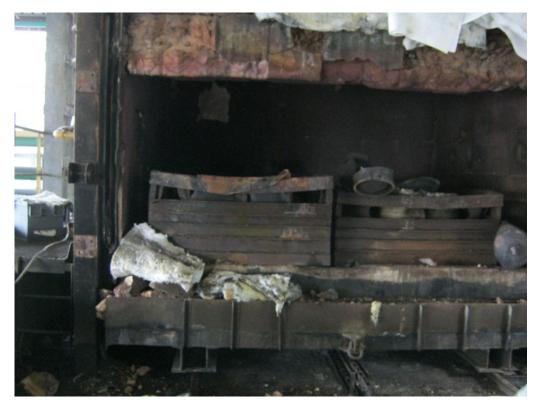
Explosion within the copper furnace of a hazardous waste incinerator (ARIA 45127)

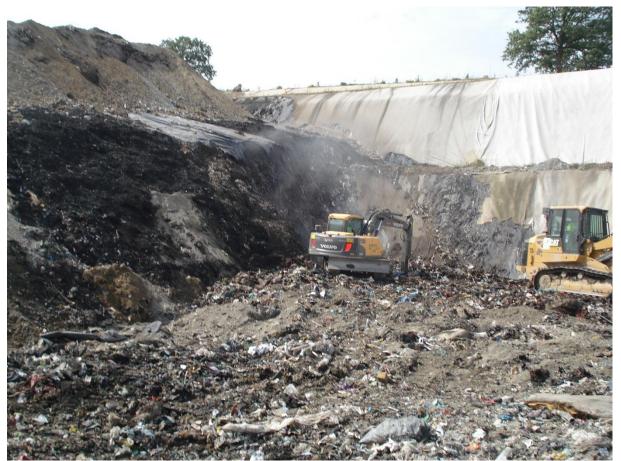
Damage to the geomembrane and geotextile during a fire at a landfill (ARIA 42875)
