Meteorological events of early 2018

Without trying to predict the weather for late 2018 and the seasonal storms in the Cévennes of south-central France, we note that the first half of the year was marked by a number of floods impacting factories in France. In addition to the economic consequences (water damage, production stoppage, a period of technical unemployment for the employees, etc.) often observed in such circumstances, environmental damage was also reported.

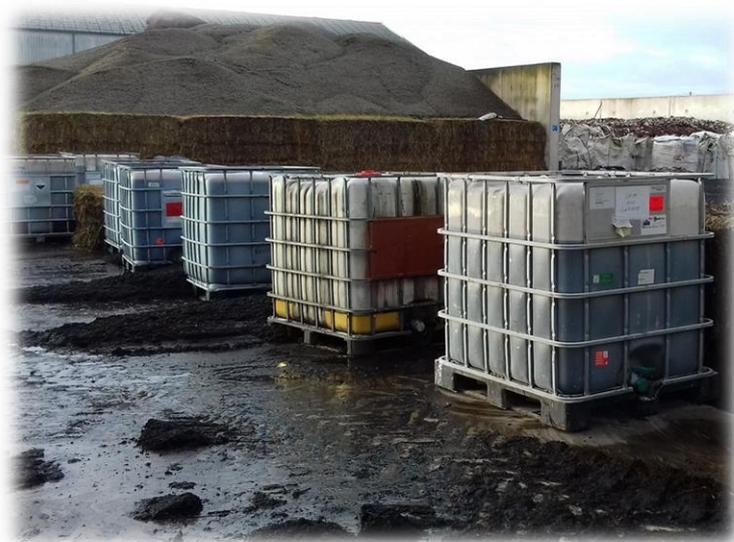
In a methanisation plant, the **leaching water from external stocks spilled over during a major downpour**. These effluents polluted 1.5 km of a trench and the Ante River. The local biodiversity services noted the pollution. The digestates disintegrated due to the excess amount of water and covered part of the site's roadways. The operator cleaned the trench.

The leaching water collection tank of the external stocks was saturated by heavy rainfall. The effluents then flowed to the non-polluted effluent collection basin and then to the outside. In addition, the outlet valves of the buffer tank, acting as a retention tank, had not been closed. **The operator had not taken any measures to limit runoff onto its storage facilities.**

Condition of the site following the overflow of leaching water (© DREAL)
