Hazardous waste: beware of incompatibilities!

Accidents caused by incompatible mixtures are not limited to newly-produced chemicals! The end of their life cycle can also be a source of risk. Several recent events in France and abroad confirm this, sometimes with dramatic consequences.

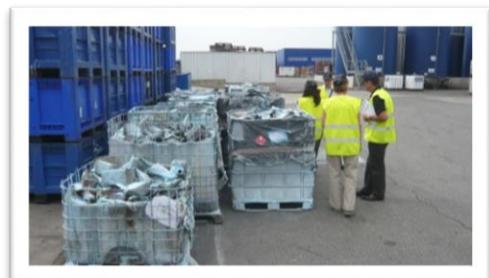
Fire in pallets containing dangerous waste following an incompatible mixture (© DREAL Bretagne)
