## Are visual diagnostics enough to anticipate concrete cell ruptures?

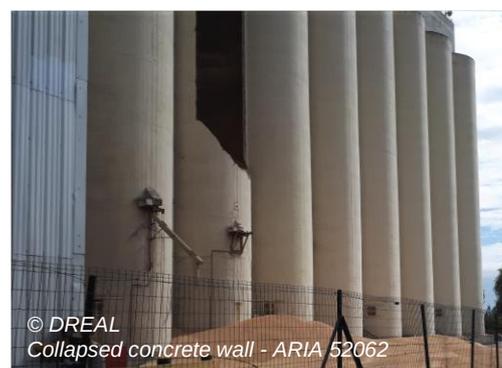
During a grain delivery operation, the upper half of a silo collapsed. A problem with the sloping flat roof, dating from when the structure was built, allowed water to accumulate and infiltrate into the voids of poorly plugged jack rods. This infiltration then led to the corrosion of the steel hoops under the flat roof over the long term. Owing to the thrust created by the grain during the filling operation, these steel elements failed, causing the non-corroded hoops to break in a cascading manner.

A visual diagnosis had been performed a year earlier. Disorders had been identified but not those resulting in the collapse. These visual diagnoses are unable to detect highly localised corrosion such as that which led to this accident. A corrosion potential measurement could have highlighted this, but this rather expensive technique is proposed only for structures exhibiting chipping with visible steel elements. This was not the case for the corroded steel elements that failed on this silo.

In order to mitigate this accident, the expert report recommended a generalised operation to detect the corrosion of the steel reinforcement in the concrete by compiling potential maps, combined with targeted spot surveys on the results of the potential map established.
