## Industrial accidents initiated or exacerbated by high temperatures

May 2020

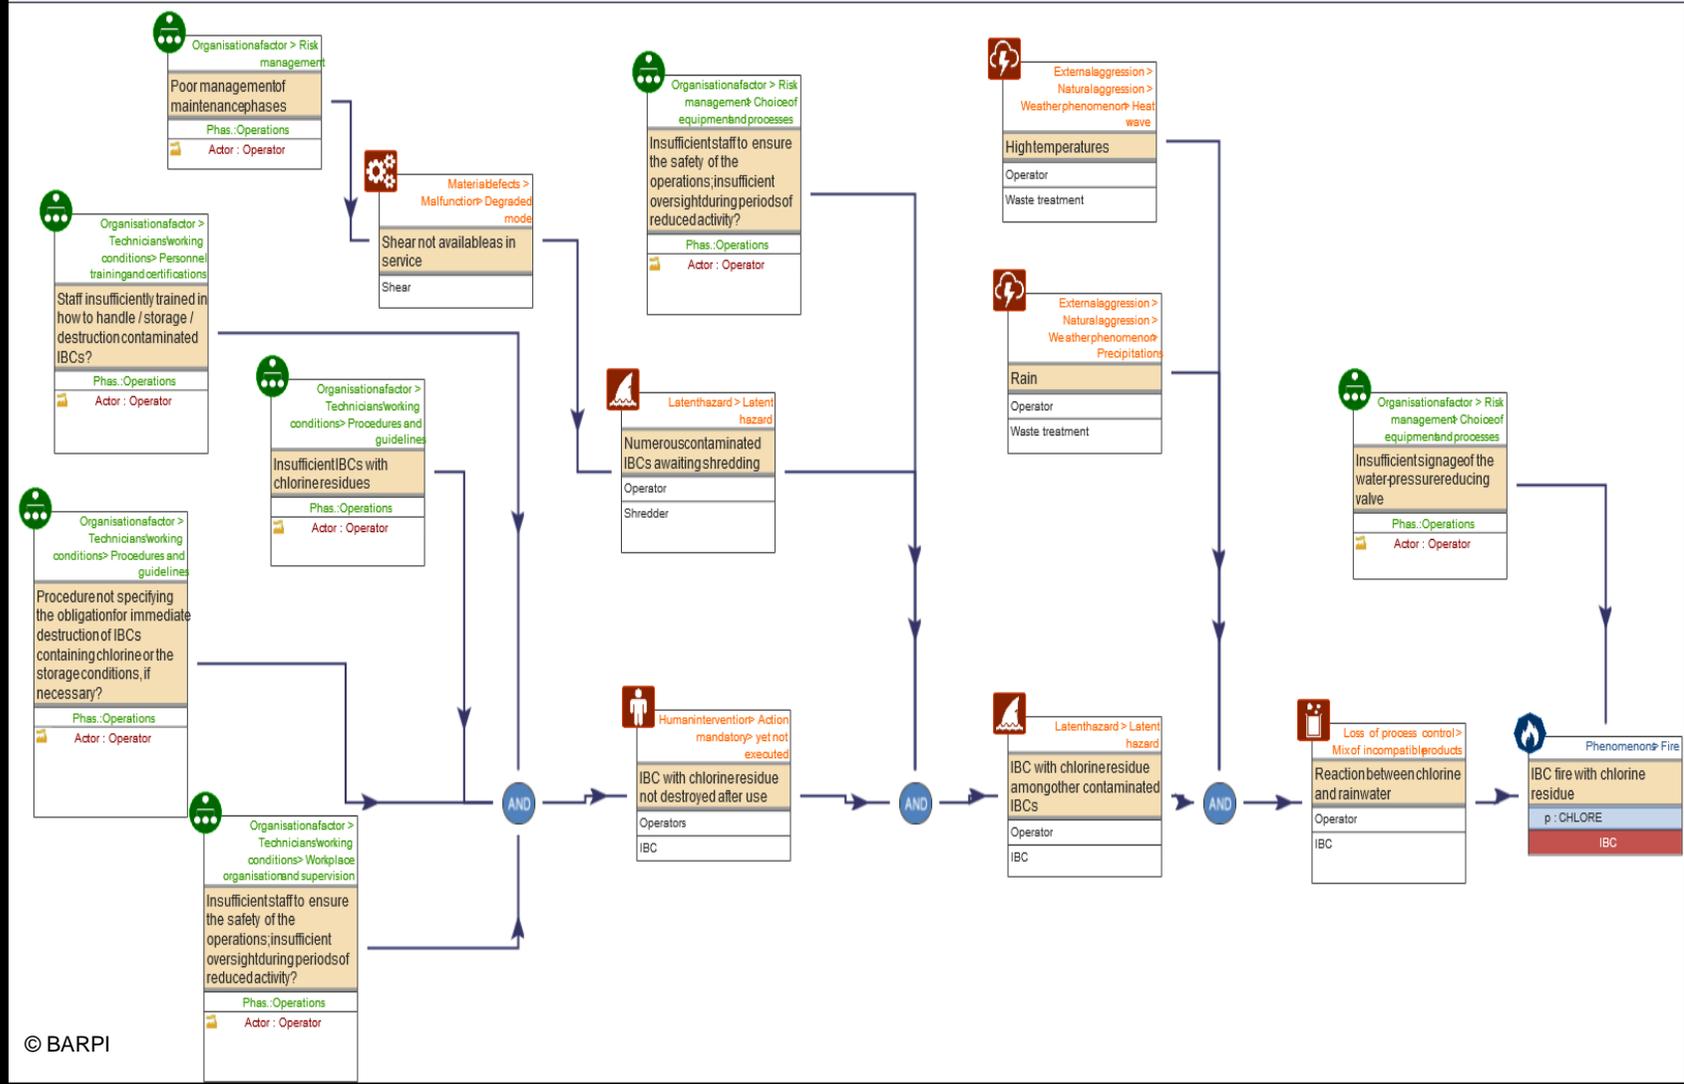
# ARIA 49894 - Fire at a hazardous waste treatment plant

At around 10 p.m., a fire broke out in an intermediate bulk container (IBC) stored outside at a Seveso-rated hazardous waste treatment facility. The IBC had been stored near other similar packaging in the storage area reserved for "contaminated IBCs" intended for destruction. White smoke and flames rising 2 to 3 m high were detected by the site's security company, who then informed the operator. The fire brigade's intervention was slowed down by the search for the operation's pressure reducing valve. They were then able to put out the fire and left the premises at around 11:15 p.m.

The IBC involved in the accident had previously been used to neutralise chlorine tablets. The fire was caused by a reaction inside the IBC between a chlorine residue (oxidiser) and rainwater (from precipitation on the evening of the event). The reaction was promoted by the ambient heat. The "contaminated IBC" storage area had been more congested than usual due to delays in shredding these containers. The backlog was due to a combination of factors: reduced manpower during this period of the year and the transfer of the workload from a shear, undergoing maintenance, to the shredder. Beyond the problem of congestion, the IBC used to neutralise the chlorine tablets should have been destroyed immediately after it had been used, instead of being placed among the other IBCs waiting to be destroyed.

- identification of IBCs that had been used to neutralise chlorine (with an "oxidiser" label) among the IBC waiting to be destroyed. These IBCs are destroyed immediately after use. If immediate destruction is not possible, the IBCs are stored in a workshop and not in the uncovered outdoor storage area;
- improvement of the signage designating the location of the pressure reducing valve;
- increase of its workforce;
- shear returned to service;
- increase employee awareness of the new guidelines.
