LESSONS LEARNT from INDUSTRIAL ACCIDENTS

13th SEMINAR

22-23 May 2019 • Rennes

LESSONS LEARNT

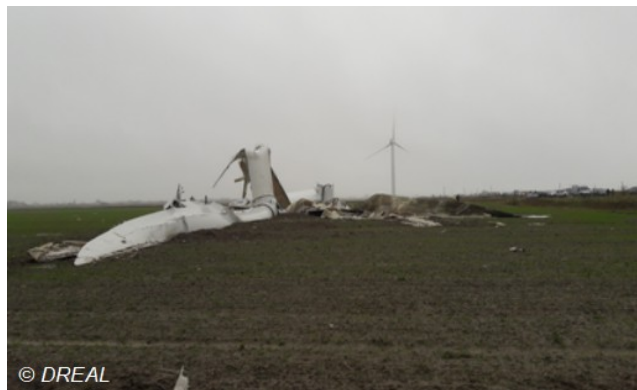
- the combination of undetected abnormal wear of the brake blocks and wind speeds in excess of 40 m/s, caused the pitch of the three blades to change uncontrollably and made the turbine automatically stop. The control system had been designed to automatically stop the turbine in the event of a deviation in the blade pitch control system;

- following a misinterpretation of data, an operator used the remote management system to manually reposition the turbine. This caused the rotor speed to quickly increase and exceed the safety limit. Although the overspeed protection system kicked in, the condition of the brake blocks on the pitch control system and the extremely high wind speeds made it impossible to stop the turbine. The mechanical loads acting on the tower greatly exceeded the turbine's design limits, causing it to collapse.

The operator's investigations revealed that the mechanical linkage between the blade pitch motor and the brakes was not covered by the maintenance inspection protocol. As a result, the accumulated wear had not been detected during the annual inspections.

- they revised and clarified the maintenance procedure to be followed in the event of failure of the blade pitch control system and trained their maintenance technicians;
- they updated their maintenance instructions. From now on, all or a portion of the components of the blade pitch control system's brake blocks (gear wheel in particular) are to be replaced every five years and the replaced components are to be inspected by sampling to confirm this frequency;
- since March 2018, they have been using special software that assesses the condition of the blade pitch control system's brake blocks by comparing the actual position of the blades against the setpoints sent electronically;
- a safety warning has been written for operators who have not signed a maintenance agreement with the manufacturer and who own the same type of wind turbine.

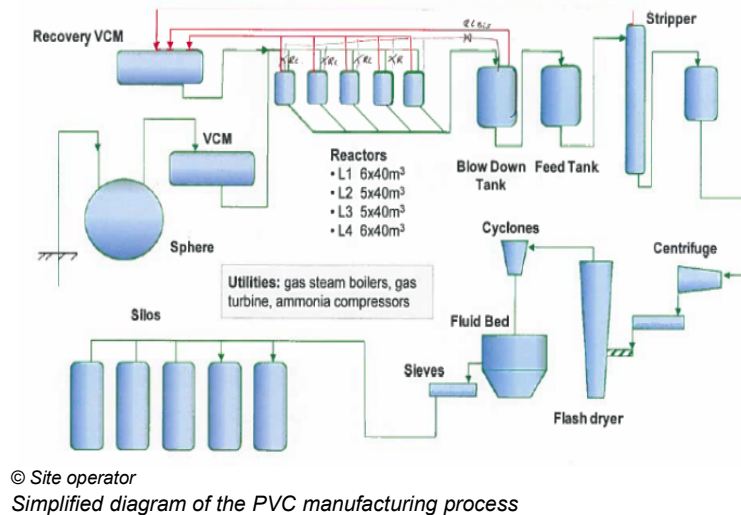
The significant rise in temperature inside the 45 kV transformer room, which occurred when the main network's fans shut off, is what caused the main power supply to shut off. The electrical panel powering the network's fans had a faulty electrical outlet that caused the panel to trip when a device was plugged into it. A high-temperature alarm on the 45 kV electrical network tripped during the technicians' rotation. However, they did not deem it a priority;

The reaction inhibition system is an active safety function that trips when the pressure in the reactor is high (15 bar) or when stirring is lost. When the accident occurred, the 'reaction killer' was injected due to the second situation. This injection, carried out using nitrogen as a driving gas, failed for one of the 22 reactors due to a loss of pressure in the nitrogen line that made it impossible to achieve the pressure difference needed to break the rupture disc between the tank and the reactor;

- creation of an overall supervision view of the reactors and creation of an alarm that appears when there are problems with injecting reaction killers into the reactor;
- leak detection by means of loss of nitrogen pressure (with alarm);
- closer follow-up of electrical check reports and main-to-backup power supply switchover tests.

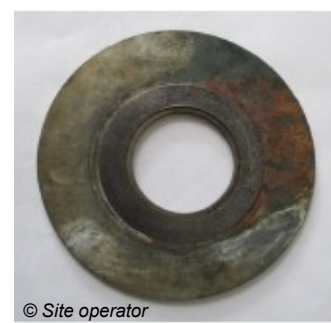
The initial leak inside the containment was caused by a leak on the pressure sensor of a pump and a leak on a flange's seal upline of a flow meter connected to this pump. The flange's seal had been replaced by a subcontractor called to assist an other subcontractor shortly before the accident. However, it had been incorrectly fitted. Seal installations are supposed to be inspected and inspected seals have to be identified with a label. As no label was on the valve in question, there was no way of knowing if an inspection had indeed been performed.

© Site operator
 Flange's seal upline of the flow meter

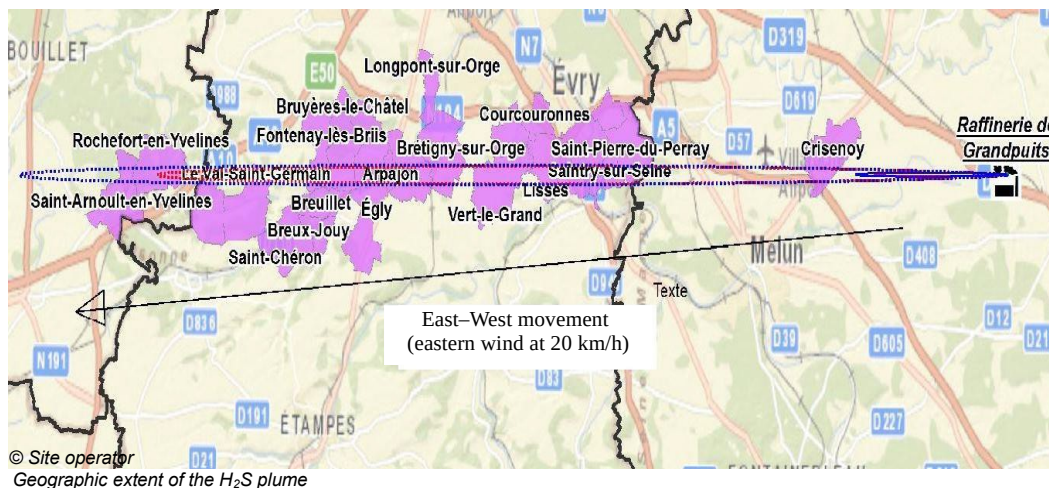
An analysis of the event showed that the leak occurred on a valve on the gas line between the purification column and the gas-flaring system. It was found that the valve's cap had been distorted by ice (outdoor temperatures below -5° C). During normal operation, the gas contained in the line does not flow. Heat tracing is used to prevent the formation of condensation, but the operator noted that it was not working. The expansion of the ice caused a crack to form in the valve. This crack then allowed the gas to leak out when the ice thawed. The lack of insulation and the fact that the valve was positioned at the bottom contributed to the build-up of water in the valve.

An estimated 187 kg of gas was released. The icy temperatures, strong wind, and atmospheric stability that remained very high throughout the event and the area explain why the odour was noticed in three counties. Computer models and air-quality measurements taken near the site show that the H₂S concentrations were very low (less than 1 ppm) and thus there were no offsite toxic effects. However, the significant lethal effect thresholds¹ may have been exceeded in some areas near the leak inside the refinery.

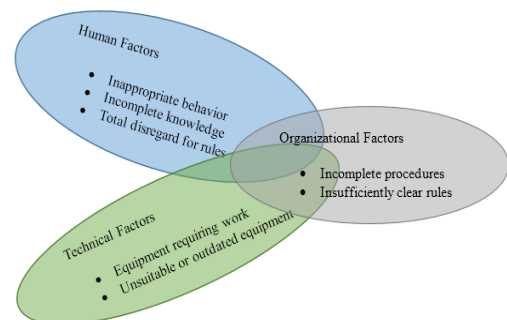
Lastly, the investigation showed that technicians inadequately understood basic safety rules despite thinking that they were following them and that technicians continued performing operations even if they did not go as planned (fear of being singled out as responsible for abnormal situations and for losses in site efficiency). In addition, half the refinery’s technicians stated that they preferred to keep silent about safety incidents out of fear of being punished. Employees no longer gave managers feedback because they feared bothering them and, because of a lack of responsiveness and pragmatism, have little motivation to take part in the process.

© Site operator
 Characterisation of the root cause behind various incidents

Following this assessment, a programme was launched to improve the safety culture at the refinery, focused on human and organisational factors. Using feedback from employees, the refinery’s management committee proposed four areas of improvement:
