LESSONS LEARNT from INDUSTRIAL ACCIDENTS

14th SEMINAR

LESSONS LEARNT

from industrial accidents

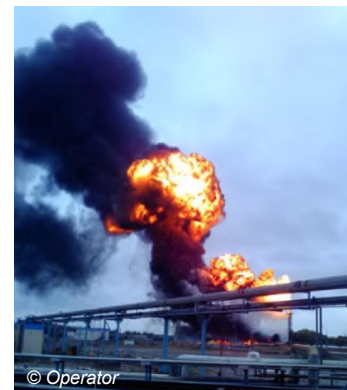
Ignition gas oil flare outlet

While the load operations were underway on HD1, the console operator brought a vacuum drying column on line to finalise the unit's restarting process. Although the operators are familiar with this operation, it is not mentioned in the specific restarting procedure. It was not considered as critical by the operators. However, it is expected that in the shutdown phase, the bottom level of this column will fill up due to condensation following the loss of the vacuum. Its design does not allow it to be purged before being brought back online and the restart procedure does not identify the risk of the flare tank overflowing. When this column was put into service, the high level alarm appeared. The console operator was having to concentrate on several operators at the same time and acknowledged the alarm while increasing the column's discharge rate. However, the discharge rate was less than that entering the equipment. The material balance between the incoming flow and the outgoing flow was not displayed on a single mimic diagram view. The column overflowed and the liquid diesel fuel flowed toward a buffer tank upstream from the flare. The high level alarm on this tank was triggered. At this point, the operator acknowledged the alarm and checked that the drainage pump was in operation. The pump's output was also insufficient. The tank's high level alarm was briefly activated, but then disappeared. The emergency drainage pump, slaved to the very high level, did not start. An external operator contacted the control room to report the smell of gas near the flare. The chief operator, busy with operations on the utilities console, came to check the HD units console for any operational discrepancies. Seven minutes later, another external operator called the control room to report flames and liquid spilling from the flare. The second pump on the buffer tank upstream from the flare was manually started and the column was bypassed, stopping the overflow of liquid from the flare.
