Ageing: it happens to all facilities

When the ageing of ICPE facilities (i.e., French classified facilities for environmental protection) is discussed, we often think of the PMII (i.e., French facility modernisation plan)¹. The purpose of implementing this plan is to manage the integrity of production facilities in order to protect against technological and environmental risks associated with certain equipment and systems.

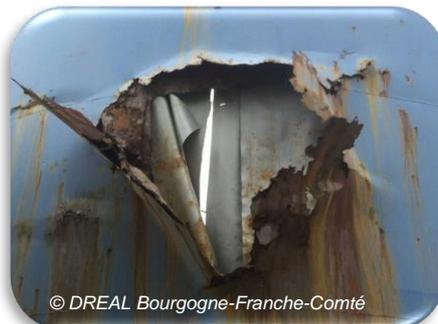
ARIA 51102 – 20/01/2018 – JURA

A breach occurred in the upper section of a vertical tank 96% filled with rainwater containing mercury in a chemical plant. This lined 628m³ steel tank was used to collect excess rainwater. Staff detected the incident at around 04.30 a.m. during a round. 134m³ ran into the SAÔNE river with a flow of 65g of mercury. In May 2017, an inspection of the tank had revealed it was in a degraded condition (non-PMII tank). It had been scheduled to be shut down by the end of April 2018, i.e., allowing the time required to replace this tank with another existing tank. Pending this permanent shutdown, the tank was not disconnected so it could potentially be used to store effluent requiring storage. The tank operating instructions were adjusted (limiting of filling level to 60%) and its use was deprioritised.

The unscheduled shutdown of the residual water processing facility due to non-delivery of one of the reagents used by the plant, combined with heavy rain, generated an increasingly large stock of effluent. To handle this stock, the tank was used and its filling level was then exceeded.

The operator authorised staff **not to follow this instruction** to deal with this unusual situation. In May 2021, another accident happened. A breach in a tank of brine containing mercury released 2.5kg of mercury into the SAÔNE

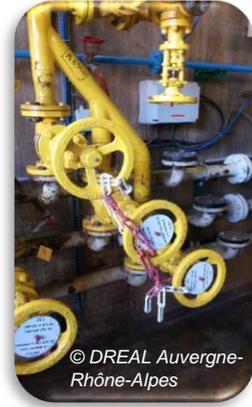
ARIA 52654 – 23/11/2018 – RHÔNE

In a PVC production plant, when decanting was started up, a **chlorine leak** occurred on the compressor inlet gas **pipe, outside** the chlorine storage building. The valve was shut off to isolate the leak. White fumaroles were observed. Given the very calm wind, the cloud stagnated, then headed towards a neighbouring business that **evacuated its staff**.

According to the operator, the leak lasted 1 minute at 3 bars, causing the discharge of 5kg of chlorine. It stated that this event did not generate any irreversible effects outside the chemical platform.

The leak was from a full elbow. Localised corrosion was suspected due to the presence of ferric chloride. The pipe could have caused major accidents and **was monitored via a PMII**.

The classified facilities inspectorate found that the **pipe inspection reports were incomplete**:

- they did not enable **monitoring of the thickness measurements** taken;
- the lines' **singularity points** were **not clearly identified** in the diagrams;
- the ferric chloride **mode of degradation** was **not identified**.
