Synthesis

Accidents involving fires at surface treatment facilities

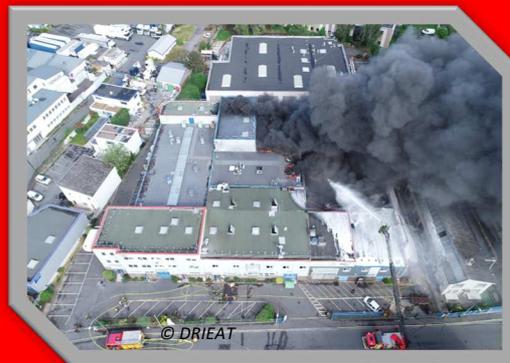
ARIA 56568 – 10/01/2021 – Marignane (Bouches-du-Rhône)

The section of the workshops housing the surface treatment facilities, i.e., a business line crucial for the site, was destroyed. There was an estimated €11m of property damage. 35 staff were laid off. 650m³ of water used on the fire was collected in the firefighting water basin. In the evening, the operator decided to discharge 200m³ of polluted water, exceeding the zinc emission limit value (ELV) in order to maintain storage capacity in case of failure of a surface treatment product retention tank, which would have been far more hazardous for the environment. The anti-pollution basin was treated by the site's decontamination plant. The retention basins and other polluted zones were pumped off by a specialist business. The operator took cyanhydric acid measurements every 30 minutes in order to be able to ask the fire department to lock down the zone in case of anomaly. Piezometric monitoring of underground water quality under the site was set up, as was off-site sampling to measure fall-out from the fire (soil and surface sampling).

The fire was caused by an electrical fault, either in an electrical control cabinet located near the processing line, or directly affecting one of the treatment lines. This fire then spread to the remainder of the facility via Plexiglas anti-splash panels, acid vapour extraction ducts, and bath vats. It mainly spread via convection, facilitated by the acid vapour extraction system's venting and high combustible potential in the surrounding area. The lack of surface treatment line fire detection systems, limited smoke extraction on the premises, and the ceiling's construction format were contributing factors in the spread of the fire before the alarm was raised.

The facilities had been secured (water supply shut off, bath heaters shut off) by a trained and qualified operator the day before the accident (information confirmed by surveillance cameras). The security guard's patrols until 06.00 had not identified anything abnormal. The fire broke out due to an electrical failure or electrical heating linked to a metal part left on the vat according to the investigation that was carried out. The line-type smoke detectors and optical flame detectors in the workshop were inoperative due to their inappropriate position following building work carried out a few months earlier. As a result, there was no fire detection for 90 minutes preceding the flashover on the line.

After this fire, the operator planned, among other measures, to:

- review the design of the workshops to shut off electrical supplies in production zones during non-production periods;
- modify the site closure procedure to record and check every stage of the process;
- reinforce the fire detection system with new detectors;
- double the containment basin to separate incompatible types of water used on fires (acids / cyanide);
- create several separate fire-walled compartments.

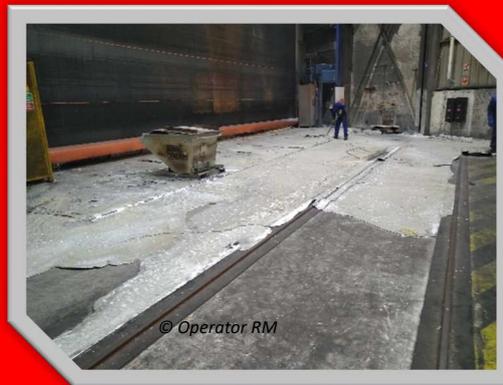
Explosion including splashing zinc and fire

At 19.10, at the end of the immersion of a part in a galvanizing bath, there was an explosion at a metal surface treatment business. **The explosion splashed 15T of zinc** over a 200m radius around the basin. As the zinc had been heated to 450°C, 3 fires broke out involving combustible materials located in this zone: PVC, electrical cables, a plastic looped carpet, a curtain tarpaulin, and an HDPE hose-based compressed air system. First responders brought these incipient fires under control until firefighters arrived. Production was shut down for 27 hrs. Waste generated included around 100kg of burned plastic and approx. 20kg of steel. Fumes emitted during the accident were partially extracted via the facility's zinc filter that was running. A set of electrical cabinets controlling an ash U-trough conveyor was destroyed.

The part involved was unsuitable for galvanization as no holes had been drilled in it. During immersion of a hollow body in molten zinc, if the body has not had holes drilled in it, the pressure increases sharply until the hollow body breaks. The pressure released by the hollow body generated a shock wave in the zinc bath and splashed zinc outside the tank. The event was due to **failure of the inspection line** checking customer parts from delivery to galvanization.

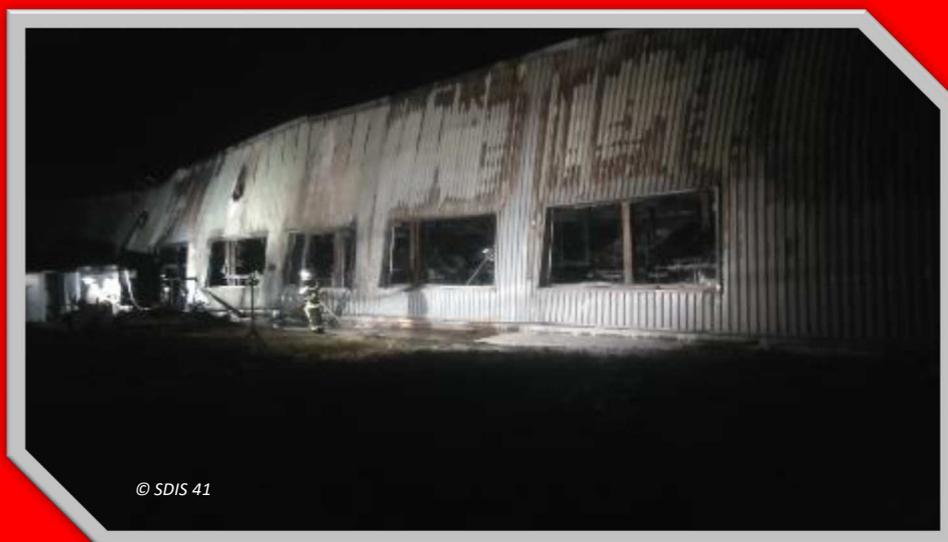
It would appear that the fire broke out in a PVC degreasing bath that had been emptied for maintenance. An issue affected **the level sensor: it was stuck in its upper position, preventing the bath heater from shutting off even though a low level was detected**. It would appear that the formation of sodium hydroxide crystals around the float was the cause. Nobody checked that this sensor functioned when the bath was emptied. The timer used to automatically control heating was programmed to start the baths back up on Monday morning. Production decided to heat a specific bath on Thursday evening. This bath was on the same programme as the empty degreasing bath. As programmed, heating started at 23.00. The electric immersion heater was turned on in the empty bath and set light to the vat. The continuously functioning extraction system fanned the incipient fire and set the rest of the workshop on fire...

The operator drew up an empty tank securing procedure, including possible disconnection of the heating system at the electric cabinet by the maintenance department. The procedure also includes systematic checking of proper functioning of the level detector.

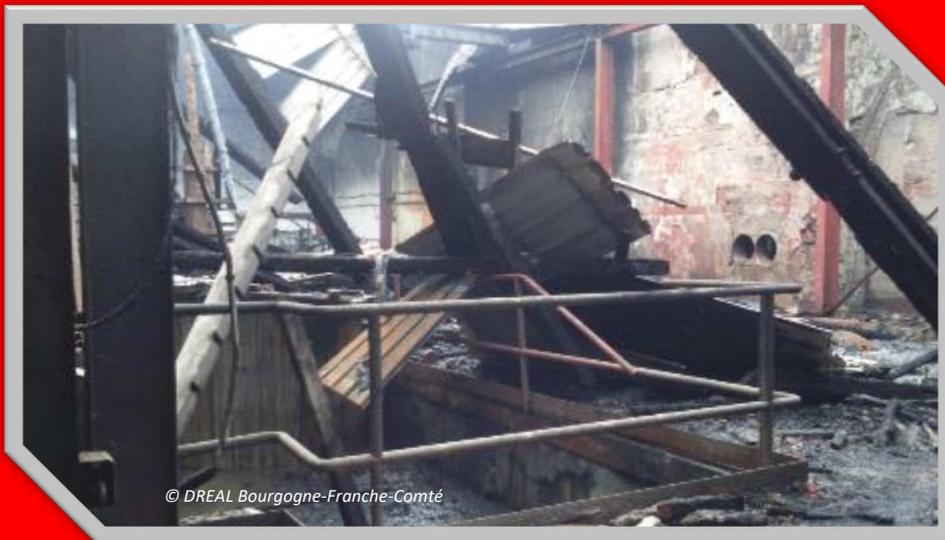
**Destruction of a surface treatment workshop in a fire
ARIA 47964 – 27/04/2016 – Autun (Saône-et-Loire)**

At approx. 22.30, a fire broke out in a pickling workshop in the galvanization zone of an industrial boiler shop. The fire spread to the adjoining workshop, causing the destruction of 1,000m² of the building. The metal roof and its wooden framework were affected by the incident and collapsed. The workshop plus various adjacent premises were entirely destroyed. **The main extraction duct facilitated the spread of the fire.** Effluent poured into retention systems. Some retention systems, made from composite materials, were ineffective. They were burned in the fire. The site's systems were sealed with inflatable devices. The fire was extinguished at approx. 03.30 and monitoring was set up until 07.30. The next day, rubble was removed, and a folding canopy was set out over the retention tank pending recovery of the chemicals by a private company.

An electrical short-circuit on an electric immersion heater in one of the 12,000L plastic tanks containing 10% hydrochloric acid caused the fire.

The operator was planning to set up non-electric heating systems and modify their firefighting water retention system.

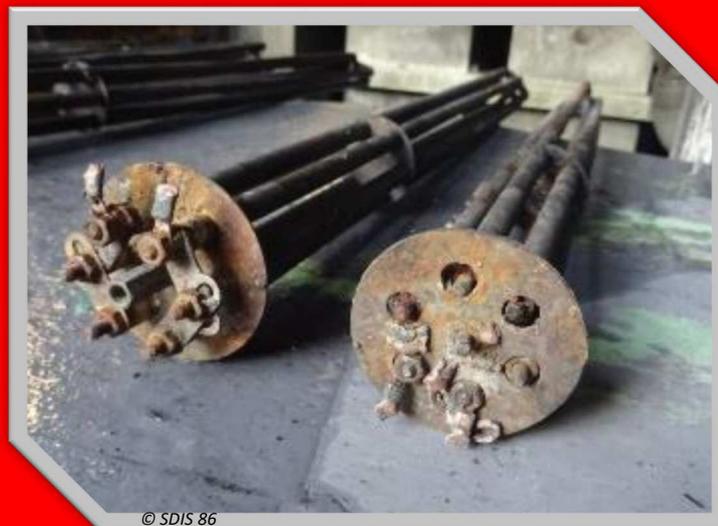
ARIA 52811 - Fire in a surface treatment workshop

Shortly before 14.00, a fire broke out in acid baths containing several chemicals in a metal treatment plant for leatherworking accessories. The accident happened during the end-of-year leave shutdown period. A large plume of black smoke rose from the building. A security perimeter was set up and traffic stopped around the site. Firefighters extinguished the fire using water and foam at 17.30. Several tens of m³ of water were used. Some of this water ran into sewer systems. The municipal WWTP's management was informed. Monitoring was put in place for 2 days. The fire destroyed 600m² of the building's surface treatment workshop. The other parts of the building were spared. The 17 employees were laid off. The site filed for cessation of operation following the fire.

The fire was caused by a **short-circuit in an anti-condensation heater connection box. The heater continued to heat the bath, even though the liquid had evaporated. The temperature then increased until it short-circuited.** The heating zones had been cut off at the electrical control cabinet, but the cabinet's breaker had not been cut. The operator found that **nobody checked that the anti-condensation heaters did not function in the heating contactor's "stop" position.**
