LESSONS LEARNT from INDUSTRIAL ACCIDENTS

15th SEMINAR

23 - 24 May 2023 - Marseille

LESSONS LEARNT

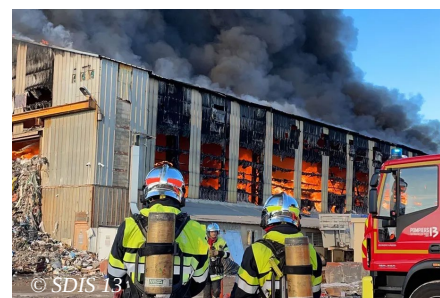
Given the large amount of waste, inaccessibility of the seat of the fire, the risk of building collapse and the inaction of the operator, the public authorities decided to demolish the building, before setting to work on the piles of waste and spreading them to reach the burning areas and water them abundantly. About 6,000 metric tons of waste (about 7,500 m³) had to be removed urgently to allow the intervention of the fire engines. The fire was finally extinguished 47 days after the outbreak. About 15,000 m³ of waste was burned.

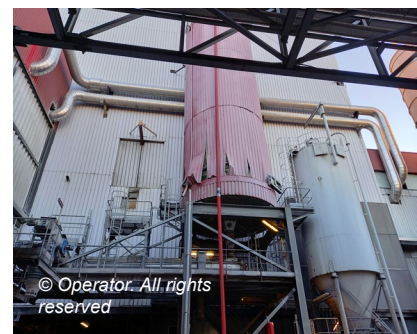
At about 6:30 a.m., at the start of unloading operations, a silo measuring 15 m in height (25 m with supporting feet) and containing 130 metric tons of RPIFW (Residues from the Purification of Incineration Fumes from Household Waste, in powder form, considered to be hazardous waste) collapsed on its base.

When it collapsed, the silo came to rest against the building housing the fume treatment plants located just behind it. In addition to the risk of the silo spilling, the operator feared that it might collapse onto nearby facilities—an activated carbon silo (30 metric tons) and steam pipes—and that they might be damaged.

Damaged RPIFW silo

The silo had been installed in early 2000 to replace an existing silo. There were no obvious signs of ageing. However, heat insulation around the silo masked the walls, preventing any visual detection of any anomaly.

The silo was dismantled and cut up. The initial observations showed that the walls were thinner at the bottom of the silo, at the site of the collapse, leading to an assumption of chemical corrosion at the lower crown of the silo.

- provided evidence of corrosion of the silo steel, which did not have anti-corrosion protection (paint coating type) in the weakened area;
- noted the presence of more marked degradation on the internal surface of the silo (RPIFW side);
- also specified that the chlorine in the RPIFW could be aggressive enough, in the presence of moisture, to allow the corrosion process to begin. Nonetheless, CETIM experts believe that the rate of corrosion (determined from electrochemical measurements) cannot alone explain the loss of material observed;
- finally underscored that a thin coating (epoxy paint type) was identified on the internal surface of the silo on undeformed areas of the silo and concluded that this type of coating (which was originally present on the internal surfaces of the silo), although generally very resistant, had more limited mechanical strength (wear, for example).

The subject is about to be closed 18 months after the event. A new silo was ordered with a capacity of 200 m³ (instead of 300 m³ for the old silo) and special anti-corrosion and abrasion-resistant coating. It should be delivered and installed in March and April 2023. However, discussions are still ongoing between the operator and the inspection team about the heat insulation that the operator is again planning around the silo.

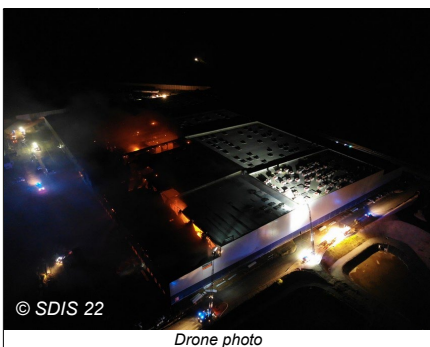
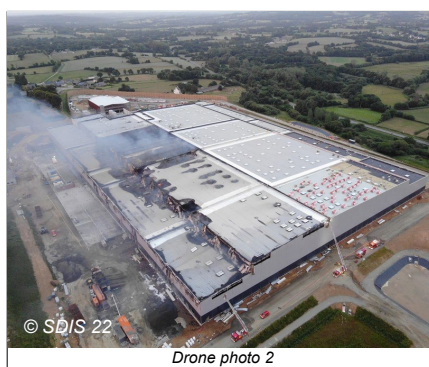
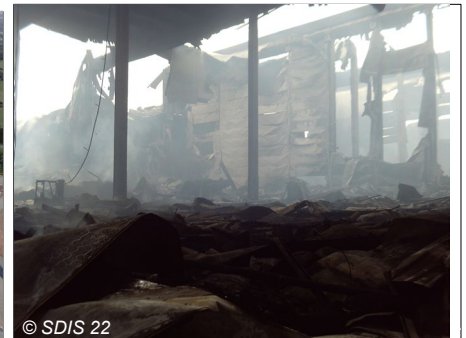
Waste was disposed of using appropriate streams (including pumped water): a total of 1,650 metric tons of waste was treated.

The operator estimated the cost of the loss to be €34 million. One hundred and fifty people were laid off temporarily. Commissioning of the platform was delayed by 15 months.

The origin of the fire related to concrete floating work (using a double-blade concrete power trowel) in a cold store under construction. The presence of insulation board stored near the thermal float machine explained the rapid development of the fire, which then spread to the structure (timber frame).

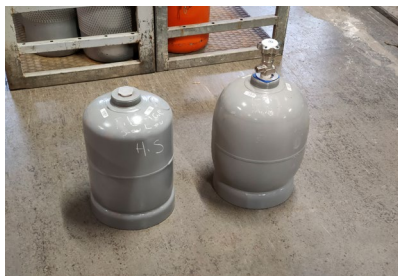
The explosions were due to overpressure during the inflation phase of the test, resulting in the bursting of the steel cylinders. The operator in charge of the test connected 4 low-pressure cylinders (LP, 22 bar) to the high-pressure cylinder filling system (HP, 200 bar) for the nitrogen leak test. After a few minutes of pressure increase, 3 cylinders exploded and a fourth deformed.

Normal (left) and deformed LP cylinders after leak test (right)

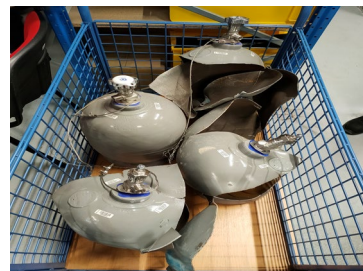
LP cylinders after the accident
