Ammonia Equipment malfunction Rupture disc / relief valve Human error Organisation / crisis management Media impact Incident analysis

No. 12671

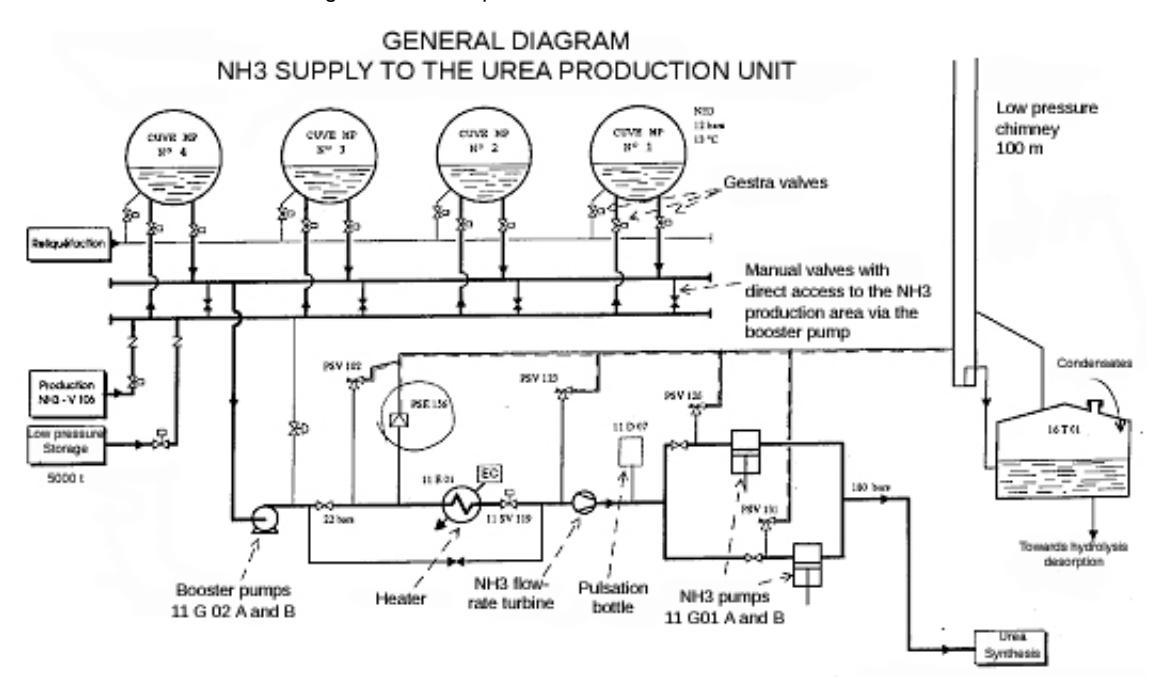
At 5:20 am, a night watchman noted a frosting (which indicates the presence of ammonia) downstream of a relief valve (PSV126) at the output of pump 11G01 that supplied NH_3 to the urea production facility. The corresponding equipment was located on the exhaust collector system shared by all relief valves installed in this part of the plant and connected to the chimney base. The leak was considered to be very slight and induced by reactivating the NH_3 circuit after opening direct conduits. A steam reheating unit was set up on the PSV126 relief valve to defrost the circuit.

From 5:50 to 6:25 am, once the assigned plant engineer had arrived on duty and analysed the situation (in drawing the conclusion of inefficient valve heating), the heat exchanger located downstream of the NH_3 pump was isolated along with its relief valve.

The hypothesis of a rupture to safety disc PSE153 was suggested at one point but then rejected since the unit supply intake appeared to be operating correctly; instead, the focus was directed towards a break in the seal of a relief valve after its opening subsequent to disturbances created by malfunctioning check valves.

The accident analysis revealed that this leak occurred at night while the unit was in stable operating mode, following a quarter-turn opening of its cross-section by a PSE156 rupture disc (ref.: P. rupture 33,4 b), which served to protect a tubular exchanger subsequent to a pressure surge on the liquid NH_3 circuit connecting the medium-pressure NH_3 storage zones with a urea production workshop. The exchanger was also protected by a relief valve adjusted to 31 bar (PSV102). The exhaust from this disc and relief valve was collected in the same pipe, which was also hooked up to a duct common to all liquid NH_3 relief valves in the circuit (12-inch duct diameter). Moreover, this duct was connected to the low-pressure chimney in the shop area.

The site operator conducted an in-depth technical analysis of the accident, and plant installations were subsequently modified (by eliminating the rupture disc, installing sensors and automated safety devices). A safety report was also produced for all of the site's ammonia circuits.

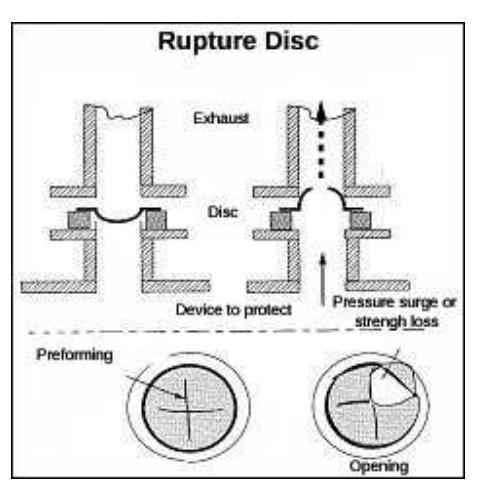
- ✓ A defective rupture disc supplied from an old batch (1982) and installed in 1995. The accident investigation revealed a smaller thickness (0.05 mm) than that of "identical" discs supplied afterwards, resulting (according to calculations performed) in an actual bursting pressure significantly less than the design pressure, i.e. a value of 22.3 bar, which lies very close to typical pressure levels encountered. This disc needed to be eliminated from the installation.

- $\sqrt{}$ Poor design of both the circuit and rupture disc (i.e. a shared collector pipe).
- $\sqrt{}$ Despite the poor dispersion conditions, inoperable NH₃ detectors installed around the plant periphery were detrimental, given that the toxic cloud was discharged by a 100-m tall chimney.

- $\sqrt{}$ No NH₃ leak detection device had been installed at the chimney flue.
