Fire in an agropharmaceutical products storage area February 1st, 2001 Port-Ia-Nouvelle – [Aude] France Chemistry Pesticides Sulphur Works Hot spot Fire-permit Soil clean-up operations

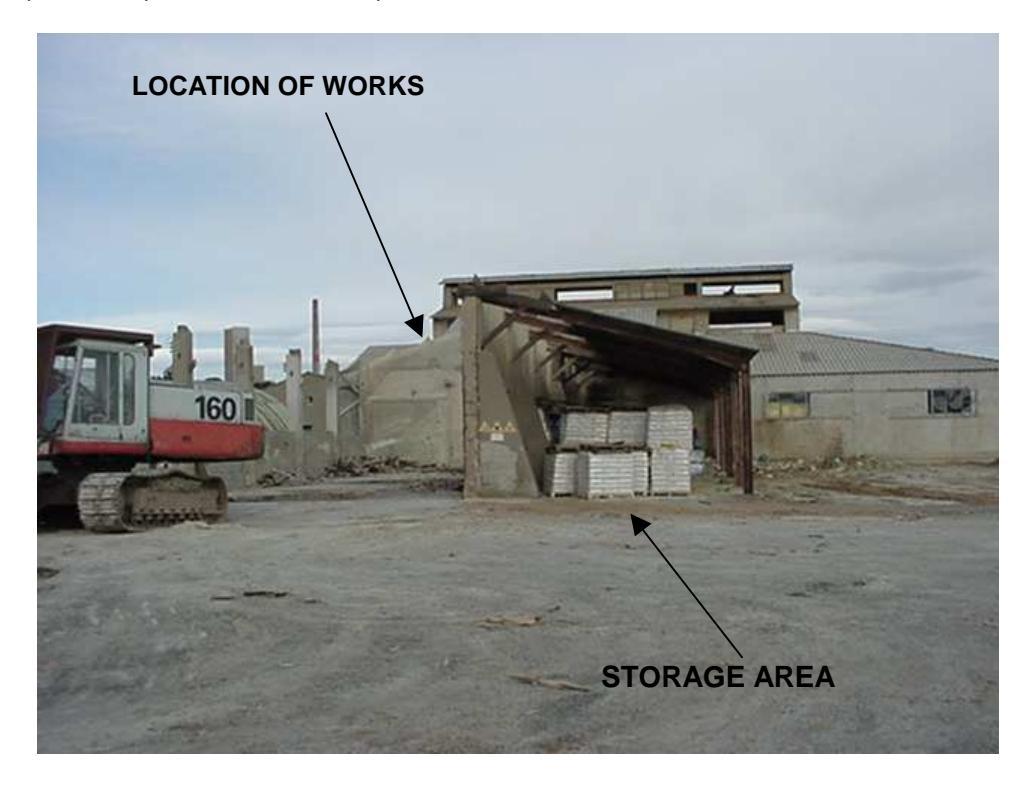
The site where the fire broke out is a storage area located under a canopy and back-to-back with a small building.

The building is covered with fibre-cement roofing panels supported by a timber frame whose beams traverse the common wall and support the roofing panels that cover the storage area under the canopy.

A total of around 50 tonnes of agropharmaceutical products are stored in sacks on pallets on this site.

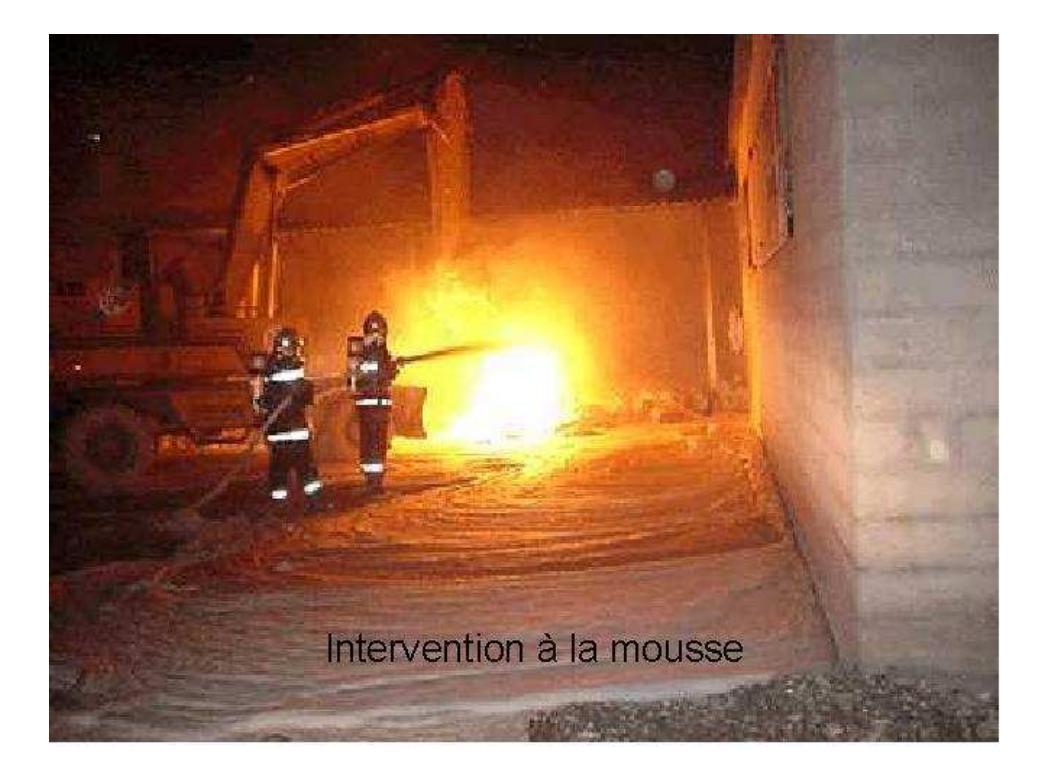
Alerted by neighbours at approximately 7.30 p.m., the fire department arrived on the site immediately and saw that part of the materials being stored under the canopy was on fire.

The fire was brought under control at approximately 10.30 p.m., after several minutes of using a water-foam concentrate mixture, consecutive to the initial attempt to extinguish it by applying water.

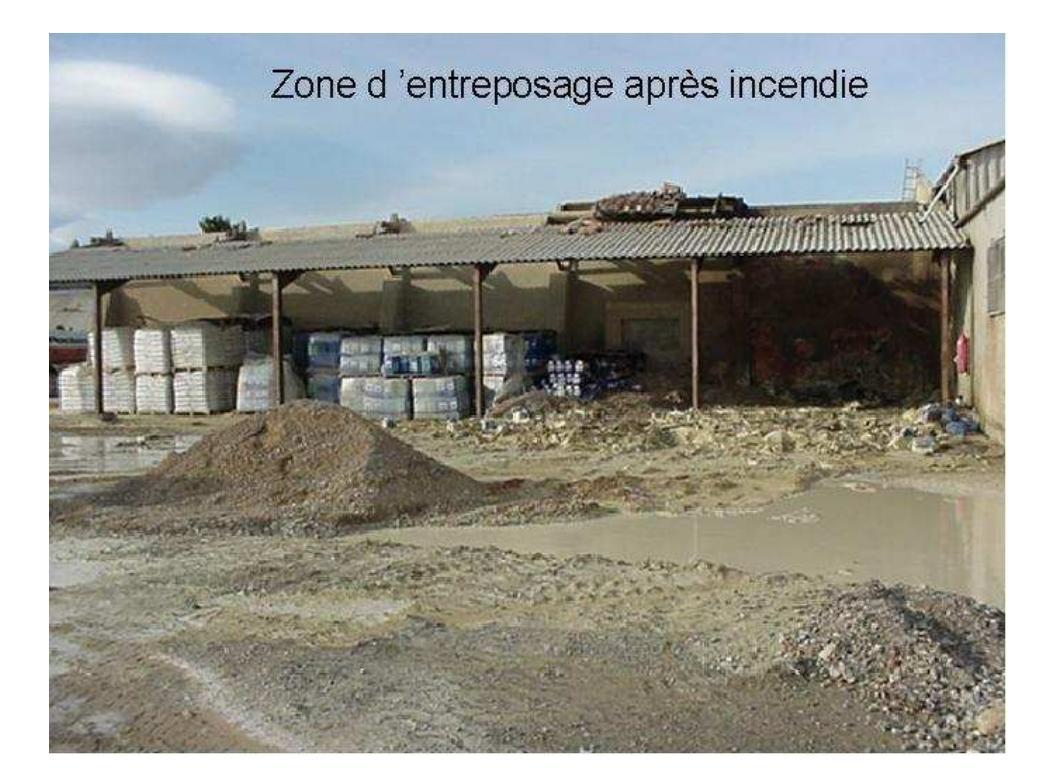
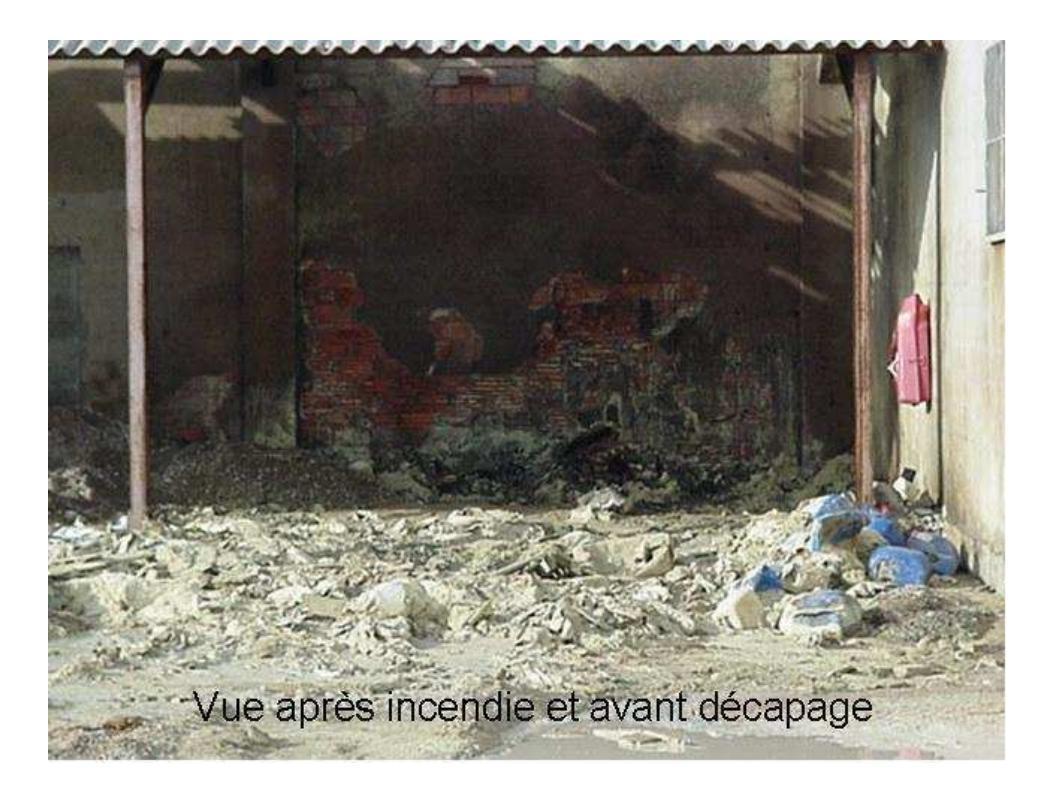
Twenty-four tonnes of phytosanitary products of the 50 tonnes being stored were destroyed; the materials involved in the fire were :

The firefighting water caused mud containing agropharmaceutical materials to spread over approximately 300 square metres, leading to the excavation and incineration of 120 tonnes of polluted soil.

✓ Clean-up of the soil by strip excavation to a depth of 20 cm and incineration of the 120 t of products collected in an authorised waste disposal site

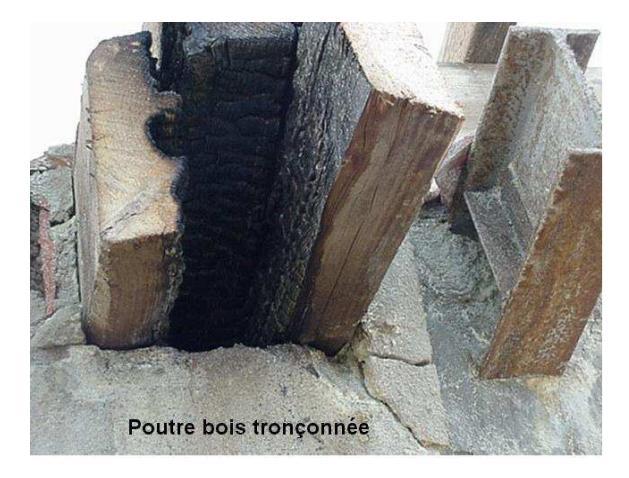
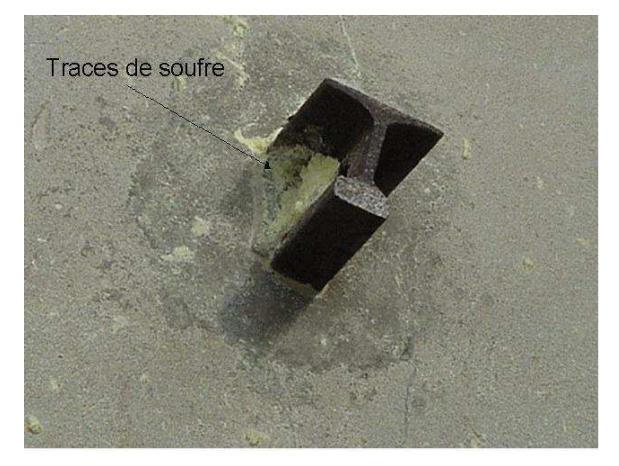
The frame was cut up using a circular saw which, according to findings made on the site, heated the wood to the point of triggering, on part of one beam, a slow, imperceptible phenomenon of combustion at the time the work stopped and the worksite was evacuated at 5.45 p.m..

The beam in question had been cut off at the level of the wall on the building side, but its end, which remained inside the wall, was sticking out under the canopy (roofing support).

The heating phenomenon was probably amplified due to sulphur residue present in the cracks and cavities in the frame and the wall.

Burned particles fell onto the plastic sheeting, causing the fire to spread more easily to the packaging and then to the materials being stored and the pallets.

✓ Updating of the procedure and records concerning work permits and fire permits:

- extension to all locations on the site,
- obligatory work stoppage at 3 p.m.,
- inspection 1 h after work stops on the site.
- ✓ Setting up of an internal contingency plan;
- ✓ Purchase of foam concentrate and periodic fire drills with fire-fighters;
