Explosion during maintenance in a refinery October 6, 2000 Port of Antwerp **Belgium**

Explosion Fire Refinerv Cracker **Propylene Small branch connections Static electricity** Maintenance Equinment failure

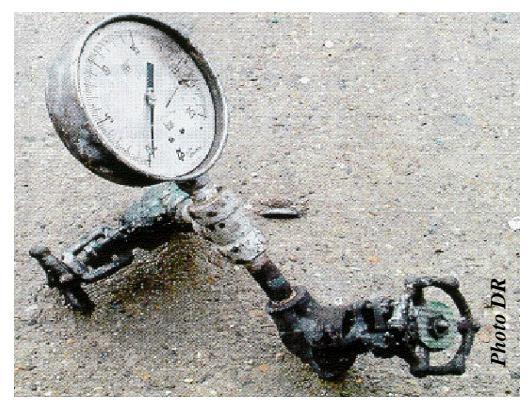
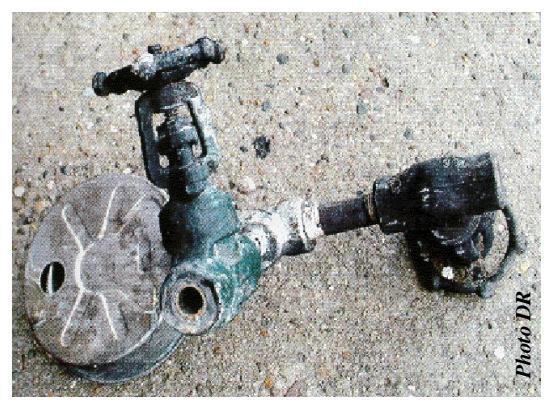
At 00.27 am, a plant employee was attempting to replace a pressure gauge located on a branch connection on the hydraulic upstream side of the pump which conveys the propylene from a tank to the depropaniser (a tower designed to separate propane from the rest of the products). The pump is located at the limit of the unit, in an open space. Its discharge pressure is 20 bar. Using a wrench, the employee attempted to unscrew the pressure gauge on the branch connection. During this operation, the branch connection ruptured at the pump's discharge pipe connection. The employee was sprayed with propylene then product began moving toward the open space. A gas cloud formed near the production unit then ignited very quickly. This ignition was followed by an explosion and a fireball roughly 20 m in diameter.

The fire then was limited to a "torch" which lasted a few minutes until the propylene leak was stopped. The flow rate of the leak was estimated to be 16 t/hour. Approximately 1 ton of product was released.

The clothes of the employee performing the operation caught fire. The individual suffered 3rd degree burns, particularly to the face, arms and legs despite the fact that he was wearing clothing in compliance with safety regulations. Property damage was limited. Damage was essentially located around the pump. Piping located on the other side of the open space, between the 2 units, was damaged by the fire.

✓ The connection was between a ½" branch connection and a 4" pipe. The specification indicates that, for this type of construction, a "model 80" connection must be used. In this configuration, the tube is 3.7 mm thick.

✓ The actual thickness measured (2.5 to 2.7 mm) tends to show that a "model 40" was used, for which the corresponding specification calls for 2.8 mm.

✓ In compliance with specifications, the junction between the valve and the pipe must be welded while on the section concerned, the junction was threaded.

The calculations show that the connection, as built, had a rupture strength 5 time less that then one described in the specifications. Rupture during handling operations in such conditions is thus not abnormal. The construction of a non-compliant connection is the direct cause of the accident.

A vast inspection and repair program was set up regarding the branch connections currently used and considered to be at risk. The other branch connections will be included in the periodic inspection plan. Assemblies that are not compliant with the construction criteria (in compliance with the construction rules governing small branch connections) shall be identified with a specific marking system indicating that they should in no case be manipulated with the installation in operation.

The implementation of the inspection and repair program showed that different specifications were used in the construction of the assemblies on the small branch connections. A new specification for these elements was thus drawn up, based on international practices on the subject.

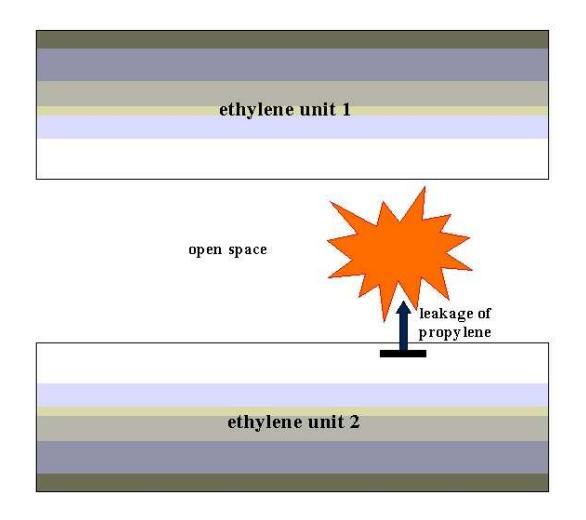
However, the installation of the pressure gauge and its configuration on the pipe allowed the cloud to drift to an open space. The Inspectorate thus asked the operator to engage in reflective thinking focused on what may have happened if the cloud created by the leak had drifted in a different direction and had ignited near a production unit.
