- FFO leak in a petrol station October 12, 2001 Gennevilliers – [Hauts-de-Seine] France
- Aquatic pollution Petrol station Furnace fuel oil Pump Equipment failure Installation defect Organisation Danger study Floating barrier

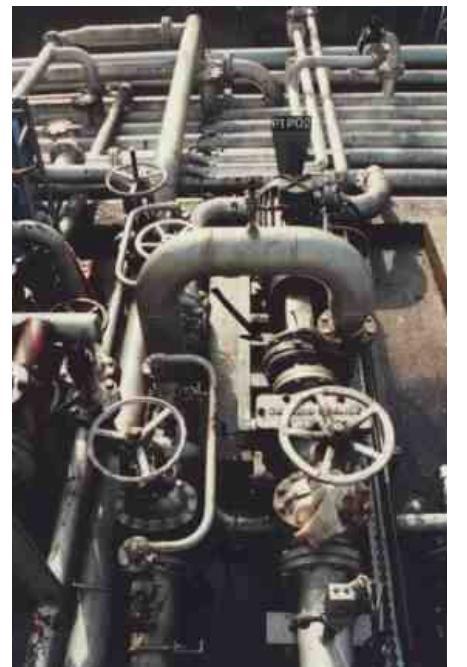
Photo : DRIRE Ile-de-France

The leak occurred on one of the pumps of pump station No. 1. The pump body ruptured. This rupture was due to the accumulation of excessive stresses linked to:

- incorrect supporting of the lines and line accessories,
- lines incorrectly attached to the pump.

The phenomena was aggravated by the nature of the pump's casing (cast iron).

- the depot was secured,
- disassembly and verification of all the pumps of pump station No. 1,
- expert evaluation of the pump, (it should be noted that an attack alert occurred the day before),
- closure of the Seine discharge valve.
