Explosion in a carboxymethyl cellulose production plant

11 July 2009

Nijmegen (Gelderland)

Explosion
Fire
ATEX
Degraded mode of operation
Human factor / operating procedures
Risk analysis
Management of modifications

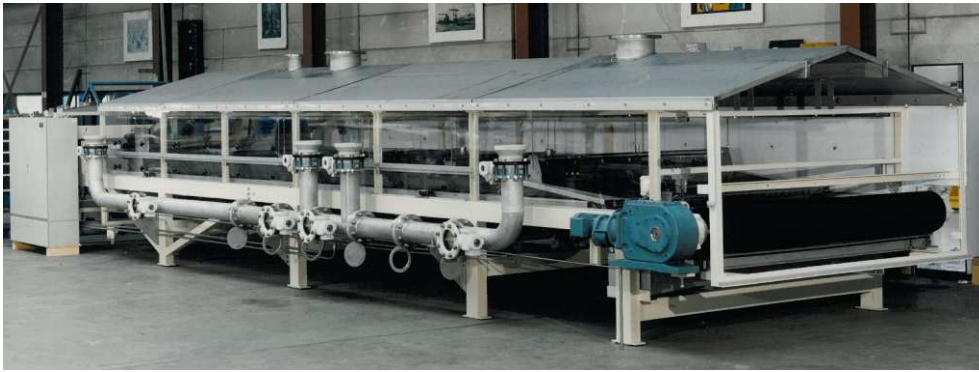
Generic illustration of a RT vacuum belt filter (Picture Larox Pannevis R.R.)

The involved unit is a vacuum belt filter type RT (Reciprocating Tray). A continuously moving filter cloth is supported inside a rigid, profiled movable vacuum tray, providing the vacuum area of the filter. The bottom of the tray is an open grid structure. The cloth is driven via a head pulley.

The slurry is distributed on the cloth at one end and the liquid from the slurry is removed via the vacuum tray in a first vacuum step.

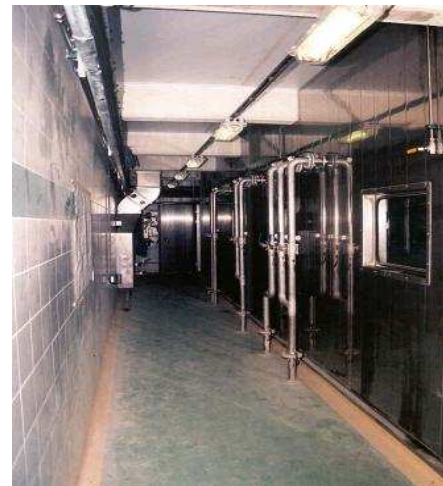
Outside view of the steel plated enclosure (RR)

Good practice is to use a GT (Gas Tight) type vacuum belt filter when a solvent is used during the purifying process. However, due to the experience of this company (difficulty for maintenance, adjusting the belt) and the costs involved (GT Type 3 times more expensive than RT type)) the company decided to buy two RT Types vacuum belt filters and build the enclosure on their own behalf.

Since possible ignition sources were present in the enclosure, the prevention of an explosion entirely rested on upon the prevention of an explosive atmosphere. A nitrogen purge unit was used to prevent an explosive atmosphere in the enclosure.

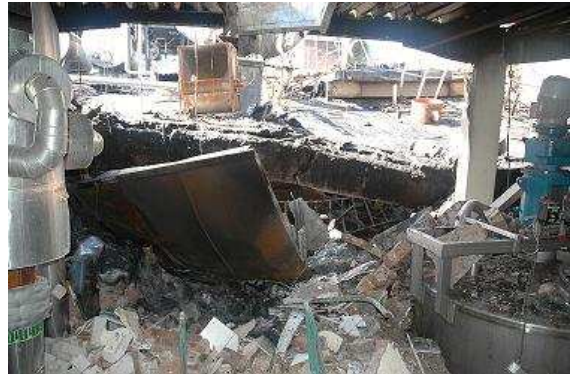
At about 4.15 pm, the supervisor opened the slurry valve in order to continue the production process. Immediately after opening the valve an explosion occurred and destroyed the enclosure and surrounding compartments of the factory and set fire to the building. The stored CMC in the expedition part of the factory smouldered for 38 hours.

The explosion was the result of an ignition source associated with an explosive atmosphere in the enclosure of the vacuum belt filter :

- The ignition source is not precisely known, as the explosion completely destroyed the vacuum belt filter and surrounding enclosure, but several plausible sources were present: moving items, electrical components and a mechanical cake-breaker inside the enclosure as well as electric lights, pumps and engines outside the enclosure.
- The explosive atmosphere was present due to the presence of ethanol and air. Indeed, fresh air was brought into the enclosure via the opening of the trap door of the transport screw, which led to an oxygen (O₂) concentration of 20 %vol.
