## Flooding of Process Industry sites

05-06 December 2013

East coast

United Kingdom

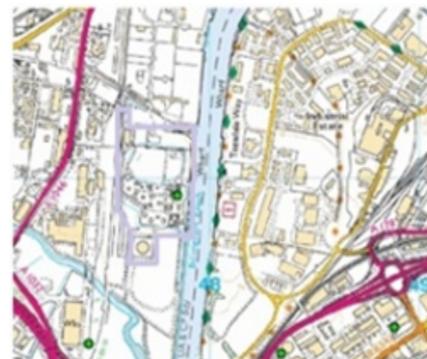
Source Environment Agency

Inter Terminals, Riverside Terminal, is located on the north bank of the River Tees. The site provides bulk liquid chemical storage in above ground storage tanks with facilities to carry out import/export operations associated with shipping, road vehicle and pipeline transfers. It is an upper tier Seveso storage operation. The site is substantially automated with remote valve operation to enable transfer routes to be selected automatically.

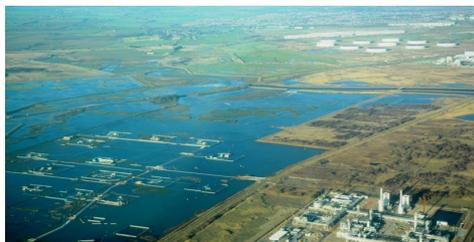
Figure 5 : SABIC Brinefields and the flood defence breach, source Environment Agency

At approximately 11pm, whilst undertaking a routine tour of the Brinefields and Cavities area, a process technician heard a large crashing sound and observed what he later described as a tsunami like wall of water coming from Greatham Creek and heading toward the Brinefields and Cavities area which stores thousands of tonnes of hydrocarbon in underground salt cavities. Fortunately the technician was in a safe location away from the incoming water.

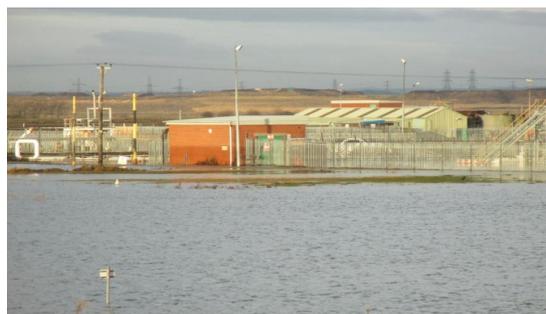
Figure 6 : Control room on the Brinefield – note flood level mark on control room wall, Source Sabic UK Ltd

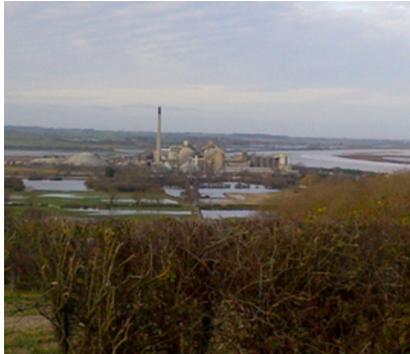
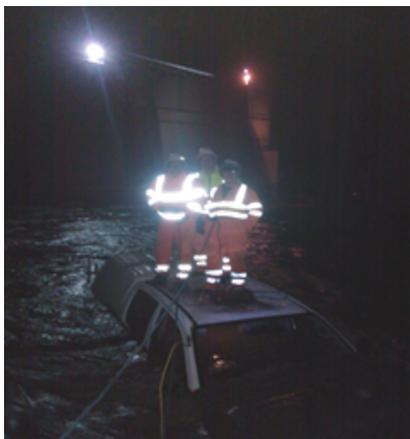
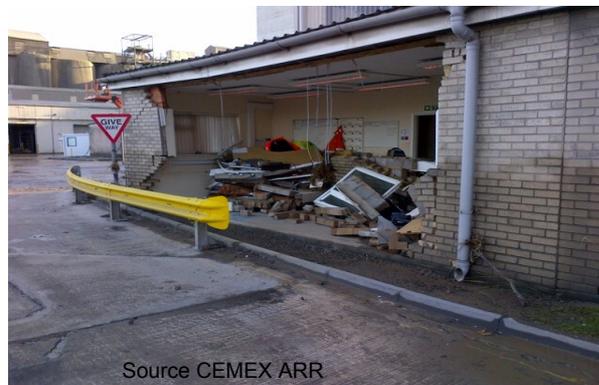
The flood water and silt caused catastrophic un-repairable damage to control systems, the power supply network, compressed air systems, buildings and the cement kiln which was currently operational due to insufficient cooling time. High and low voltage systems were wiped out by water tracking into the terminated ends of the cables. Production was not possible due to the flooding.

The site was without electricity for many weeks and production did not start until the summer of 2014. The main lesson learned was to protect electrical systems such as transformers from flooding by building walls around them or raising them above the level of flood water.
