Fire on two industrial sites with adjoining storage areas

26 September 2019

Rouen and Petit-Quevilly (Seine-Maritime)
France

Conflagration
Pool fire
Combustible liquid
Warehouses
Outdoor storage areas

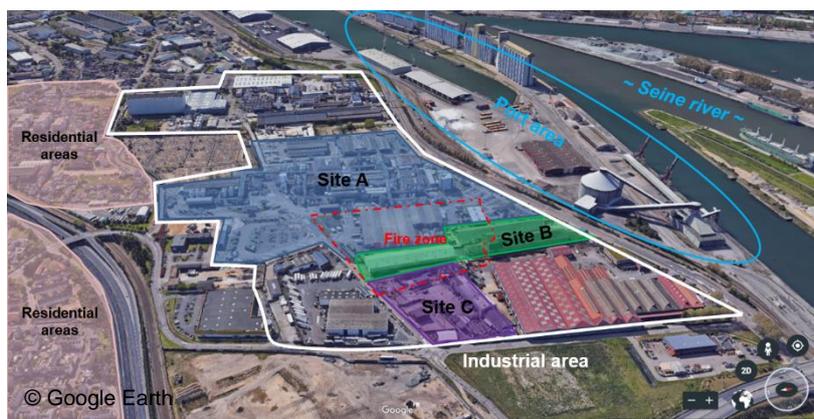
Authorised in 1953 under the "general stores" statute to perform warehousing activities, it consists of four covered buildings. This site, which benefited from historical precedence,² was known to authorities under reporting arrangements. Given the volume of the facility, it is now subject to the ICPE registry system under section 1510.³ Among others, packaged products from site A are stored here. Two of the buildings on site B adjoin site A, and another adjoins site C, an ICPE specialising in waste treatment.

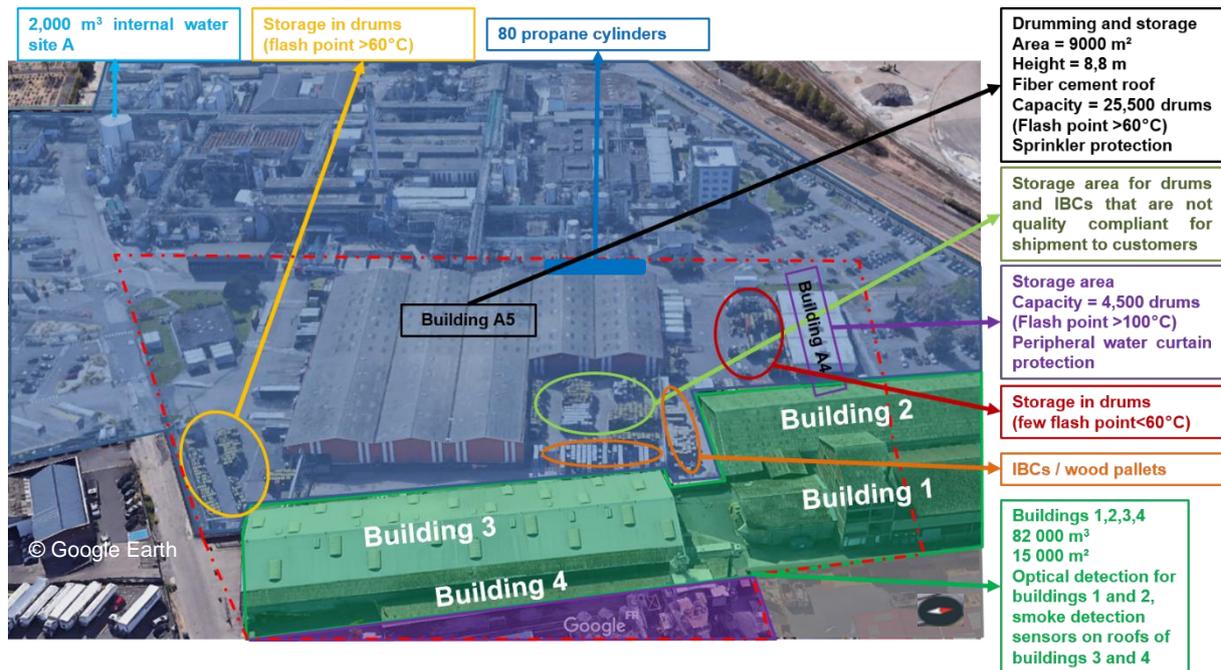
Closeup of fire zone:

Three sites were involved in the accident: sites A, B and C. Site C was little affected.

For site A, only the storage area for packaged products, consisting of buildings A4 and A5 and the outdoor storage areas of these buildings, was involved. No production hall or large storage container area was affected. The image below shows the positions of containers (drums and IBCs) in the zone, whether they are empty or filled with flammable liquids,⁴ category 4 flammable liquids⁵ or liquids with flash points above 93°C. Phosphorus pentasulphide is stored near this fire zone.⁶ Moving these containers was one of the first actions taken by site A employees and the fire-fighters. This prevented potentially much more serious consequences given the hazard statements for this substance. For security reasons, its location is not specified on the map below.

The four buildings on site B were affected by the fire. About 8,000 tonnes of products were in storage. Of these, about half were products belonging to site A, either combustible liquids or liquids with flash points above 93°C, as well as combustible solid products. There were no flammable products.

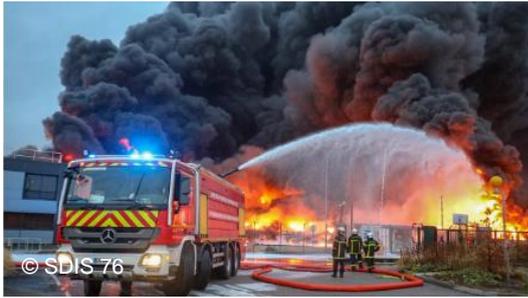
Impact on the industrial zone:

About 10% of the area of site A was affected. On site B, buildings 3 and 4 were destroyed and buildings 1 and 2 partially. Site C, neighbouring site B, suffered only a little material damage.

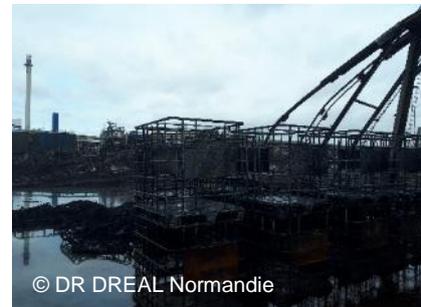
Among the drums stored outdoors on site A, about 1,300 containing oils with ZDDP¹¹ were exposed to thermal radiation. As they broke down, they released mercaptans and resultant foul odours.

For four months, a containment area was created and specialised equipment (robot) was used to treat these drums.

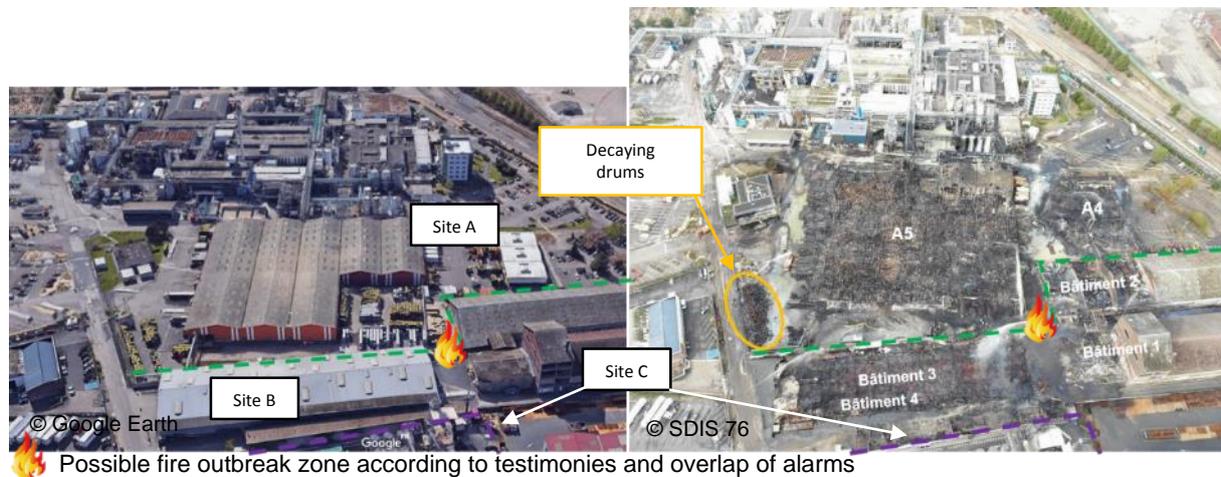
The judicial investigation to determine the origin and exact location of the fire outbreak is ongoing. Although it is not possible to determine whether the fire broke out on site A or B, testimonies and the sequence of the various alarms (smoke detection system in buildings on site B, melting of a manual alarm casing without operator action on site A) converge to suggest a fire outbreak zone in a perimeter comprising the storage area outside site A and the corner of buildings 2 and 3 of site B.

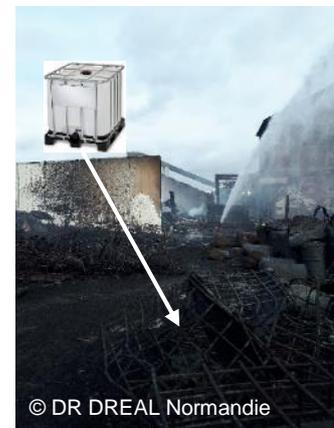
IBCs are usually made of polyethylene (thermoformable plastic) surrounded by a steel cage. They can be equipped with an inside pocket to be compatible with the type of product they are intended for. Plastic IBCs are combustible because of the material they are made of. Heat melts the plastic and releases its contents. Fire-fighters describe the advance of the pool fire as an uncontrollable lava flow. Examples from accident analysis taken from the ARIA database show that IBCs, plastic, polyethylene, fiberglass and resin tanks, and even pallets of water bottles, empty or full, can ignite very easily, melt and release their contents,²⁶ which poses a problem, especially if the contents create a pool fire.

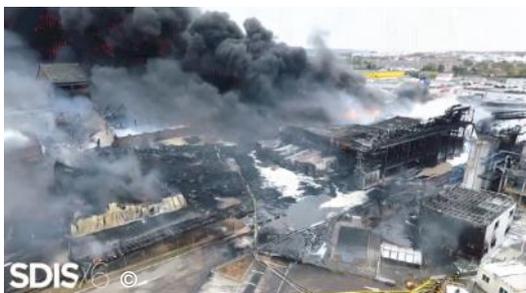
Site B was not equipped with any retention and containment system. The topography of the sites favoured the gravitational flow of combustible liquids and fire water, forming and spreading a fire pool. The containers (drums and IBCs) in the outdoor storage areas on site A were not on dedicated containment. The retention and containment of fire water was transported through open drains to a retention basin that can discharge into a reservoir then into septic tanks and reservoirs accessible to various areas on site A if connected with hoses. The volume calculated for these systems had been calculated in accordance with the regulations in force²⁷ but was insufficient given the extent of the fire. In addition, during the incident, the drain pumps extending from the basin to the various reservoirs near the production halls were shut down to prevent the spread of fire to those areas (production hall and storage tanks), reducing volume of retention and containment even more. The open drains and the first reservoir reached saturation very quickly (the volume of the drains and first reservoir is estimated to be about 200 m³), leading to the development of a pool fire that spread the fire to other storage areas. Pumping from the first containment reservoir to the septic tanks and other reservoirs was no longer possible because it was manually reset. However, the fire had surrounded the area and destroyed the power supply to the pumps.
