Deadly dust explosions inside a silo

7th April 1993

Floriffoux (Floreffe) Belgium

Explosions
Silo
Food processing
Dust
Hot spot works /
Hot work permitting
Victims

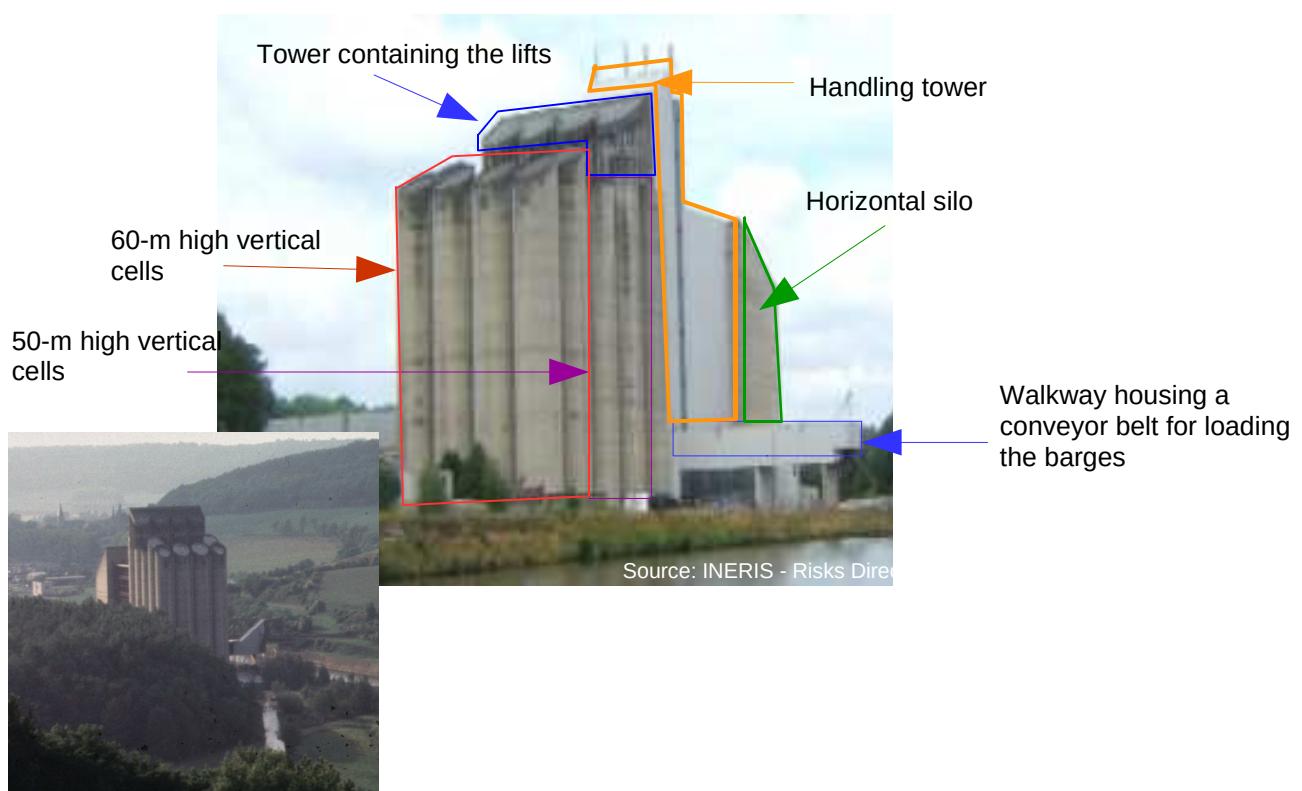
- a horizontal concrete silo with an 85,000-tonne capacity forced ventilation system containing 62,000 tonnes of product;
- a compact storage unit, composed of two groups of vertical concrete cells 50 and 60 metres high and featuring a 40,000-tonne storage capacity where some 30,000 tonnes of product were warehoused.

These cells were joined by means of a 5-story, 50-m high transfer and handling tower built with a metal frame and cladding. The first floor above ground was separated from the ground level by a concrete slab.

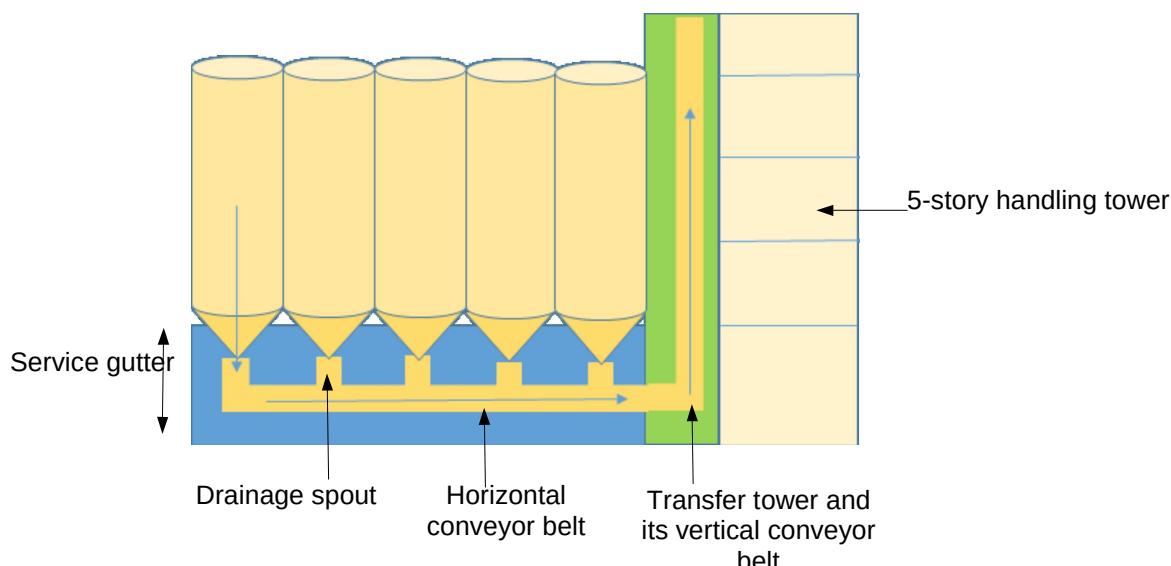
Underneath the 60-m vertical cells, three service gutters had been laid out with connections to one another. These gutters contained:

- the steel sheet drainage spouts of the various cells;
- the conveyor belts moving the cereal to lifts installed in the tower abutting the silos.

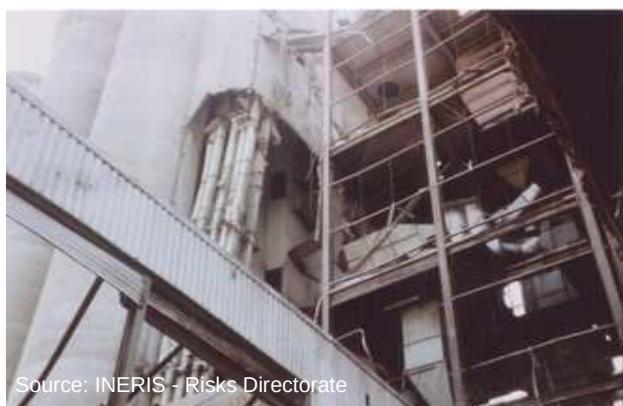
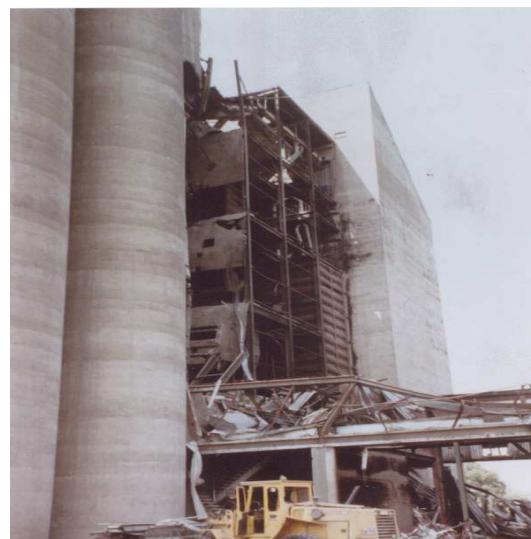
Source: INERIS - Risks Directorate

The tower's metal cladding was blasted distances of up to 100 m.

Some parts of the concrete shell surrounding the lifts were destroyed to a height of 40 m. Debris was scattered over a 15-m radius.

The concrete slab on the first floor was raised; it was heavily cracked and its embedded reinforcements exposed.

The effects of pressure in 2 of the 3 service gutters ripped out the hoppers positioned under the cells.

Traces of combustion were visible all the way to the top of the building.

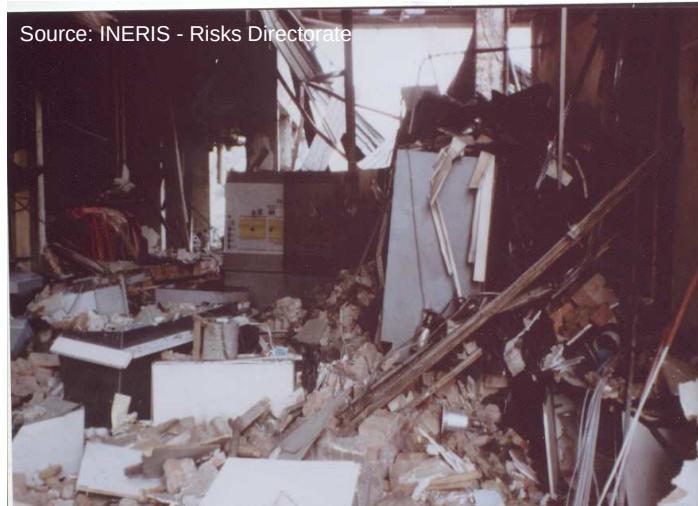
Moreover, broken windows and more minor damage to nearby dwellings were observed up to 300 m away, including the explosion of tiles at a nearby dairy.

A mound of earth approx. 20 m high, planted with trees and located between the silo and the closest residences, was certainly responsible for preventing even further damage.

Damage recordings served to determine that the pressure surge level had climbed to 6-8 kPa inside the building, 0.7-2 kPa at a distance of between 200 and 250 m, and 0.5-1 kPa at 270 to 300 m from the point of the blast. According to an INERIS Institute study conducted in 1993, the pressure surge reached in the gutter where the explosion originated would have exceeded 100 kPa.
