Explosion for a mixing operation in a multi-purpose plant

June, the 8th, 1999

**Wuppertal
Germany**

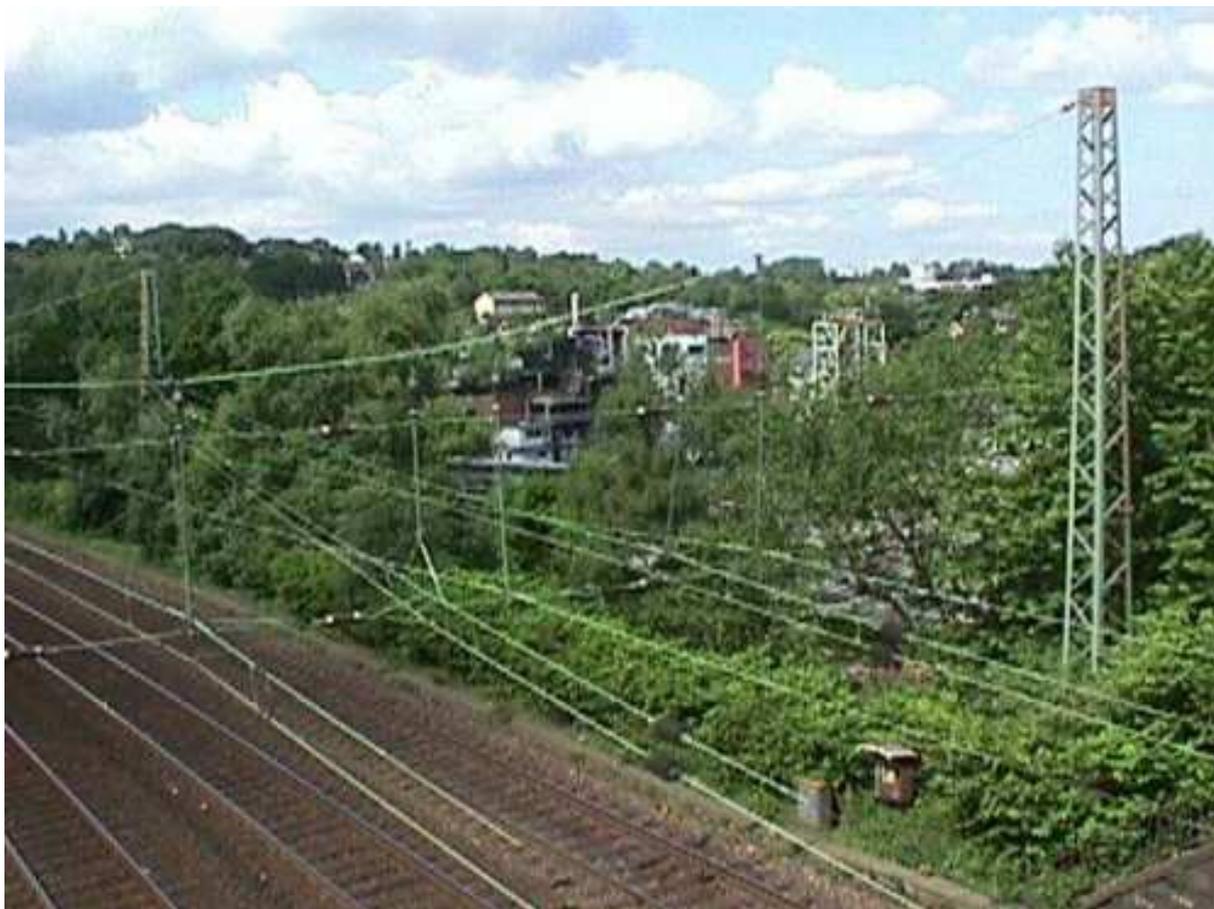
Source : Autorité de Rhénanie du Nord-Westphalie

The incident took place in an installation producing a variety of products for crop protection in a small quantity of 10 – 30 tons per months and proving new products and new operating procedures. It showed typical characteristics of a multi-purpose plant. All components could be interconnected any way and used for several productions.

The plant was subject to license according to German Federal Immission Control Act. Due to the quantities of hazardous substances at the installation in amounts that exceeded upper tier threshold limits the extended obligations of German Ordinance on Incidents had to be fulfilled by the operator. A safety report has been drawn up. The establishment is located in a valley amidst a residential district and crossed by a public means of conveyance, strictly speaking a suspension railway.

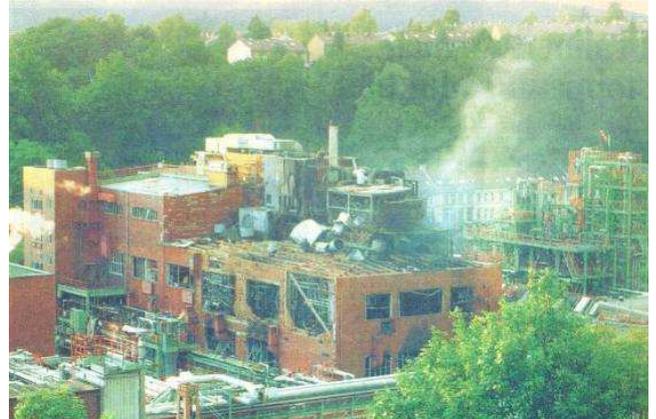
At the same moment the reactor exploded. The pressure wave grasped the two employees who were injured considerably. In the following of the explosion a fire occurred.

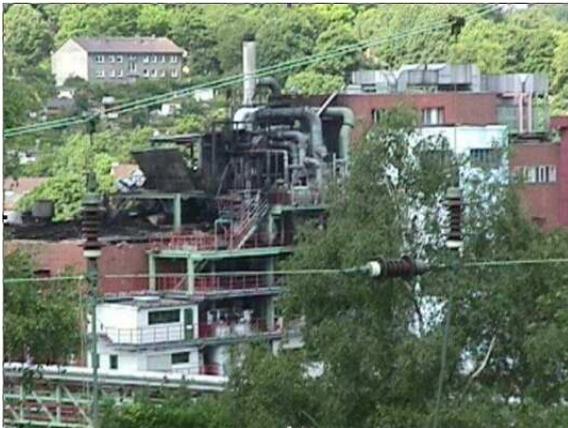
The two employees staying in the room where the explosion occurred suffered heavy injuries especially the drumheads bursted. Four other employees of the multi-purpose plant, three employees of other departments and two members of the establishment fire brigade were injured respectively had to be investigated providently at the hospital.

A lot of dwelling houses suffered partly considerable damages especially because a lot of windows were smashed by the blast. The establishment was devastated in a circuit of 200 m around the place of explosion. A contact line of the railway was pulled down.

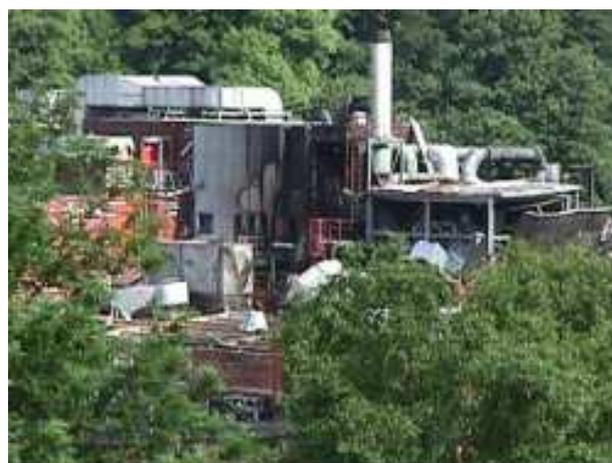
Source : Autorité de Rhénanie du Nord-Westphalie

The company itself planned a complex multi purpose plant for corp protection products at another location where the residential districts are so far away that in case of an accident no consequences for the public could occur.

Therefore obviously the competent authorities paid attention to lessons learnt from this accident in the license procedure of that new plant.

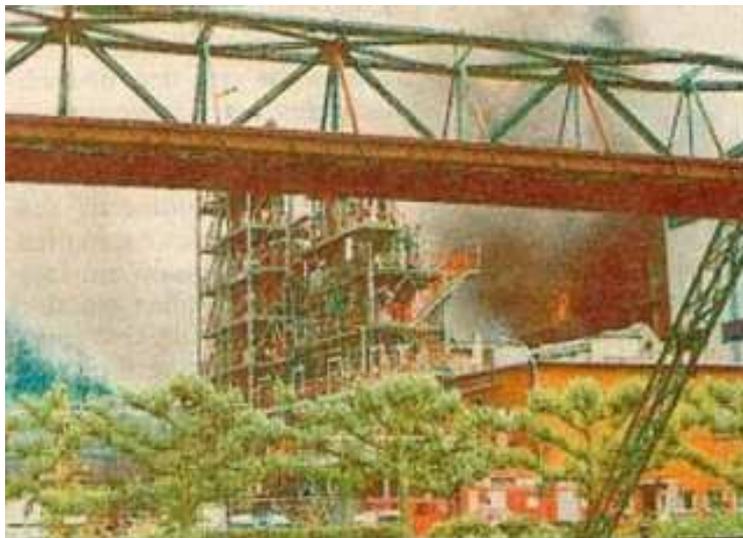
Source : Autorité de Rhénanie du Nord-Westphalie

The feeding devices as metering valves, metering screws and so on should be interlocked by process control system in a way that feeding is only possible after reading the expected code. The competent authorities are sure that the accident presented above would not have taken place, if such a technical identification system like that described above had been used.

During the lapse of the licensing procedure a lot of controversy discussions between the operator and the authorities concerned had taken place. As a final result the new plant will get a technical identification system without interlock in addition to the improved house keeping measures suggested by the operator.
