## Tire dump fire

February 12, 1990

## HAGERSVILLE (Ontario) - Canada

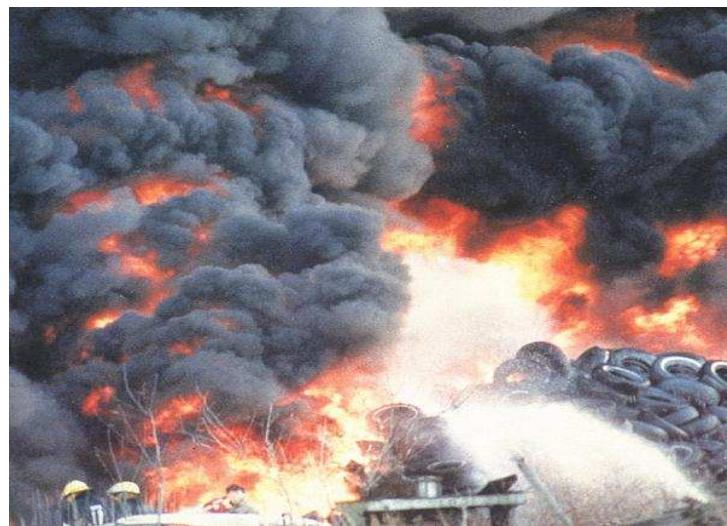
Photo DR

On the 12<sup>th</sup> of February 1990, a fire, initiated in the North-West angle extended in 8 hours to the entire depot. The wind, and to a lesser degree the violent internal convection currents favoured the extension of the fire.

For the first 7 days, the Canadian authorities recommended a strategy of "Let it burn" on account of the intense heat and the impossibility for the volunteer fire brigades to reach the centre of the blaze. The intervention was thus limited to the construction of access routes, 2 on the West and North of the site and one at the South-West corner, and the hosing of the periphery using recycled fire-fighting water. The construction of the access ways was facilitated by the configuration of the ground (flat) and the frozen soil. The supply of water (286 m<sup>3</sup>/day) was handled by 9 tanker trucks from sources as far away as 7 km.

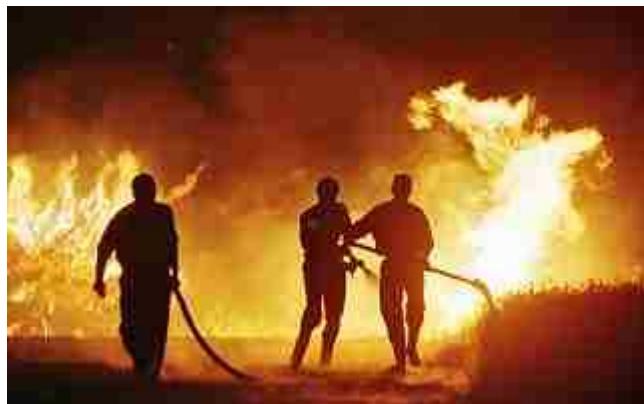
Photo DR

Later on, the requisition of heavy equipment allowed for the dismantling of the piles of tires after the passage of the fire to sort out the few unburned tires and to use them as a wind break. The firemen placed on both sides of the equipment, hosed down the cinders as well as the equipment to cool them down. At the same time, the use of foam (mixture of water / 0,3 % foaming agent), more effective than water alone, enabled the flames to be extinguished, at least temporarily. A Canadair was also requisitioned but could only fly during two days on account of the negative temperatures.

Operations were just as difficult on the ground. The firemen had to walk in the mud, always equipped with stand-alone breathing equipment. The carcasses of the burned tires were also a source of danger for the heavy equipment and their drivers who risked being immobilised in the fire zone on account of the metal wires. The fire-fighting operations continued 12 h/day in 2 teams, each working 6 hours shifts. The dangerous nature of the work (smoke, oil, mud, metal carcasses...) made it impossible to continue operations at night. The heavy equipment only operated in daytime and handled, on average 0,5 ha/day the work was finally completed after an intervention lasting 16 days and when the quasi-totality of the dump had been destroyed.

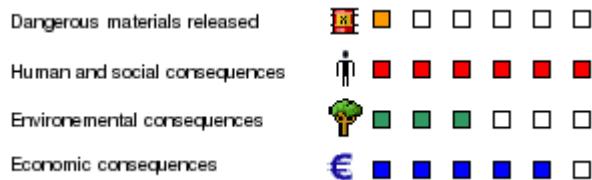
Using the rules for scaling by the 18 parameters of the scale formalised in February 1994 by the Committee of Competent Authorities of the Member States in application of the 'SEVESO' directive and taking into account the available information, the Hagersfield incident is characterised by the following indices:

The combustion of tires produced Seveso classified substances such as benzene, styrene and toluene. The quantities of dangerous substances released being unknown, the index relating to the quantities of materials the default index is 1 (see. parameter Q1). Roughly 1 700 people were evacuated for a period of 17 days. These evacuations lead to an index relating to human and social consequences of 6 (see. parameter H7 : number of persons evacuated x number of hours, or  $1\ 700 \times 24 \times 17 = 693\ 600 > 500\ 000$ ). The blaze involved the contamination of the wells in the region and the pollution of an area of 4,5 ha, leading to an index relating to environmental consequences of 3 (see. parameter Env13 : surface area to be decontaminated, between 2 and 10 ha). Finally, the costs linked to the pollution generated and the actual intervention on the site lead to an index relating to economic consequences of 5 (parameter €18).
