Fire in a tire storage facility

February 4, 2002

Artaix (71) - France

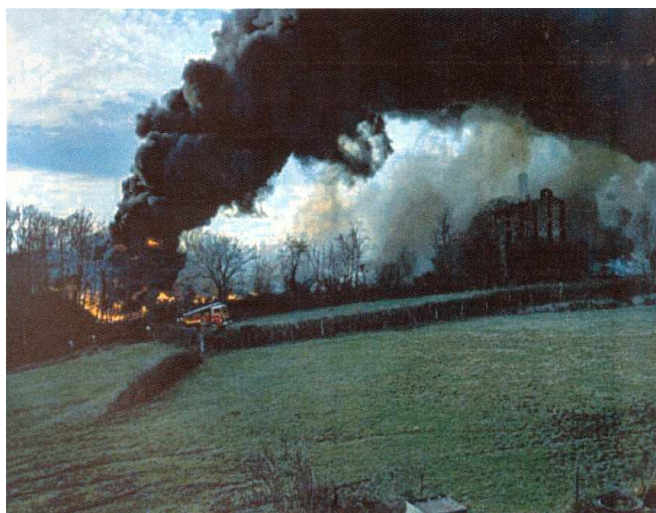
Source : Drire Bourgogne

Monday morning, February 4, 2002, a fire broke out in a storage facility holding 5 million tires extending to the base of a former 8-story roofing tile factory, also used as a storage facility. The firemen were informed at 9.53 am. The fire spread rapidly. The flames rose to heights of 10 meters and the plume of black smoke was visible 40 kilometres away.

The fire was surrounded at 6 pm, although the firemen monitored the area for more than 2 weeks. The accident mobilised a large number of firemen: 70 on the 1st day, 35 the 2nd day and 12 on February 8. Owing to insufficient local water resources, the emergency services had to procure water from the Loire River side canal approximately 2 kilometres

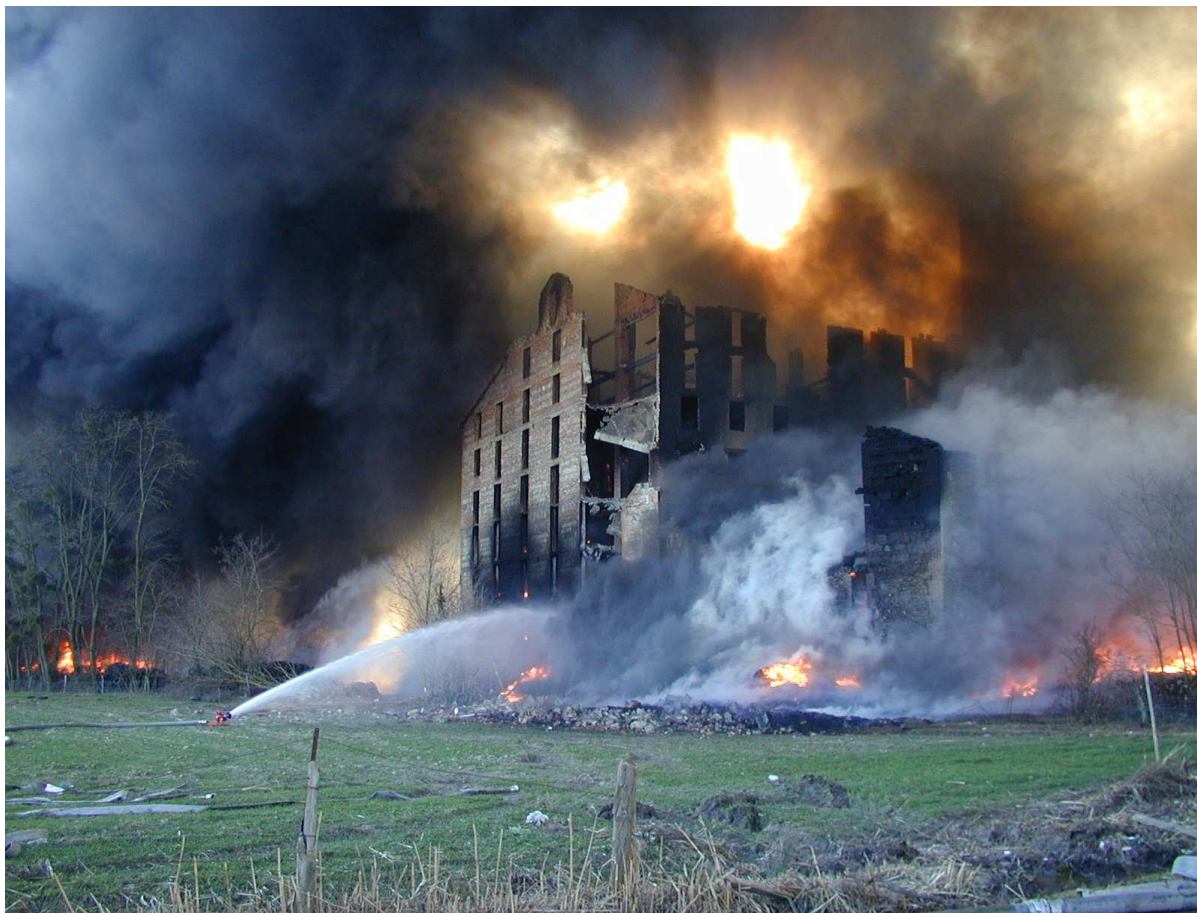
Source : DIRE Bourgogne

Once the fire was brought under control, the plume of residual smoke progressively went away until it was reduced to just a few fumaroles. The fire smouldered in this manner for 9 months. Final extinction was achieved by removing the residues or tires that were still incandescent and soaking them in a bin containing water. This action took 24 days.
