Release of hydrochloric acid by the manhole of a benzoyl chloride tank

February 5th , 2002
Persan – [Val-d'Oise]
France

Hydrochloric acid
Discontinuance of
business
Benzoyl chloride
Tank drainage

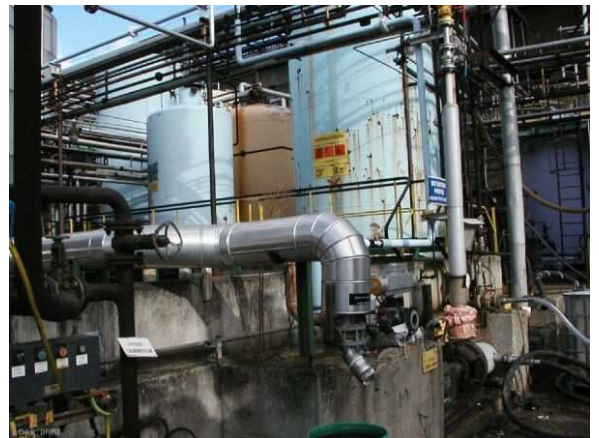
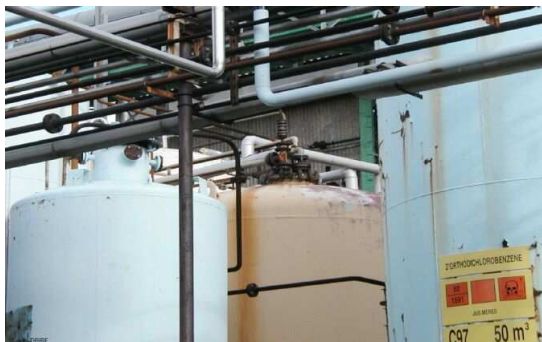
Following tests, tank draining operations were begun on February 5, 2002 at around 9.30 am. The operation, conducted by a technician from the company, and assisted by a fireman from an external company, consists of pumping 2 m³ of methanol into the tank then, circulating the product designed to homogenise the mixture, and then finally transferring the mixture into a tanker truck for subsequent destruction.

Having noted that the transfer pump was malfunctioning, the GLCF technician stopped the operation and began spraying down the tank with the sprinkler system. The personnel noted a small explosion, probably due to excess pressure in the tank, and a cloud of acid gas was released through the faulty flange seal on the upper dome of the tank.

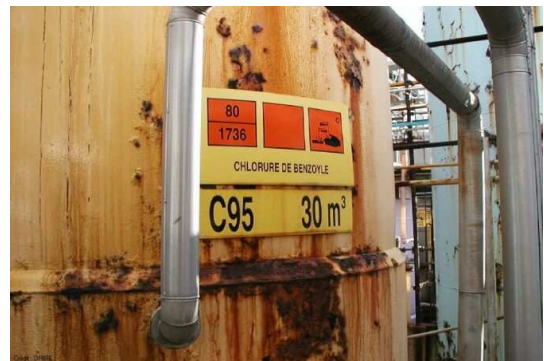
Benzoyl chloride (C6H5-COCl) is a highly reactive acyl halide. Its hydrolysis is very exothermic and leads to benzoic acid (C6H5-COOH) with the formation of hydrochloric acid (HCl). A reaction also occurs with alcohols and leads to an ester and the release of HCl.

At the time of the accident, adding methanol (CH3-OH) to tank C95 thus caused a significant release of HCl (estimated at 90 kg, or 55 m3 of hydrochloric acid for 100 litres of methanol introduced into the tank and supposing that a complete reaction occurred). The reaction was accompanied by a heating up of the mixture.

After plugging the leak on the seal, no release was visible on the tank the evening following the accident. The reaction was completed and the system returned to a stable state. At the request of the Registered Installations Inspectorate, the installations were monitored and a senior executive was placed on standby for the night and following days. A tarp was installed on top of the tank to protect it from the rain.
