Fire followed by pollution of a stream

July 22, 2001

Port of Antwerp

Belgium

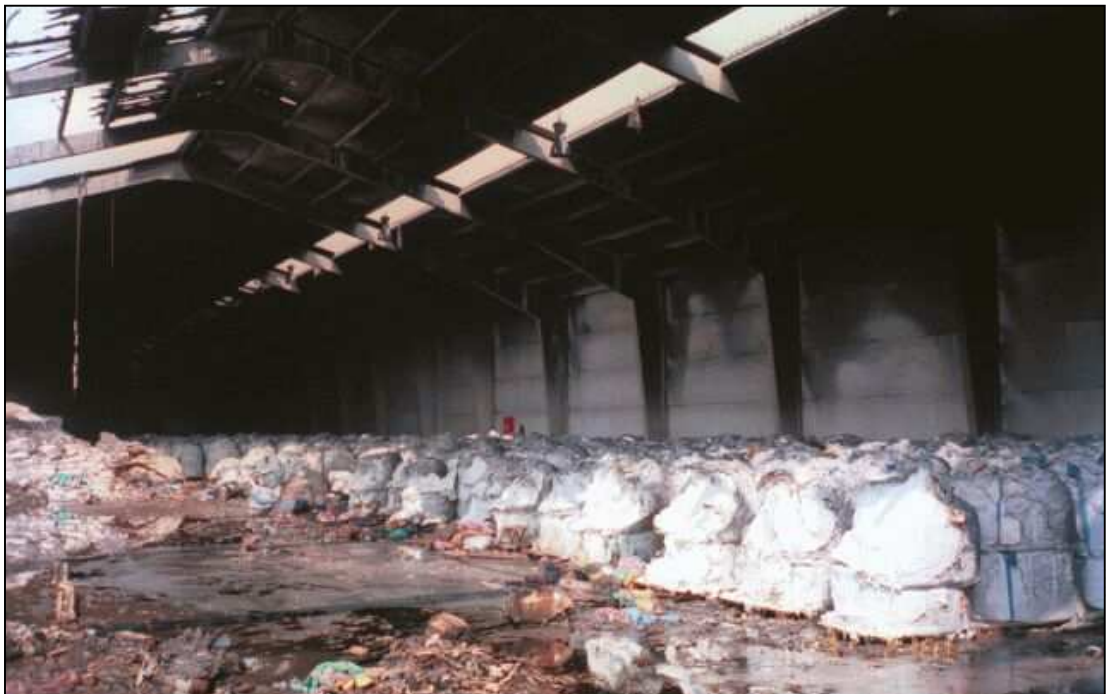
Since warehouse C was no longer being used to store dangerous materials, and consequently the condition of its firefighting water catchpits was paid less attention. At the start of the fire, the firefighting water flowed into the catchpit of warehouse C, but owing to its limited capacity, overflowed into the municipal sewer system.

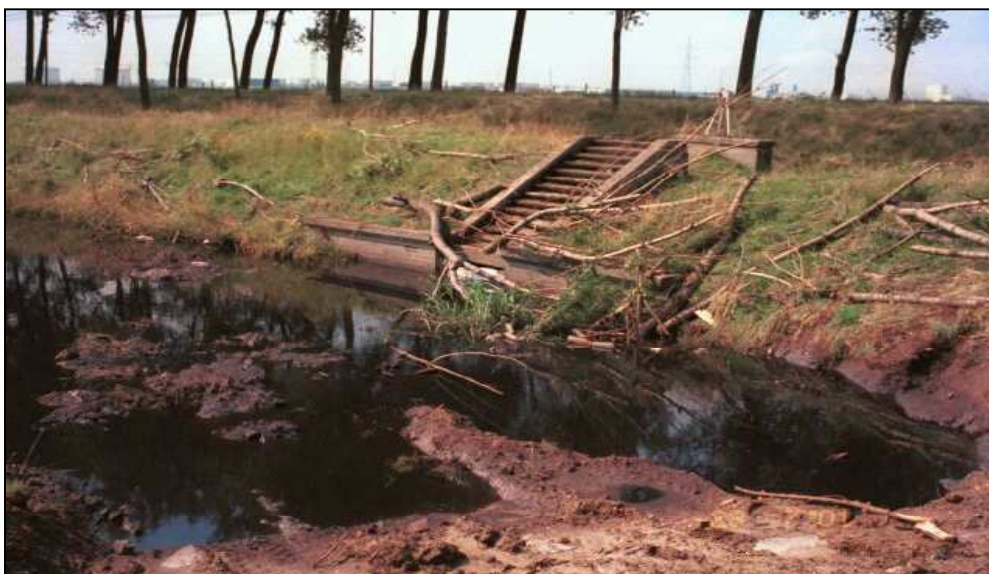
Photo BARPI

- ✓ dangerous materials, deteriorated or not, are stored in warehouse B,
- ✓ the contaminated firefighting water were released into a stream (a sample was taken at the outlet source). Dead fish present and the surface of the water was coloured.
- ✓ the capacity of the catchpit for warehouse B was insufficient.

The operator must submit a contaminated firefighting water treatment plan and have an environmental damage assessment performed by a certified third party expert.
