### Agrochemical/Phytosanitary products Storage Toxic fumes Extinguishing water Confinement Organisation / Procedure Lift pump Partitioning Automatic extinguishing Anti-intrusion device

# Fire in a pesticide warehouse 27 June 2005 Béziers – [Languedoc-Roussillon] France

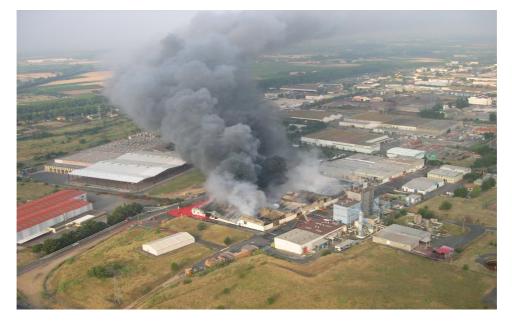
- the site was secured by special balloons to block the firefighting water and by closing the natural gas supply line,
- significant release of smoke,

Plume of smoke rising above the site

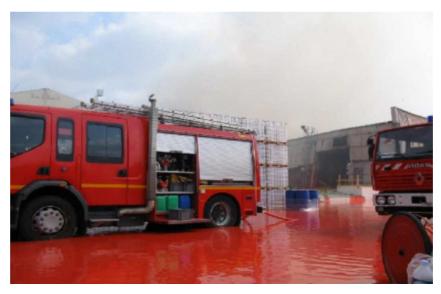
- recovery of the firefighting water in the lower portion of the building by pump trucks from the specialised company into the 10,000 ml basin after a back-up pump was put into service,

Firefighting water

- the re-establishment of the site's electric and water networks so that they participate in the protection and alarm means,
- collect the firefighting water contained upstream of installations A,B,C,D and transfer them into the firefighting basin designed for that purpose,

- elimination of the firefighting water in a centre authorised to do so. All resumption of activity cannot be considered until 80% of the fire basin's capacity can be used,

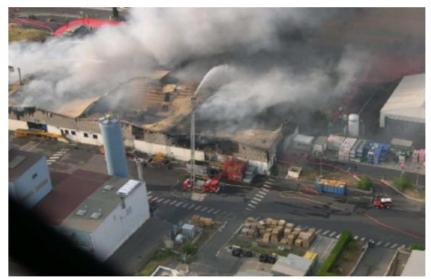
As far as the other hypotheses are concerned, neither the forensic police nor the insurance company experts were able to determine the cause of the fire, nor explain the speed at which the fire spread to the other buildings; possibly due to the lack of fire-break partitioning at the circulation alley level between buildings D and B.

- the fire's extremely rapid propagation to all the buildings placed side-by-side, while the products being stored were considered to be "flammables",
- the non-pollution of surface and underground waters; the measures in place functioned correctly despite the failure of the lift pump,

Spread of the fire to several buildings

- the concrete structure's 2-hour fire resistance for walls and frameworks,
- the partitioning of each building to separate the raw materials from the formulation and packaging area, as well as the finished product storage part by 2-hour fire break walls, rising above the roof at least 1 m,
- automatic fire extinguishing backed up by foam with a high expansion ratio for each of the cells created,
- firebreak doors slaved to the fire detection system,
- installation of anti-intrusion devices,
- installation of a back-up electrical substation.
