Explosions in a pharmaceutical plant

13/08/2003 and 09/08/2004

Linz

Explosion
 Glyoxylic acid
 Peroxide
 Ozone
 Design / conception
 Heat insulators
 Domino effect

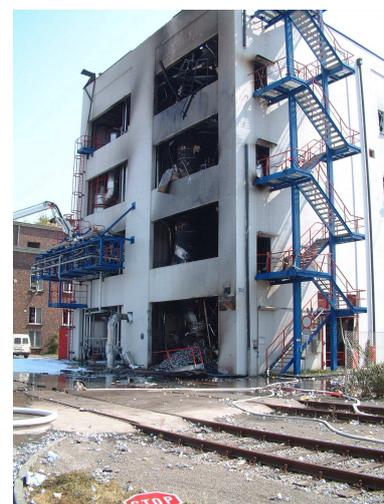
The upper part of the columns are blasted, one column is ripped on 2/3rd of its height. The 2 tanks are completely destroyed and their filling (mainly methanol) caught fire. A fireball with a diameter of 80 m is formed over the installations.

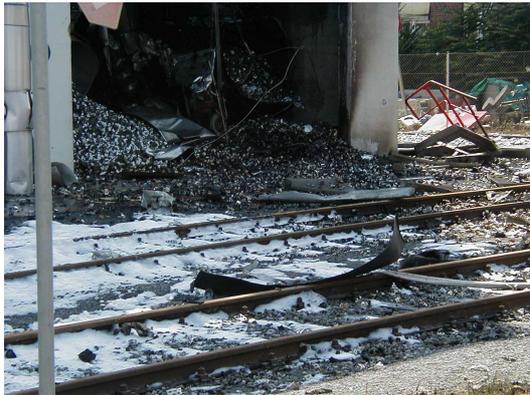
The part of the installation where the ozonolysis reaction took place (1/4 of the installation) is destroyed. Material damage are significant within a 150 m radius perimeter, mostly due to projections and broken glass. Offices are destroyed in buildings closed to the explosion.

Office at 40 m from the explosion

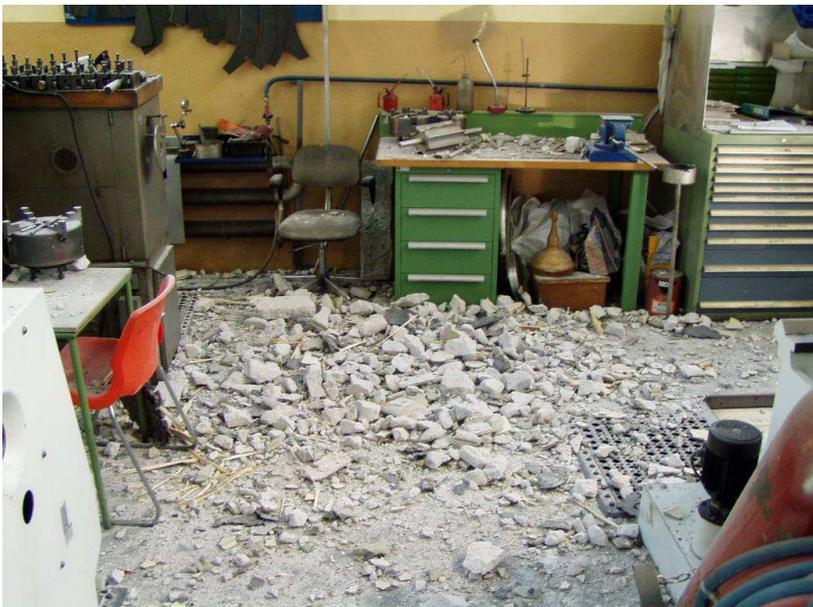
Workshop at 60 m from the explosion

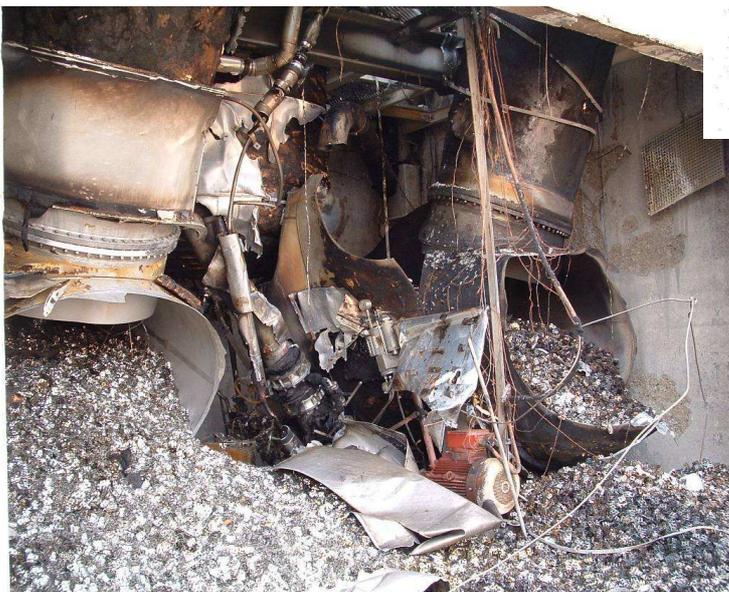
The analysis concluded that a leakage (most probably leak on a flange) in a pipe released methanol / peroxide into the insulation material of the column, made of polyurethane.

Due to long-lasting high summer temperatures, the methanol (solvent) evaporated, concentrating the peroxide, which then self-ignited and decomposed.

The rise in temperature was strengthened upon contact with the rusty grid that maintained the insulation material on the column (accelerating the decomposition reaction because of metallic ions of the grid?).

The decomposition of the peroxide started the fire, which then spread and caused the explosion of the first column followed by the explosion of the second column (domino effect).

Damaged columns filled with catalyst

Following the accident, the company kept the process unchanged but installed the ozonolysis columns in a separate cold box at -20°C in a separate building with video control. The columns are not isolated anymore, but a leakage indicator system is installed. The reactors are built to resist an explosion and a pressure relief valve is added, as well as additional safety measures such as pressure and temperature measurements.

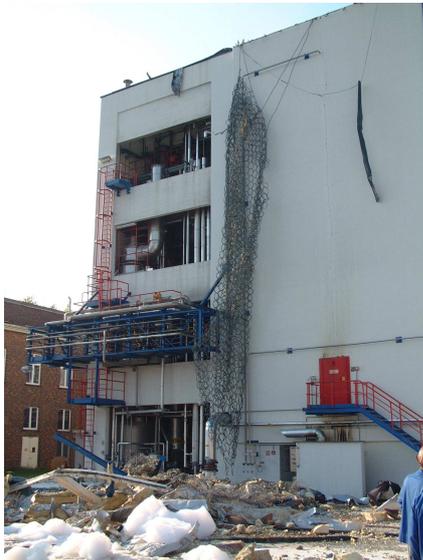
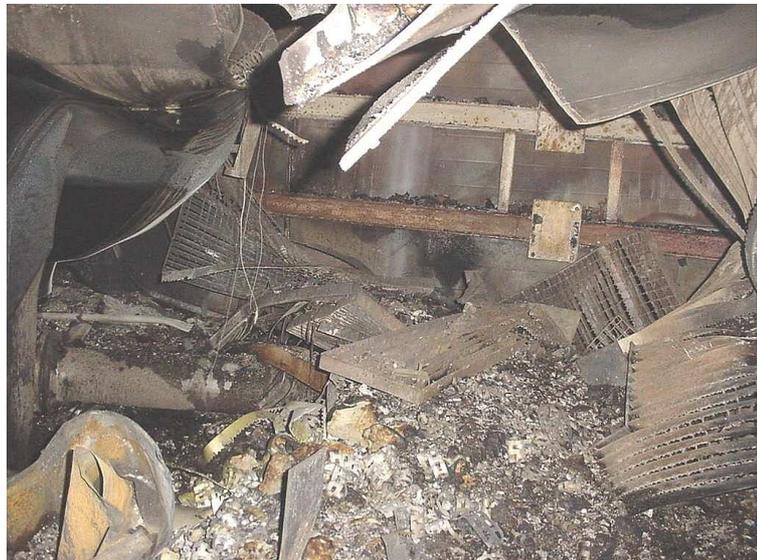
The explosions destroyed the devices in the cold box entirely. There was a big crack in the wall. No one got injured and no building got damaged, but a few broken glasses in the surroundings.

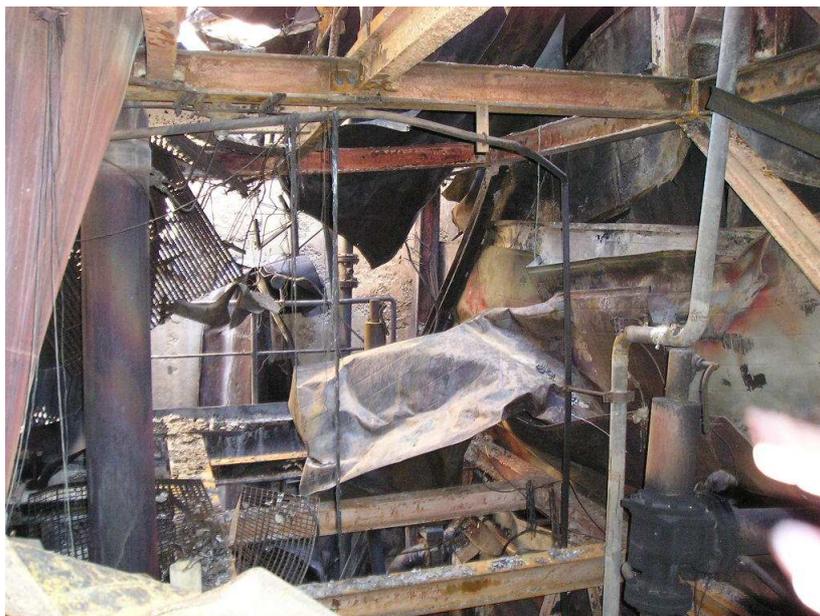
Two hypothesis of the explosions are either the creation and accumulation of foam that ignited upon local heating or hot spots (hot or catalytic particles) or the synthesis of unusual peroxides with following decomposition and ignition.

The destroyed "cold box"

The company involved more than 50 experts from different countries and spend about € 400.000 for the analysis. The company modified the process to implement a reaction with air and inert gas instead of ozone.
