Leakage of a hydrogen-pipeline due to an inadequate inspection philosophy

12 October 2007

Binnenmaas (South Holland)

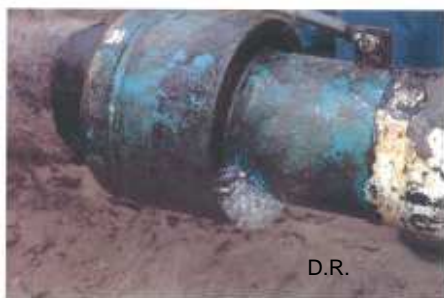
corridor. The ignition resulted in a small fire on top of the soil covering several existing pipelines transporting several types of gases.

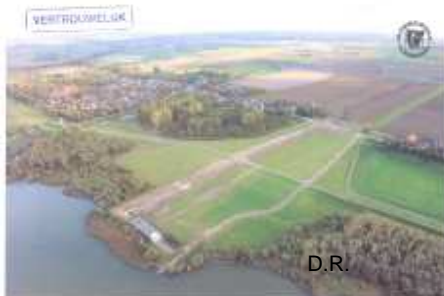
The investigation, as carried out by the Inspectorate of the Ministry for the Environment, has provided evidence that an underground pipeline, in which hydrogen gas is transported, developed a leak resulting in an escape of hydrogen gas. The leakage lasted for at least several hours but it can not be excluded that the leakage started weeks or even months prior to the discovery of the leak.

The leak occurred at a specific “weak spot” in the pipeline in which tensions could mount, resulting in the partial failure of a so-called “CP coupling”.

The escaping hydrogen gas was ignited on the 12th October 2007 by welding activities which at that time were taking place in the vicinity of the leak as part of a construction project to add another pipeline in the

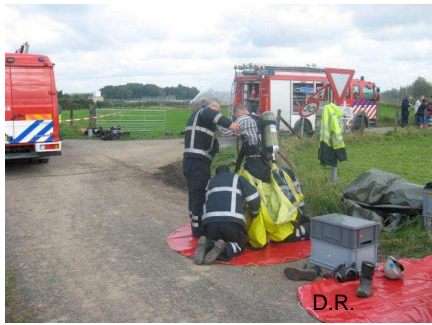
Given the fact that hydrogen gas is not toxic, and that a limited gas escape and fire were concerned, there has been no imminent danger to people living nearby.

Nevertheless, the incident has been classified as serious, because the gas escape could have been more extensive, and other transport pipelines that were lying nearby might have developed leaks for the same reason, which might have caused the release of poisonous gases.

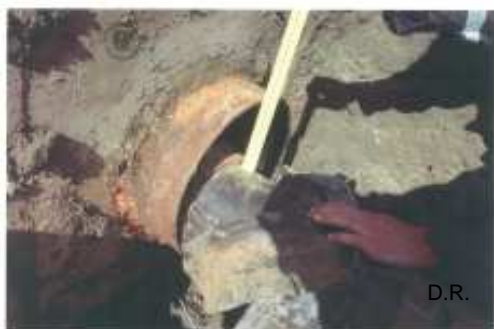
The leakage was caused by a mix of several tension factors executed on the hydrogen pipeline. The predominant stressing factor was the gradual settlement of the pipeline and the earth surrounding it. The settlement took place over a time span of several years and resulted in the bending of the pipeline at a spot where the pipeline got stuck on a fixed structure, e.g. a feed through in which the pipeline enters a building. The bending forces caused tensions on the CP coupling nearby in the pipeline, which eventually started to leak.

Other stressing factors that might have contributed to the occurrence of the accident were unallowed heavy traffic and the placement of heavy equipment on the soil covering the pipeline.

Immediate actions: Repairing the pipeline, checking pipelines with similar constructions and tightening supervision during activities in the pipeline corridor.

Long term actions: Revising technical and procedural safeguards against the stressing of pipelines.
