Rupture of a benzene pipeline

16 February 2012

Martigues (Bouches-du-Rhône)

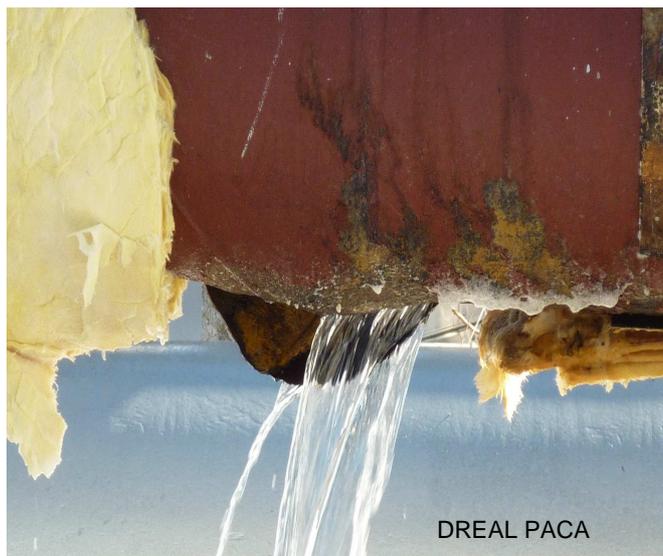
A leak occurred at 2:50 pm on an insulated benzene pipeline supplying an oil terminal. Approximately 4 m³ of product spread over the ground. The internal emergency plan at the oil depot was activated, entailing: port closure, personnel evacuated to shelters, water curtains and foam blankets deployed, plus recordings of benzene concentration in the environment. The leak was plugged using a hose clamp. 50 m³ of product remained inside the pipeline. Over the following days, other leaks were detected, each triggering an emergency plan response. Ultimately, a concrete sarcophagus was installed around the damaged section and the pipeline could be properly drained.

The freezing of benzene, which solidifies below 5°, caused this accident. The pipeline had been idle for 18 days and the system to maintain a constant temperature proved ineffective. The product froze during an intense cold wave and wound up contracting. Over an inclined pipeline stretch, some product filled the space freed during contraction; during the thawing period, the pipeline broke as a result of exposure to excessive pressure. This incident was attributed to the solidification of benzene in zones where the alignment had not been plotted (i.e. crossings via nozzles running beneath roads). These “plugs” created pipe segments isolated from vacuum relief valves, which experienced pressure rises due to a combination of two phenomena: a benzene volume increase during melting, and thermal expansion of the liquid benzene.

A metallurgical appraisal of the failed pipe sections was conducted, in conjunction with building a model to describe the phenomenon of benzene freezing in the pipeline, in order to confirm the mechanism responsible for these leaks. Moreover, the site operator undertook the following steps:

- revise and improve the temperature maintenance system during freezing periods;
- study the feasibility of introducing recirculation on the line or draining the pipe;
- design a device to allow verifying at all times that heaters are indeed operational.
