Derailment of a train transporting hydrocarbons

13th January 1993

La Voulte-sur-Rhône – [Ardèche]

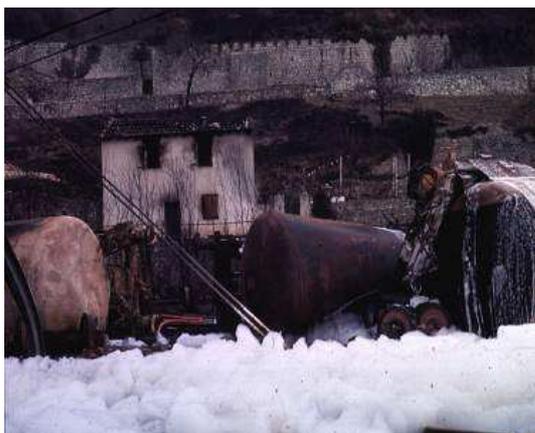
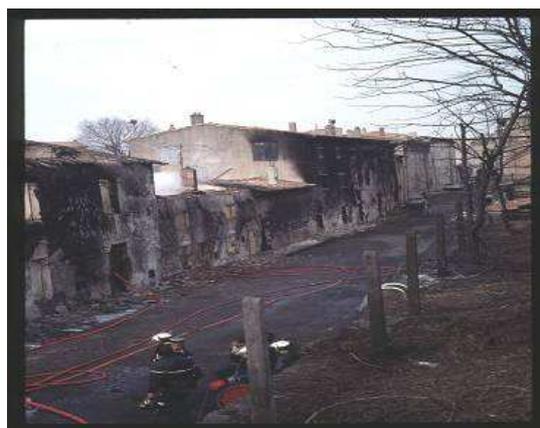
Of the seven derailed wagons, four had spilled their load on account of the major damage that they had suffered (opening of the ring die, stripping of the bottom valve, puncturing of the ring die, tearing along 1/3 of the length of the wagon at the level of the lower generator). The integrity of the tanks of the three remaining wagons remained intact.

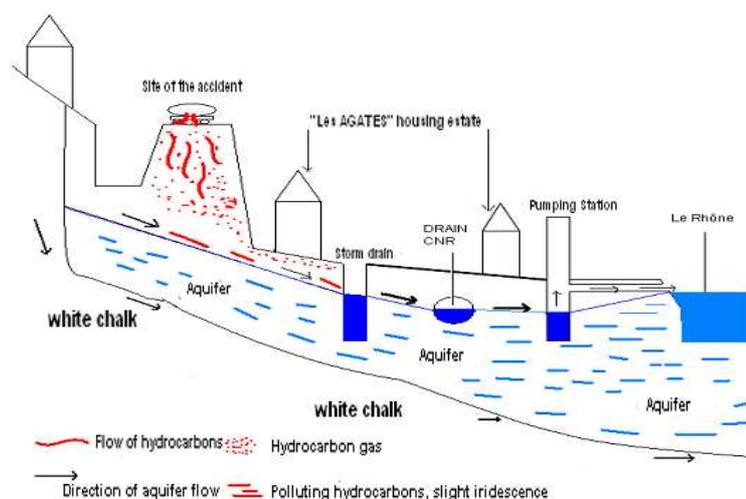
The zone in which were found the highest concentrations of hydrocarbons benefited from the experience of "venting" acquired following the accident at Chavanay in December 1990 when 250 to 300 m³ of gasoline penetrated the soil and polluted a surface area of 2 ha of land. Installed at the North and the South of the polluted lands, the two drainage networks allowed for the recovery of hydrocarbons by creation of a depression in the ground ($\Delta P=250$ mb). The polluting products recovered were incinerated in a catalytic bed oven. This arrangement was completed by a second hydraulic barrier (line of wells in a depression) installed at the Eastern border of the zone.

Four months after the accident, roughly 98 % of the gasoline spilled into the subsoil had been recovered. During this period, three types of action were undertaken:
