Fire and explosions at an aerosol storage warehouse
5 November 2010
Newton Aycliffe
United Kingdom

LPG / Aerosols
 Flammable liquids
 Explosive atmosphere / ATEX
 Fire / Explosion
 Lift truck
 Organisation

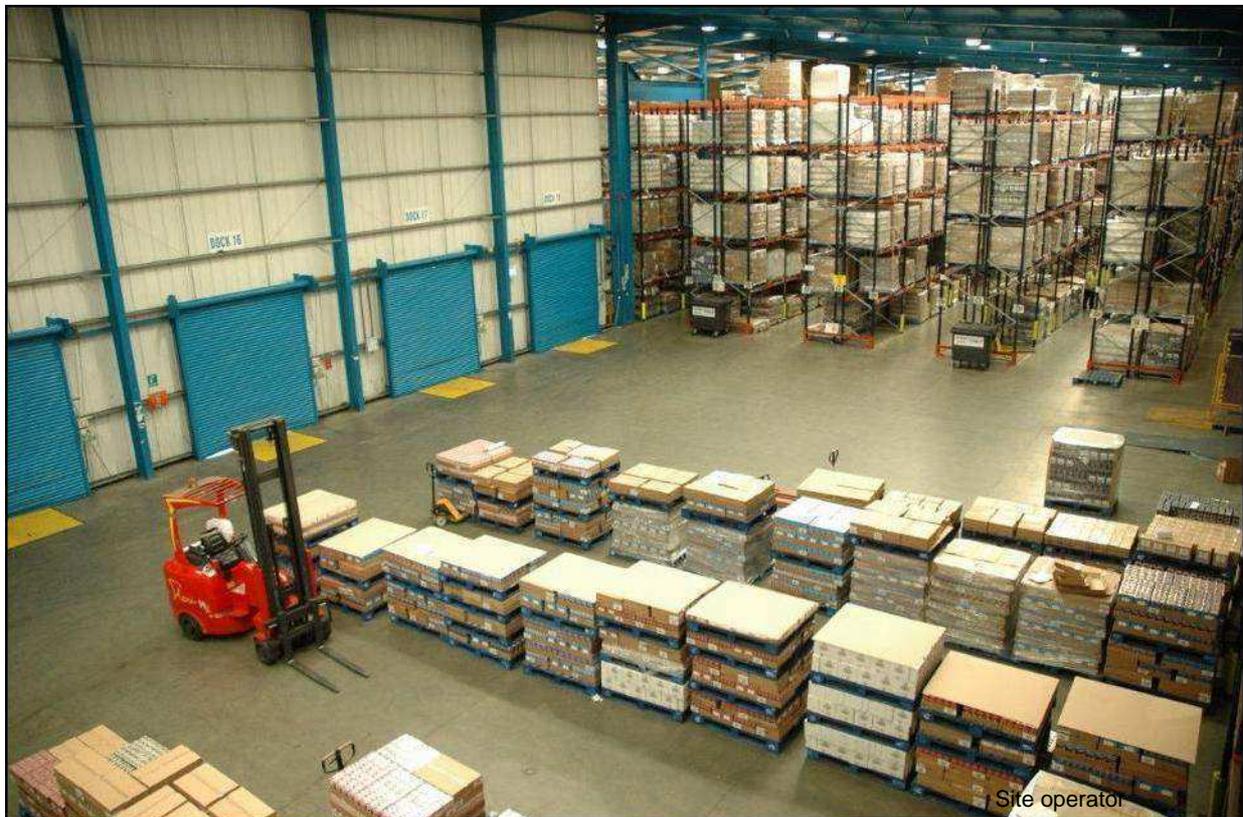
Figure 1: Interior of the facility prior to the accident

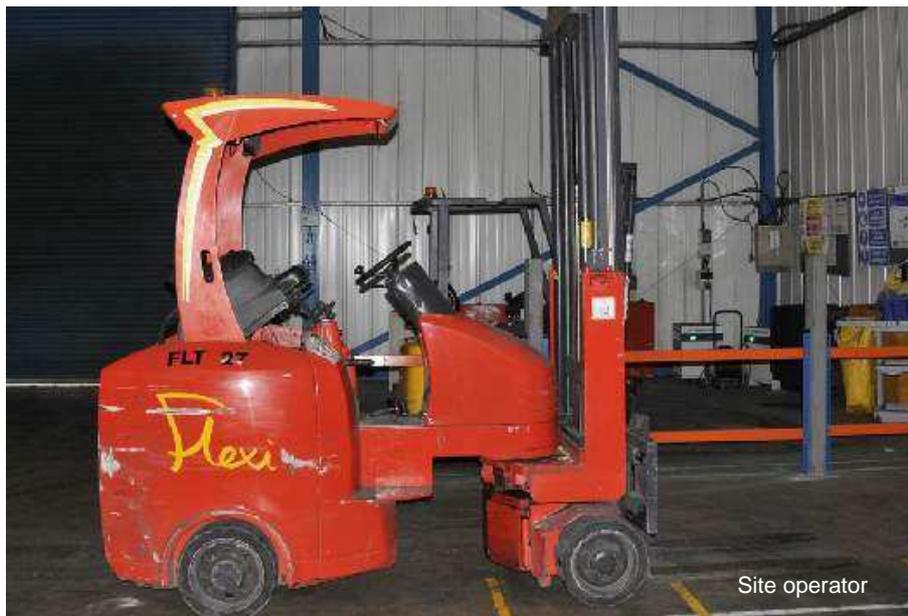
Figure 2: Unprotected electric flexi-truck in use at the site

Fork lift trucks used in the warehouse were not suitable for use in areas where there was a risk of a flammable gas cloud. This is because motor brushes and other high-current electrical contactors would have regularly produced highly incandive sparks. These sparking components were not fully enclosed, which means that flammable gas around the truck could move into contact with the sparking components and the resulting gas ignition could propagate out of the truck body and spread to the rest of the gas cloud. The Fire Service investigating officer carefully reviewed evidence relating to all potential sources of ignition other than the lift truck (including arson and smoking). His conclusion was that there is no evidence for any such ignitions. All of the evidence is, however, consistent with ignition of flammable vapours from leaking aerosols being ignited by unprotected components in the lift truck.

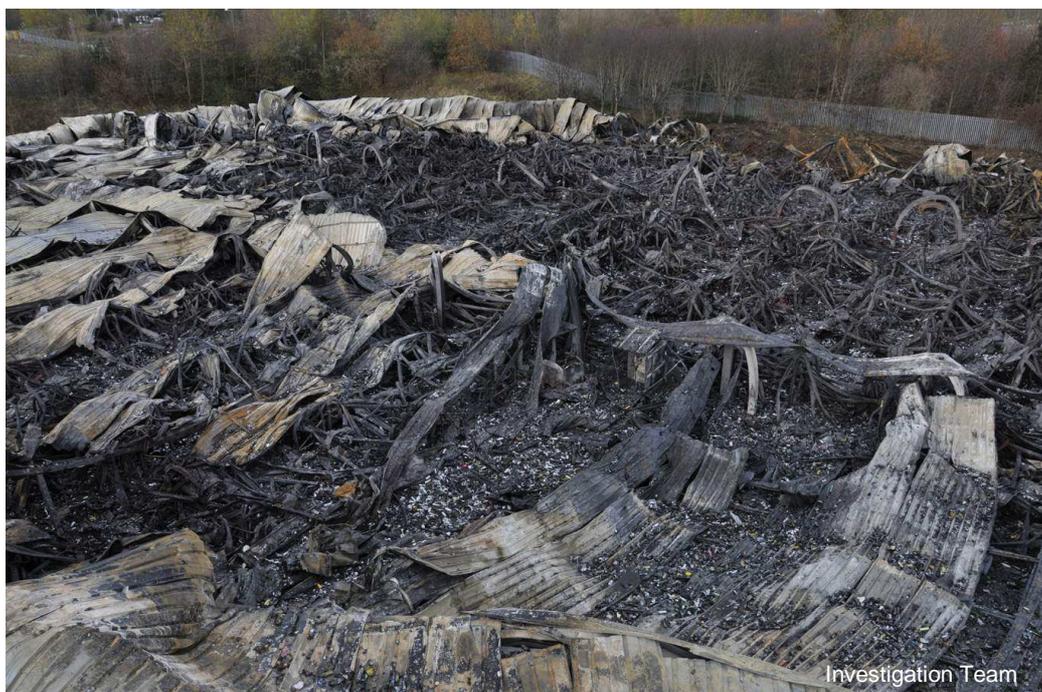
Figure 3: Damage to the warehouse and contents caused by the fire

The later stages of the fire appeared reasonably typical of the progress of a (high fire load) warehouse fire. However, the complete destruction of steel cladding over areas containing a high density of aerosol pallets is unusual. This is probably due to the combined effect of high temperatures and millions of separate aerosol bursts. These bursts have a percussive local effect that dislodges the rust scale that builds up on steel sheet at high temperatures. The steel roof sheets can therefore rust away during the course of the fire at an unusually high rate.

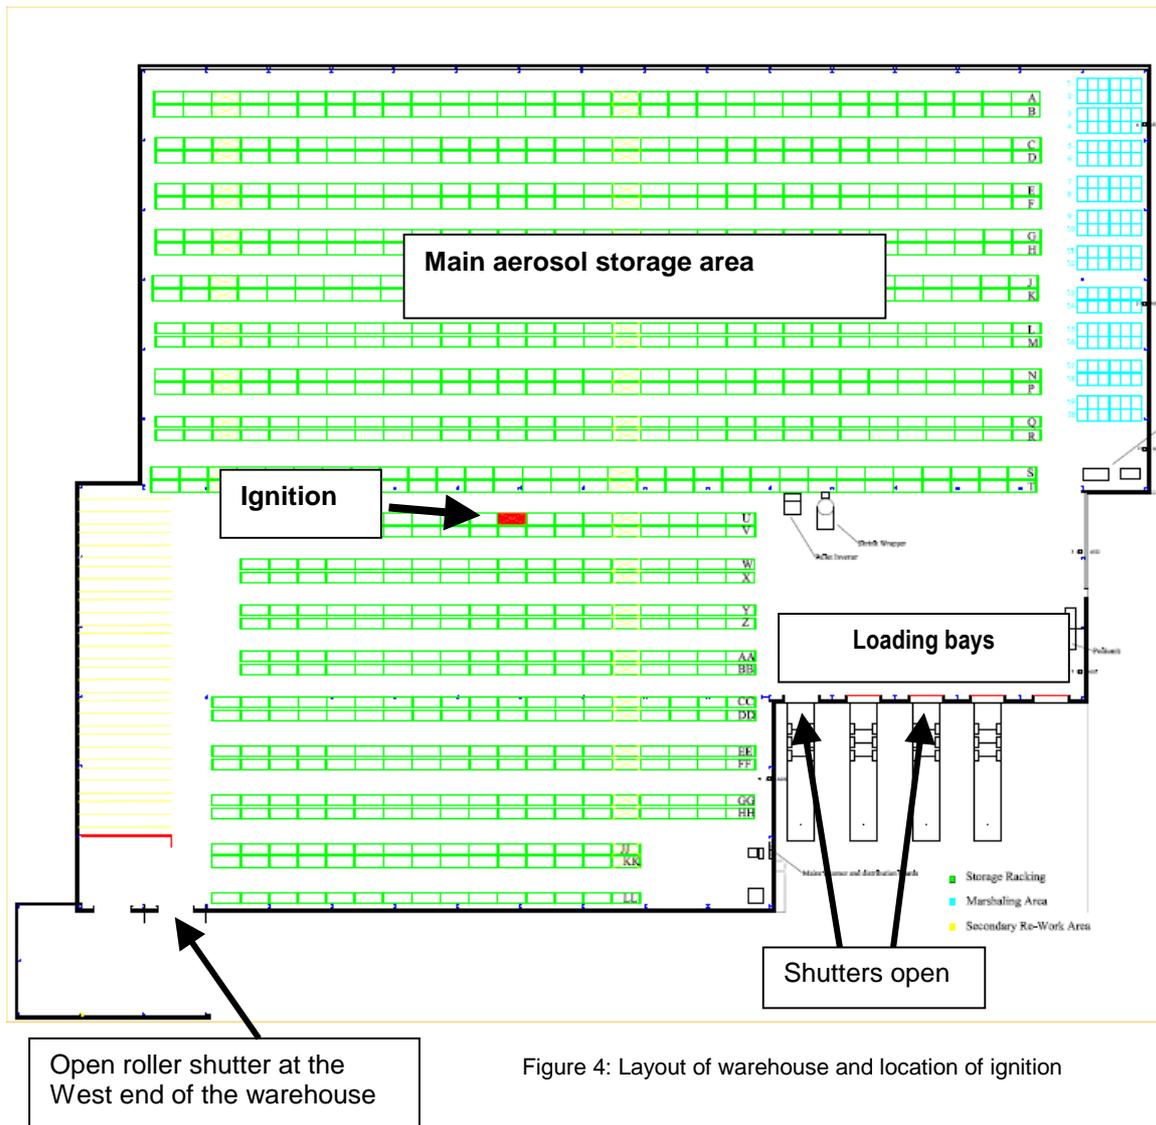
Figure 4: Layout of warehouse and location of ignition

Excellent information on the location of the ignition is available from several witnesses who observed a small flame on a full pallet of aerosols at ground level. This pallet was not close to any lights or other fixed equipment that could have acted as potential ignition sources. Immediately prior to the discovery of fire, a 7.5 tonne electric "flexi" lift truck had been used to remove a pallet from racking across the aisle from the ignited pallet. The lift operation with this truck had involved: driving into the narrow aisle rack array; turning the front section of the truck into the rack; lifting a load at high level and reversing out with the load on the forks. This operation would necessarily have brought the back of the pallet truck close to the stored pallets at a time when the driver's attention was divided between safely extracting the pallet from the high level storage slot and controlling the truck body position within the aisle.

When first spotted by the lift truck driver the flames were only 300mm high – towards the base of an aerosol pallet at ground level. A small foam extinguisher was used and initially the visible flame was knocked down but seconds later flames broke out again. Witnesses fighting the fire then heard a popping noise that they recognised as the failure of an aerosol can and started to run out of the building. The last worker to leave reported his final impressions of the fire:

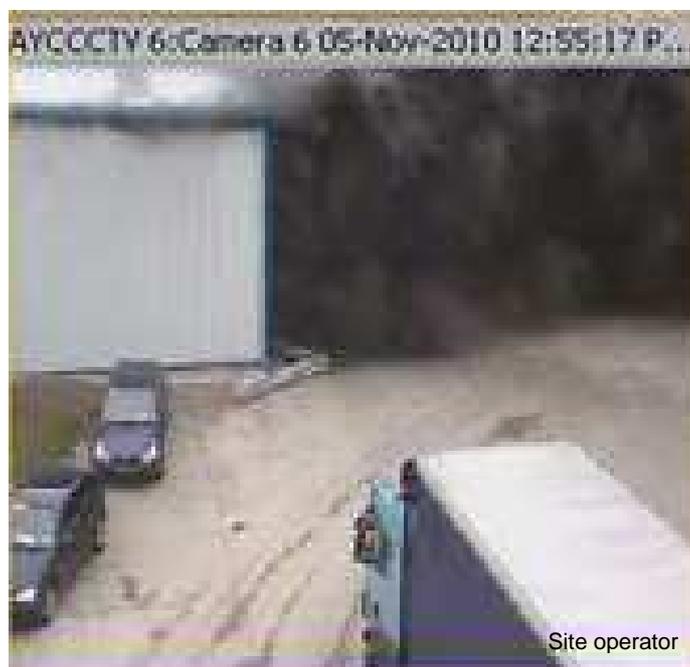
Figure 5: Smoke flow from the building 135 seconds after the fire alarm was sounded

This fire shows clearly that the release and combustion of flammable vapours from large numbers of aerosol pallets may not be a steady process. Aerosol cans may vent under conditions in which there is no immediate ignition; flammable gas and dispersed liquid then accumulates in the upper parts of the warehouse and there may be rainout of flammable liquid away from the established fire. Subsequent ignition can lead to an explosion and/or sustained burning of fuel rich volumes. The latter may generate a swelling fireball that could in principle engulf and ignite goods in a substantial fraction of the warehouse in a few seconds. Ignition of dispersed liquid may spread the fire to lower level over a wide area. This also has the effect of greatly increasing the subsequent rate of smoke logging.
