Fire outbreak inside a warehouse

5 December 2013

Crépy-En-Valois (Oise)

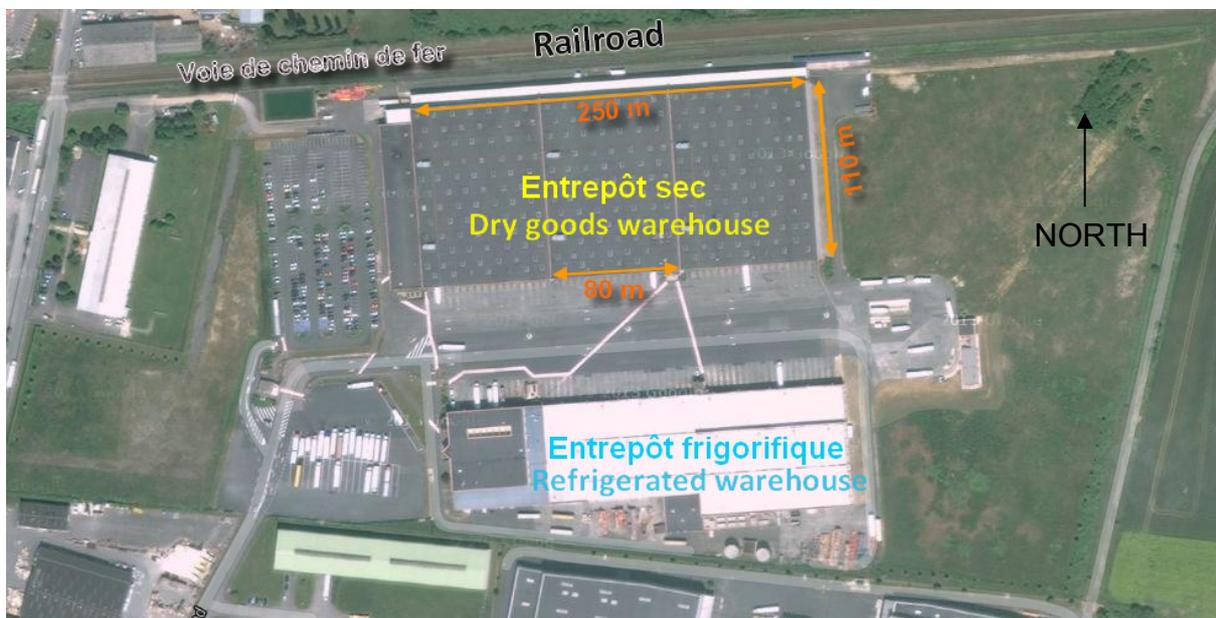
Aerial view (before the accident):

The site was composed of a refrigerated warehouse built in 1991 encompassing 17,565 m² and storing various foodstuffs (fruits, vegetables, meats, etc.), plus a warehouse containing consumer products compartmentalised into three 10,000-m² cells assigned to store dry foods, alcoholic beverages, and hardware goods and aerosols. The characteristics of this storage building were as follows:

- floor area: 33,000 m²;
- year of construction: 1993;
- metal structural frame;
- double-skin metal cladding on the facade;
- 2-hour fire walls separating each of the storage cells;
- sprinkler protection installed in each cell.

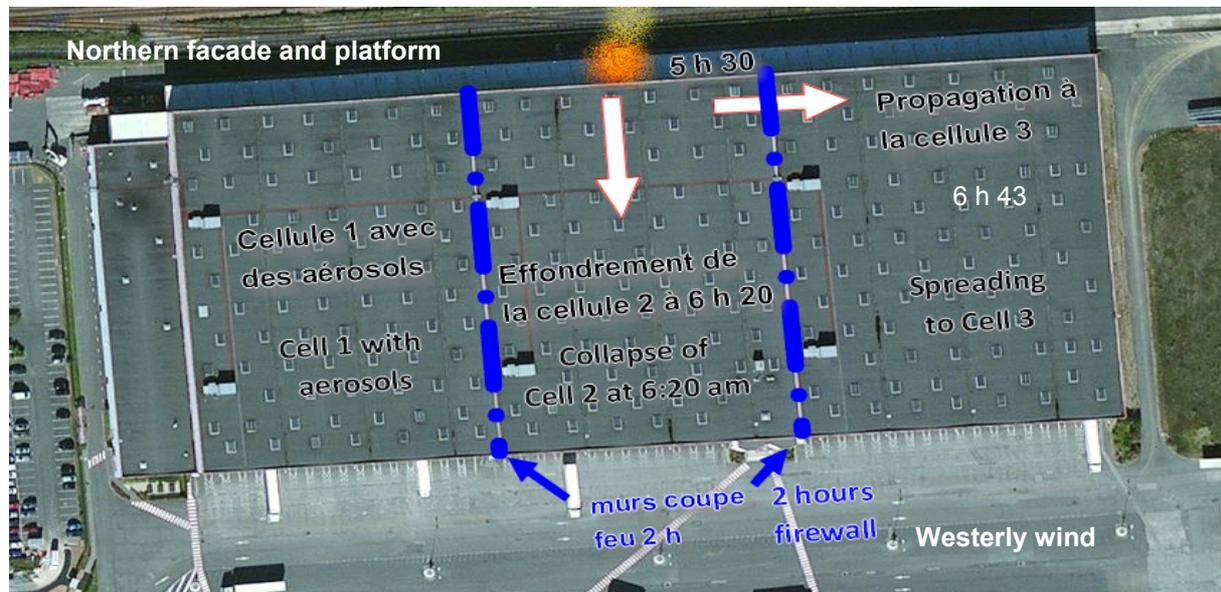
Spreading of the fire:

In the opinion of fire-fighters, flames had climbed to the roof and extended to the cladding on the northern side of Cell 3, in spite of the firewall surpassing the roofline. The fire wound up spreading from Cell 2 to Cell 3 via the smoke exhaust hatches and skylights.

The site operator informed inspectors that 2 fire doors (between Cells 2 and 3) were operable yet ineffectual: a cart had prevented one door from closing, and an explosion of canned food due to the heat release immobilised the 2nd door.

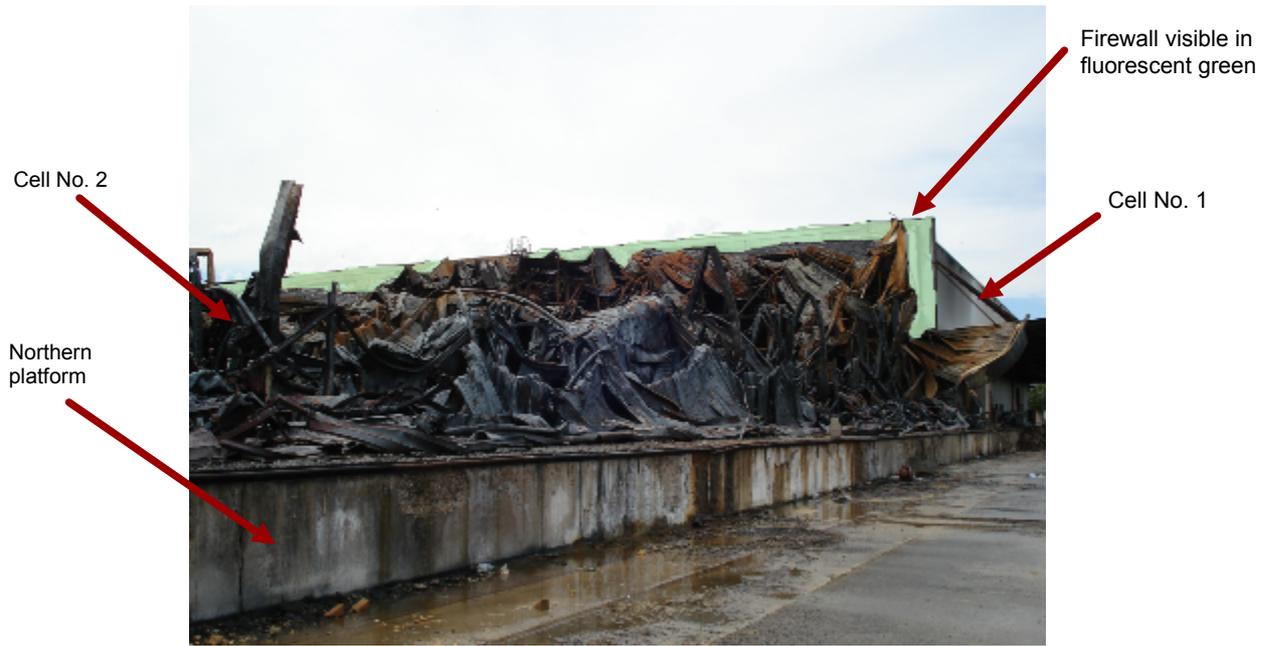
5:30 am: Fire ignited outside the dry goods warehouse on the Cell No. 2 transfer platform (northern side), where 230 m³ of paraffin oil were being stored in 20-litre cans. The alarm was sounded by the shift manager, who proceeded to evacuate all personnel.

View of the northern facade and platform after the accident (Source: DREAL Picardy)

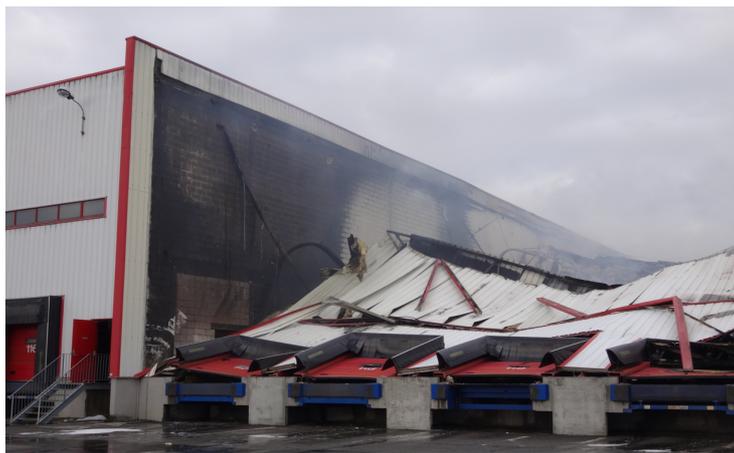
The refrigerated warehouse sustained no damage, nor did Cell 1 of the dry goods warehouse.

View of the southern facade between Cells 1 and 2 (Source: DREAL Picardy)

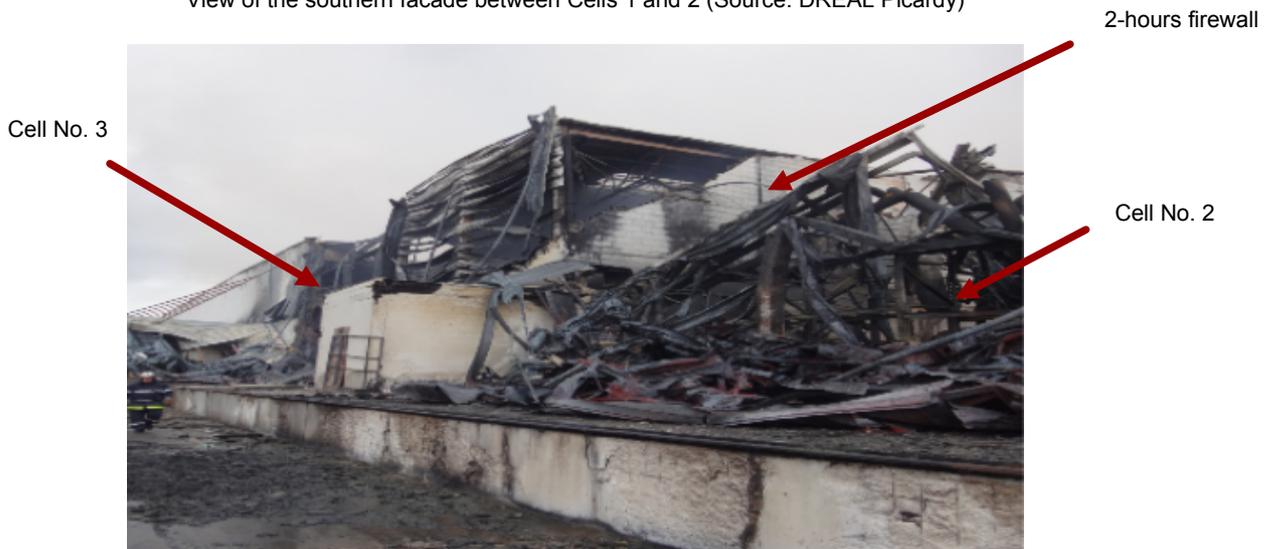
View of the northern facade and the fire wall between Cells 2 and 3 (Source: DREAL Picardy)

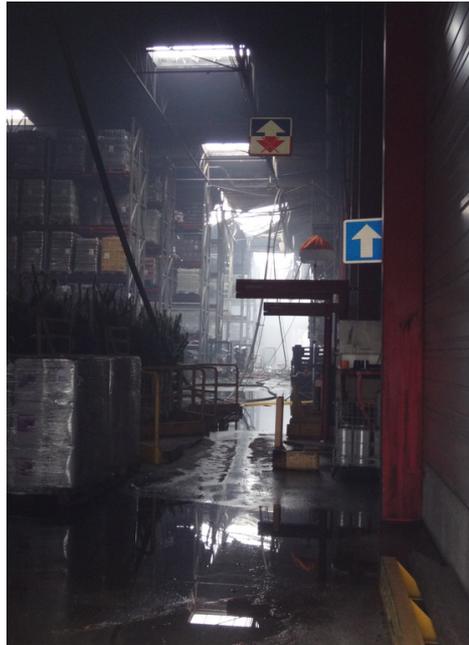
6:43 am: The fire spread to Cell 3, where about one-fourth of its contents burned. The aerosol storage in Cell 1 however resisted the raging fire.

View of the inside of Cell 3 (Source : DREAL Picardy)

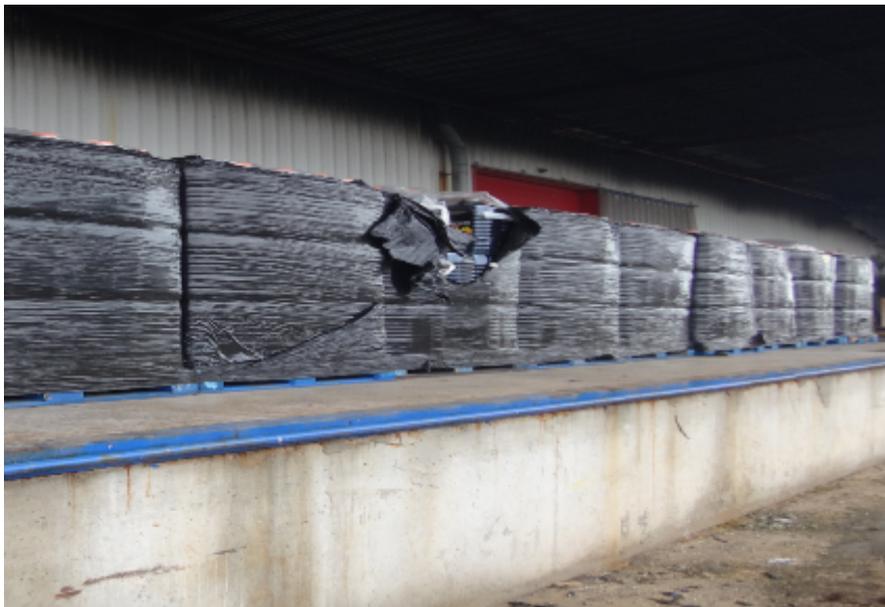
Paraffin oil storage on the northern platform (Source: DREAL Picardy)

- failure to complete an internal emergency plan drill since 2011;
- a quantity of paraffin oil stored on-site in excess of the authorised limit (230 m³ instead of 150 m³);
- persistent non-compliance recordings listed in the warehouse's electrical installation verification reports (2012-2013);
- along with technical breaches, i.e.:
- absence of a dedicated phone line connecting the facility to the emergency response centre;
- no retention built underneath the paraffin oil storage depots;
- an inoperable fire hydrant;
- a mismatched number of smoke exhaust systems (difference between facility drawings and the report);
- failure to justify fire protection ratings (doors and walls), as well as the absence of confinement for extinguishing water.

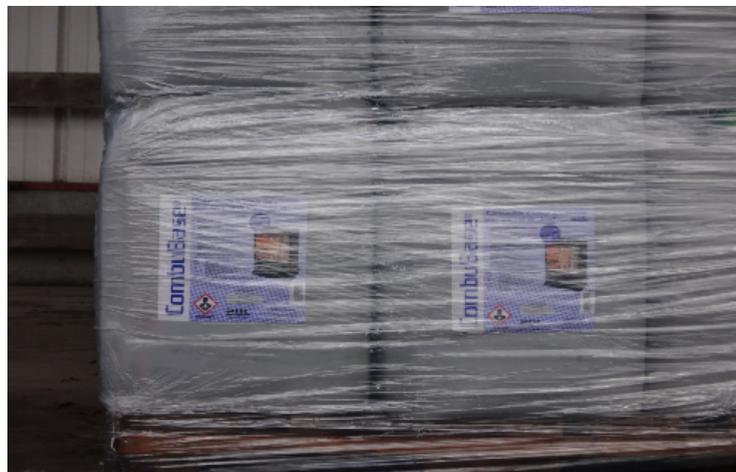
20-litre cans of paraffin oil (Source: DREAL Picardy)
