Explosions of dangerous materials in a warehouse

12 August 2015

Tianjin, China

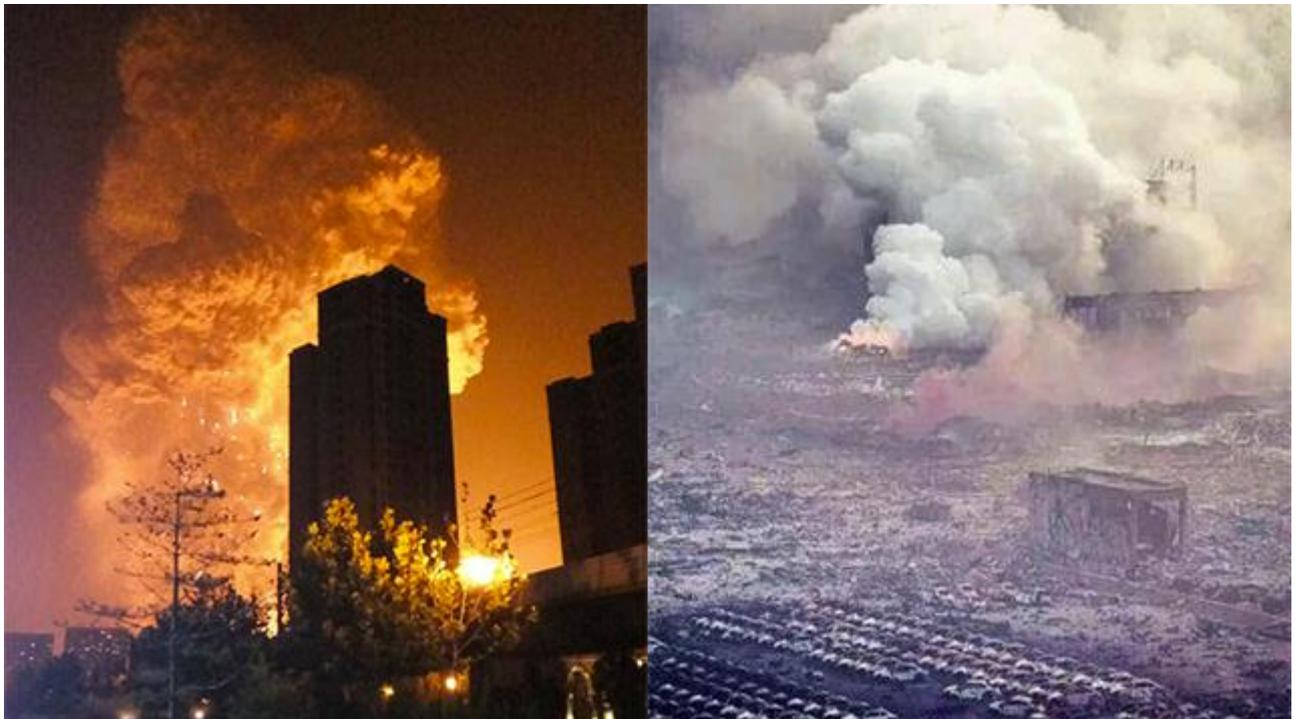
A fire broke out at 10:50 pm; two explosions occurred around 11:30 pm while firefighters battled the accident with water. The first blast was the equivalent to 3 t of TNT, and the second was the equivalent of 21 t. A massive plume of smoke formed, followed by a large-scale fire. The response by the emergency/rescue personnel included several thousand firefighters, military personnel and police officers.

Photographs of the plume of smoke, during and after the explosions

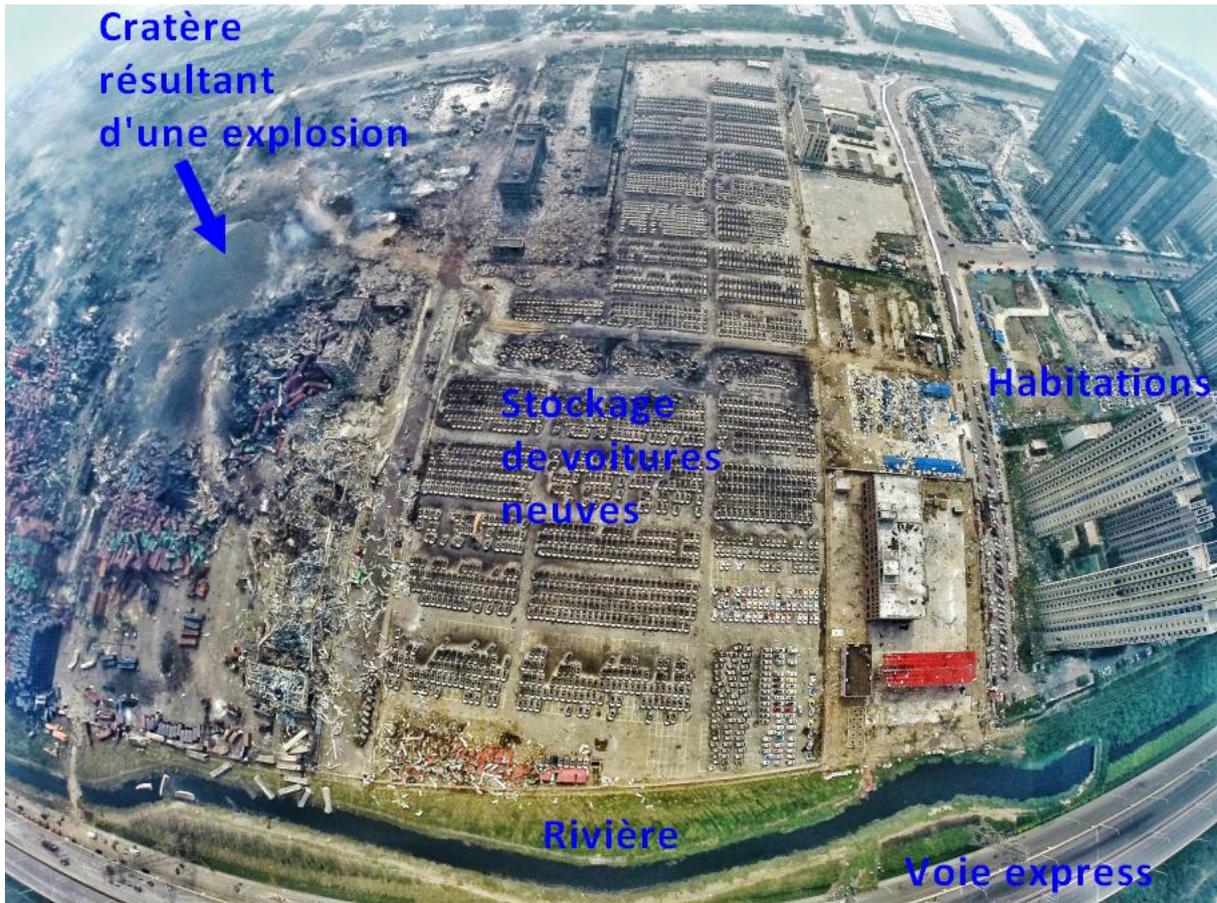
Aerial view of the site after the explosion

Cratère résultant d'une explosion	Crater from an explosion
Stockage de voitures neuves	New car storage area
Habitations	Housing
Rivière	River
Voie express	Express lane

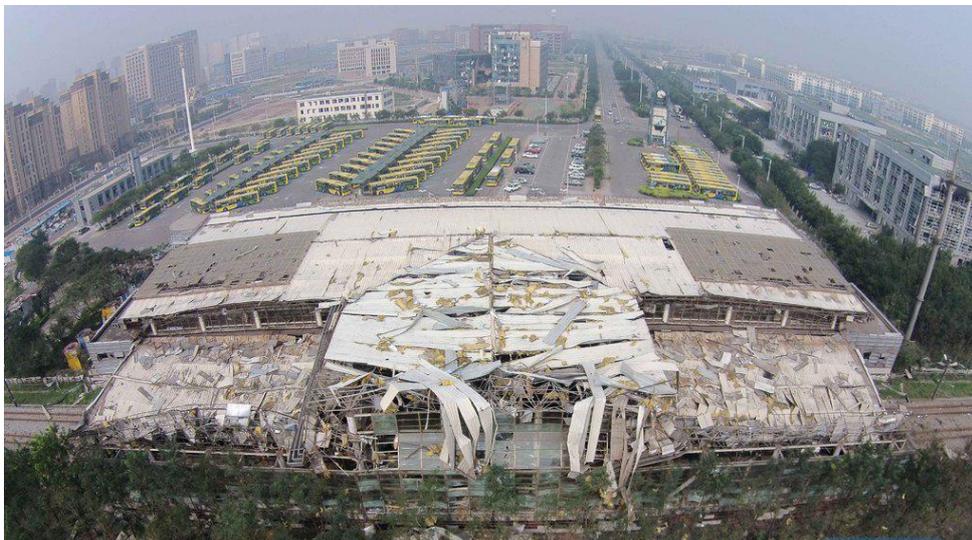
In terms of property damage, 17,000 homes were damaged, and 6,000 people were displaced. Buildings within a three-kilometre radius had their windows broken. A subway station, located 650 m from the explosion site, was also devastated. The methane terminal in the port of Tianjin (3 billion m³ of LNG/year) was affected by the accident, thus disrupting China's supply of gas for several months. An initial estimate evaluated the damage at between 1 and 1.3 billion euros. This amount was validated by the Chinese authorities' post-disaster investigation.

Metro station after the accident (Source: rights reserved)

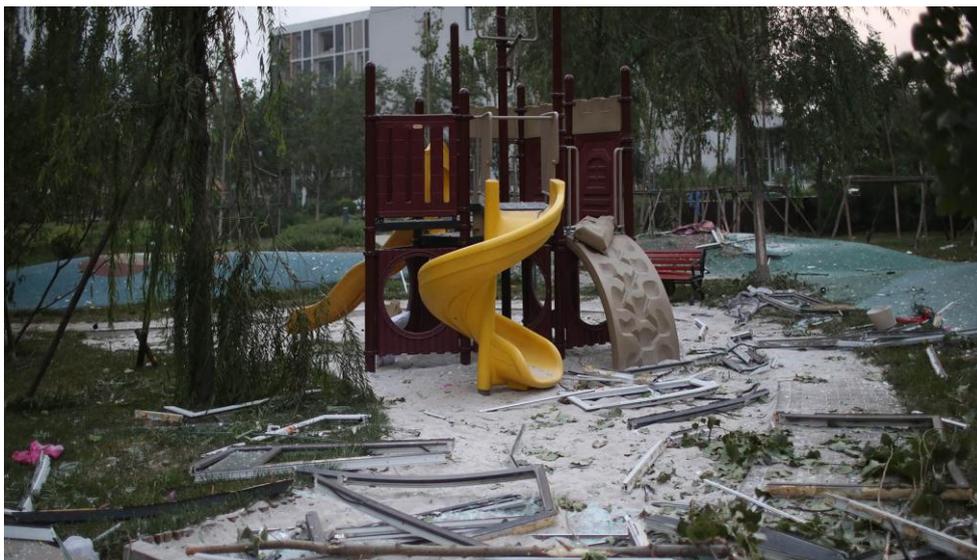
Projection of debris in a public park (Source: rights reserved)

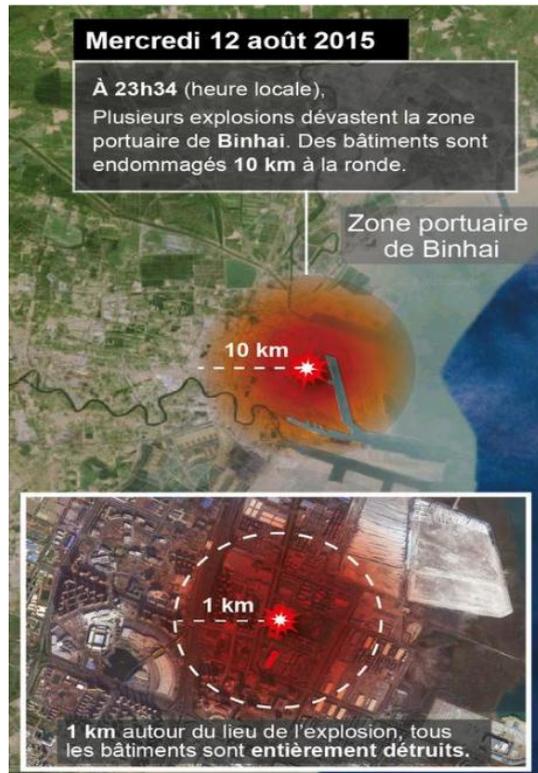
11:34 p. m. (local time).
Several explosions devastated the Binhai port area. Buildings damaged 10 km around.

All buildings 1 km around the explosion site were completely destroyed.

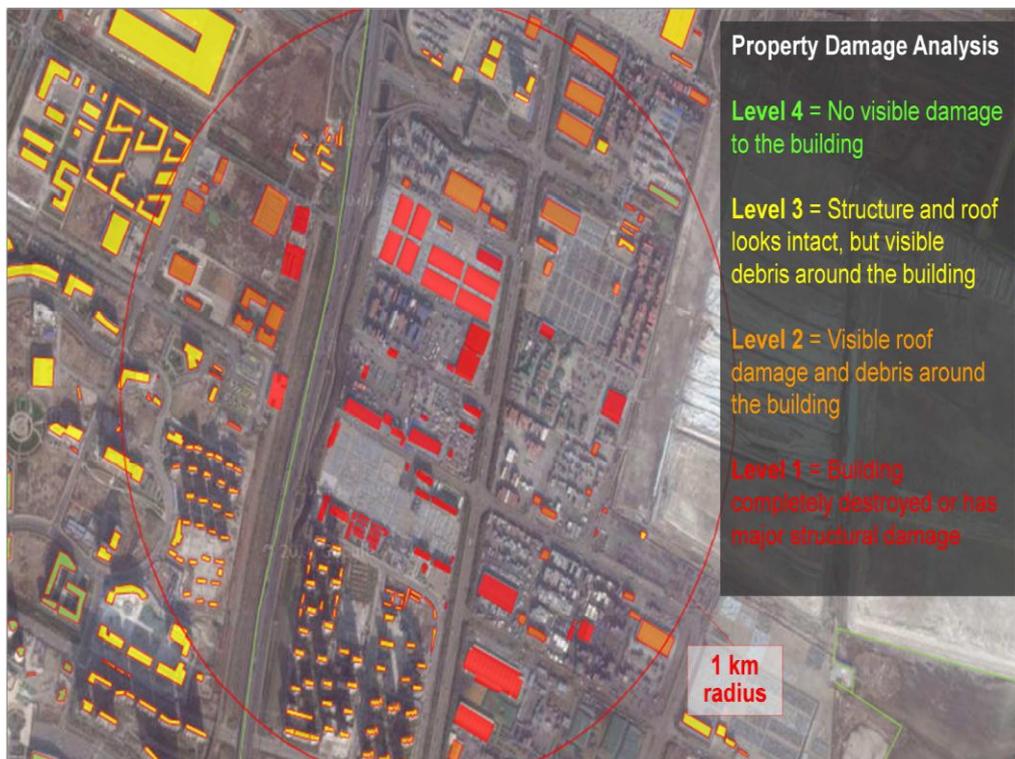
Detailed damage analysis within a one-kilometre radius of the explosion site:

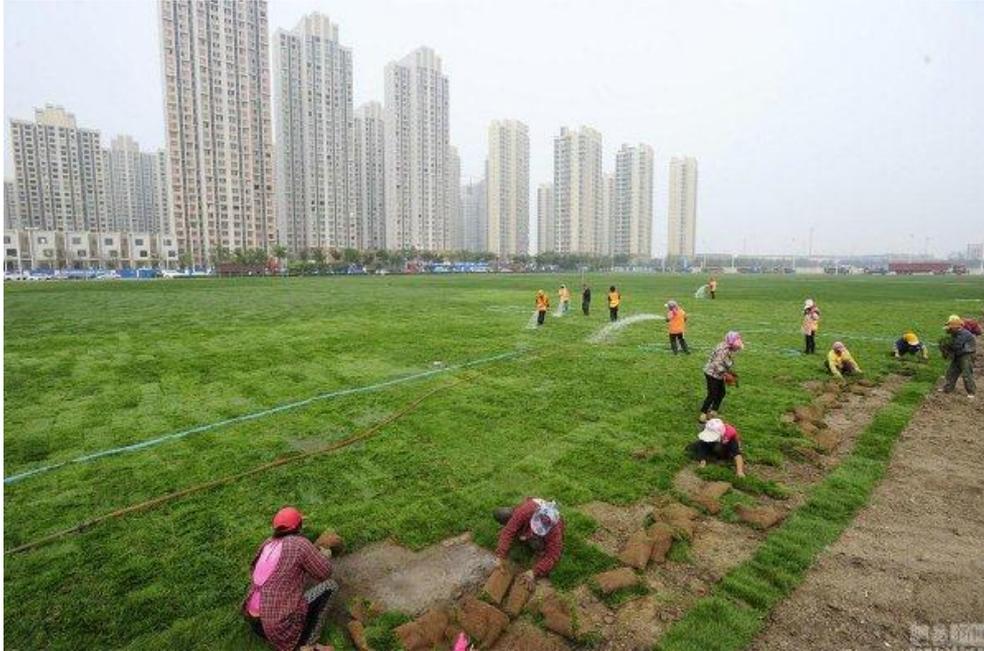
Site rehabilitation work (Source: rights reserved)

Clean-up operations in the explosion zone were declared completed by mid-September 2015. The authorities have discussed a project to rehabilitate the site into an ecopark (construction planned for mid-2016). Also, the authorities in
