## Release of acrolein into the Rhône

10<sup>th</sup> July 1976

Pierre-Bénite – [Rhône]

On 10/07/76, the release into the Rhône of the contents of a tank wagon filled with acrolein caused one of the most serious incidents of industrial pollution in French history.

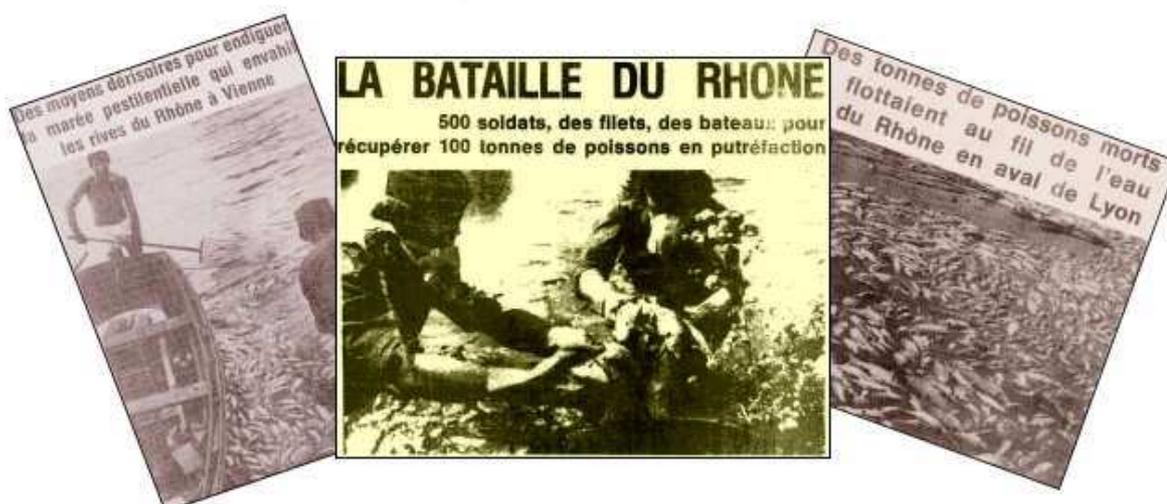
Derisory means to hold back the pestilential tide which is invading the Rhone banks at Vienne...THE BATTLE OF THE RHONE 500 soldiers, nets, boats to recover 100 tonnes of rotting fish...Tonnes of dead fish were floating on the Rhone downstream from Lyon.
