# Boiler explosion in a district heating boiler plant

30 March, 1994

**Courbevoie - [Hauts-de-Seine]**

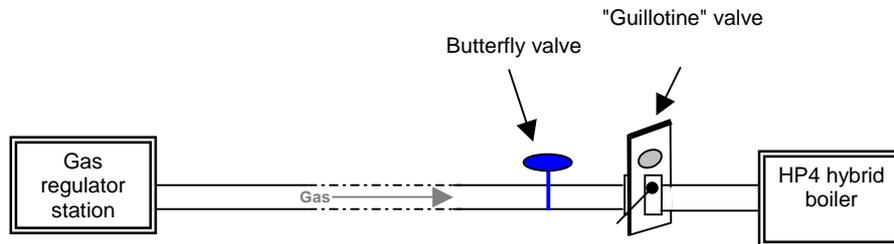
An underground pipe with a 300-mm diameter conveys the gas directly to the boiler plant basement where each boiler supply tap can be isolated by a manual valve. For the tap supplying hybrid boiler HP4, this valve was backed up by a so-called "guillotine valve" (a sort of sliding gate) actionable manually and solely in the absence of pressure. This set-up allows avoiding routing gas to a boiler that is not in a state to accommodate gas inflow.

*Diagram of the HP4 boiler gas supply process*

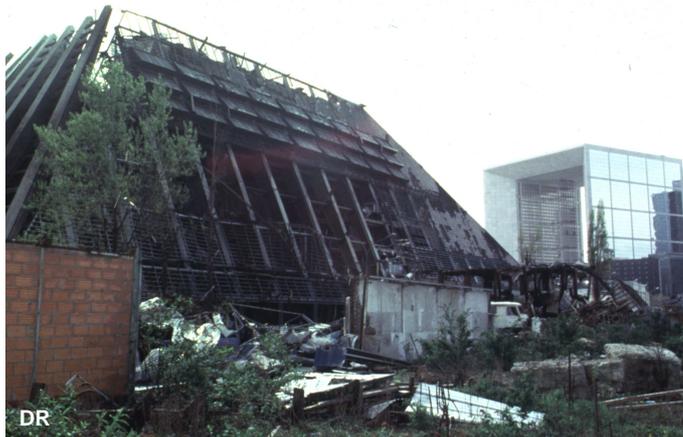
On March 30, 1994 at 1:30 am, a violent explosion rocked the boiler plant and could be heard tens of kilometres away.

✓ The explosion devastated the boiler plant: three boilers destroyed, the other boilers and auxiliary equipment quite seriously damaged, the offices and control room collapsed. Most of the slate covering the building was propelled to the ground and debris from both wall sheeting and thermal insulation was projected up to 200 m beyond the site boundary. The electrofilters were heavily damaged. The transformers and cold zone did not sustain any major loss. The Freon supply was cut in order to lower the risk of discharge.

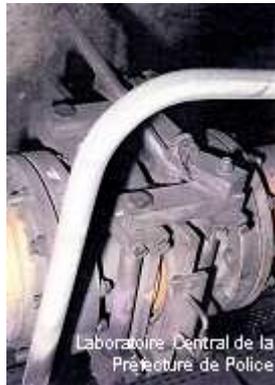
- ✓ The butterfly valve would have been manipulated by the first boiler operator without first verifying the valve, which had remained in the intermediate position, where it is no longer airtight due to slightly-spaced flanges, thereby allowing for gas to pass inside the pipe towards the outside.

Valve in the intermediate position shortly after the explosion

- ✓ A device to physically immobilize the mechanism handling this type of guillotine valve, for the purpose of prohibiting use by unauthorized personnel.

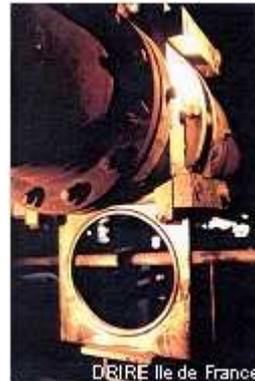
Valve in the closed position

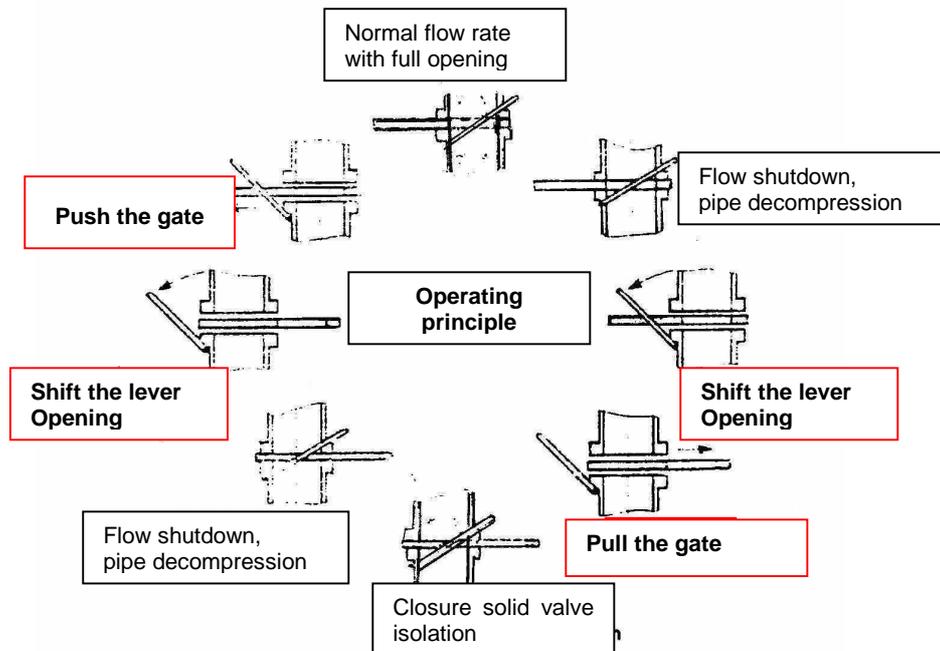
To move the valve from the open to closed position, a lever needs to be engaged in order to spread the flanges by approximately 4 mm, which enables manually displacing the support ring into the desired position (see diagram below,

with the handling steps framed in red). Opening the butterfly valve allowed for gas inflow at the level of the valve, which became locked in this position due to the pressure effect, and the leak continued until the circuit was closed at the level of the regulator station.

Operating principle for the guillotine valve  
Source: Supplier

- ✓ The valve was not designed to be handled under pressure; it had been installed in order to reinforce the butterfly valve seal for which it served as a backup and only for bleeding the line; it thus should have been closed before pressurizing the gas pipes.
