Pallet fire in a combustible materials warehouse

24 April 2018

Andrézieux-Bouthéon (Loire)
France

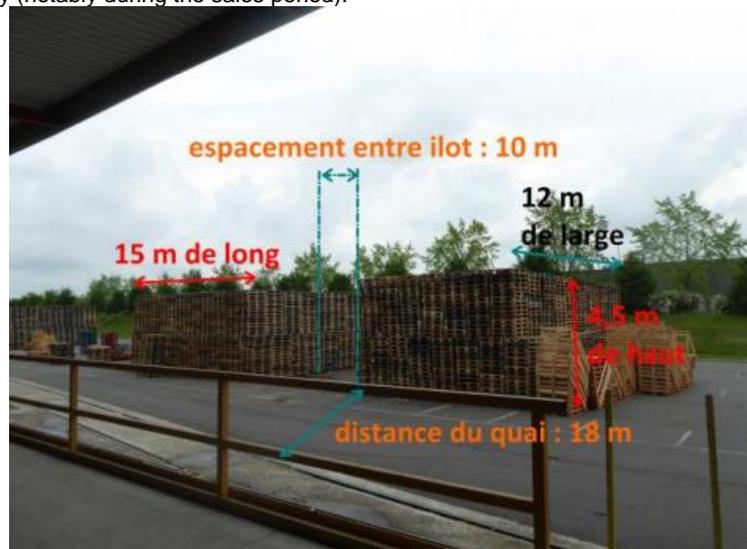
The operator stores a maximum of 20,000 wooden pallets at the rear of its warehouse (covered platform on façade) in the form of blocks. The daily flow of pallets leaving the warehouse is estimated at between 3,000 and 6,000 depending on the period of activity (notably during the sales period):

Storage of "Europe-Epal" pallets in the form of blocks (© BARPI)

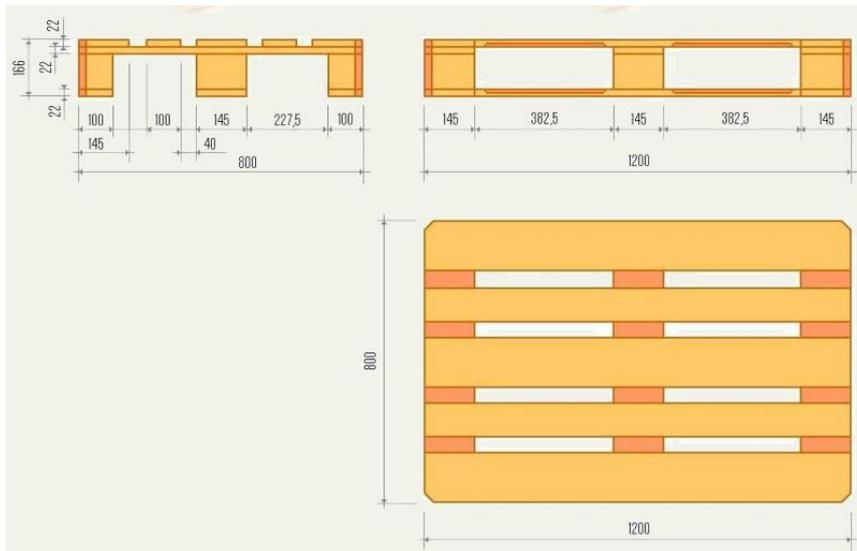
The dimensions of the stored pallets:

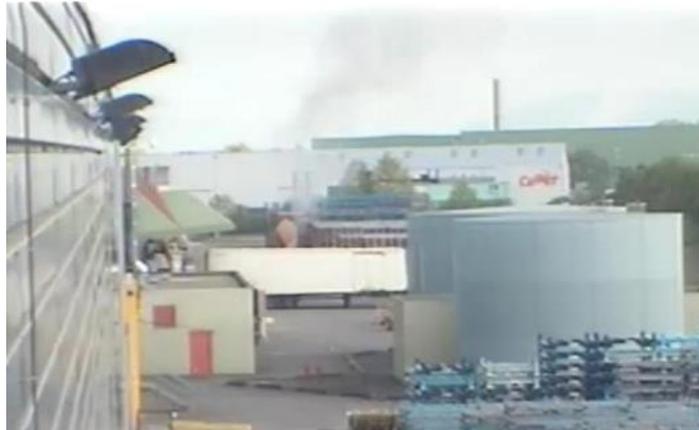
10:00 a.m.: wisps of smoke appeared:

Photo captured by the facility operator's video surveillance system

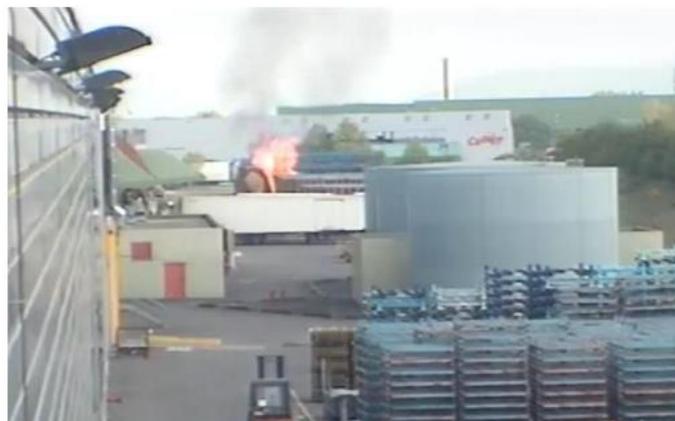
10:12 a.m.: an outbreak of fire was noted:

Photo captured by the facility operator's video surveillance system
At peak intensity, the flames rose to a height of approximately 11-12 m.

In order to protect against the risk of fire spreading to all pallet storage areas, the distance between them must also be ensured. In this case, the fire front, evaluated at 11-12 m, was comparable to the distance between each pallet block.

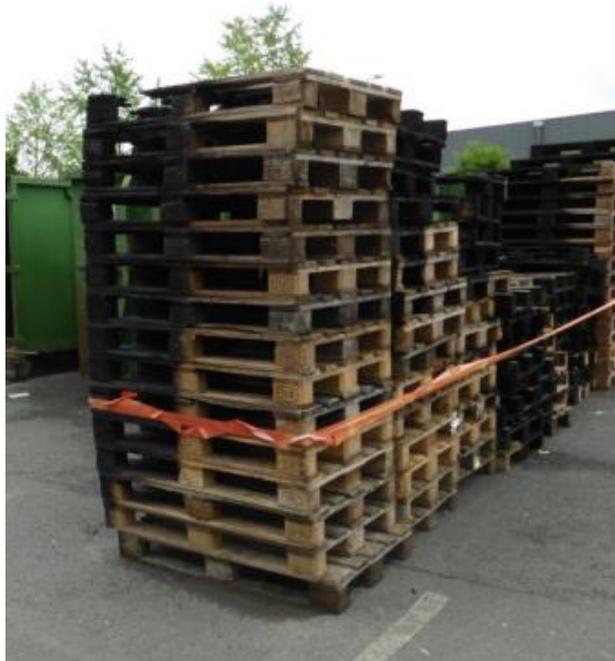
An estimated 50 m³ of water was used to extinguish the fire. The facility operator noted no damage to the environment, only a small amount of wood debris was noted on the ground. The water retained was released into the stormwater network after passing through a hydrocarbon separator.

Remnants of pallets after the fire awaiting processing in a specialised treatment facility on 22/05/2018 (© BARPI)

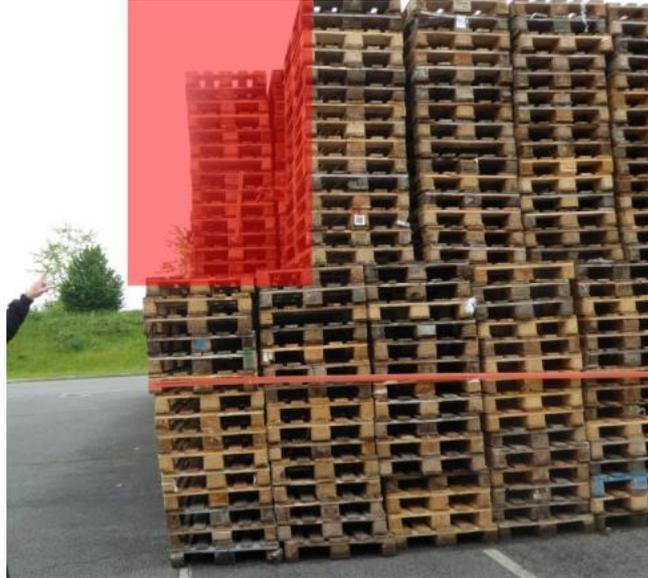
The facility operator thus blames human error for the accident. A forklift driver had used a forklift to transport a stack of 15 pallets while pushing a second stack. A pallet in the second stack was pushed along the ground over a distance of 150 m, most likely causing a nail to heat up (metal-ground contact) which ignited a smouldering fire in the pallet storage area. The fire would have been smouldering for 40 minutes in the storage zone after the forklift driver had placed the pallets in the empty area:

Location of the outbreak of the fire (© BARPI)

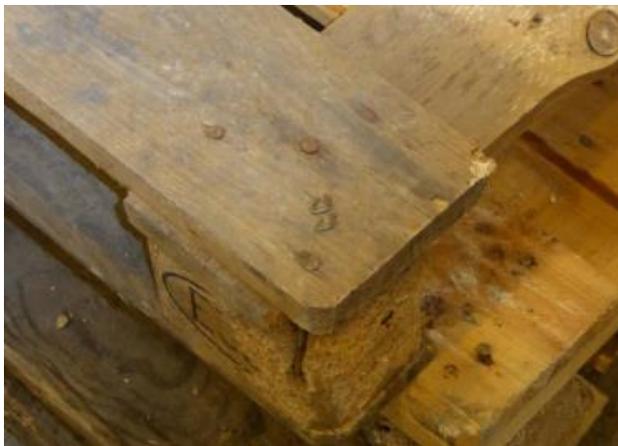
Nail in a standard pallet (© BARPI)

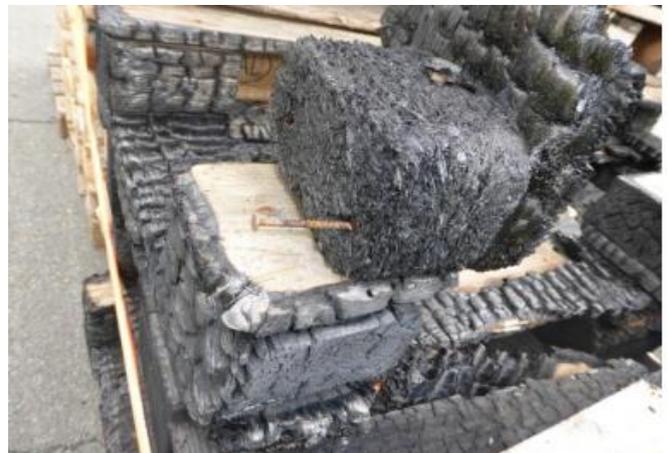
Nail protruding from a burnt pallet (© BARPI)

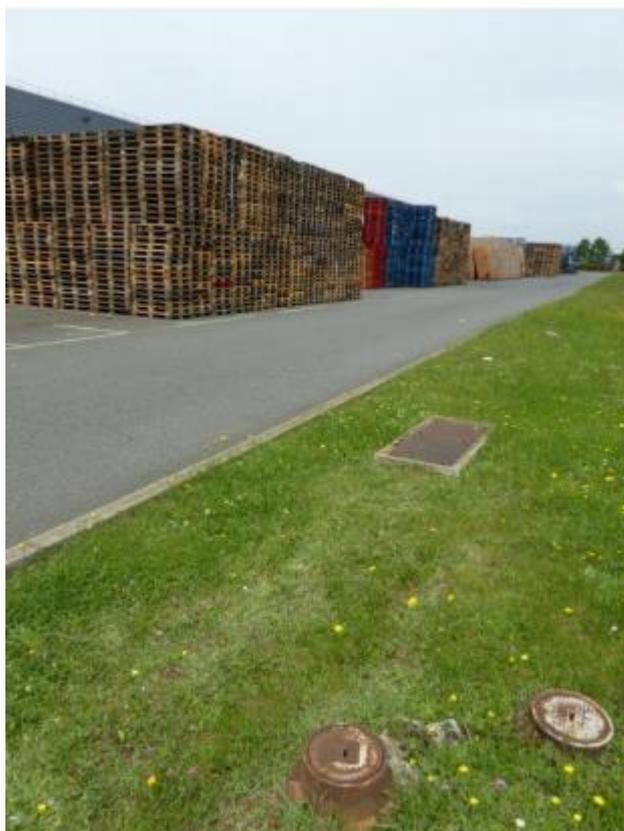
- A review of the company's internal contingency plan (POI), taking into account the need to disconnect the utility networks (gas and electricity). The burning block had been located not far from a natural gas shut-off valve which may have been difficult to operate owing to the heat generated.

Presence of natural gas system shut-off components not far from the burnt block (© BARPI)

Rapid access to 2 fire hoses allowed the personnel on site to quickly contain the fire before it could spread. This demonstrates the value of training the personnel in how to operate the fire extinguishers and fire hoses. However, the need to shut off utilities: electricity and gas, must not be forgotten (fire near the natural gas pipeline).

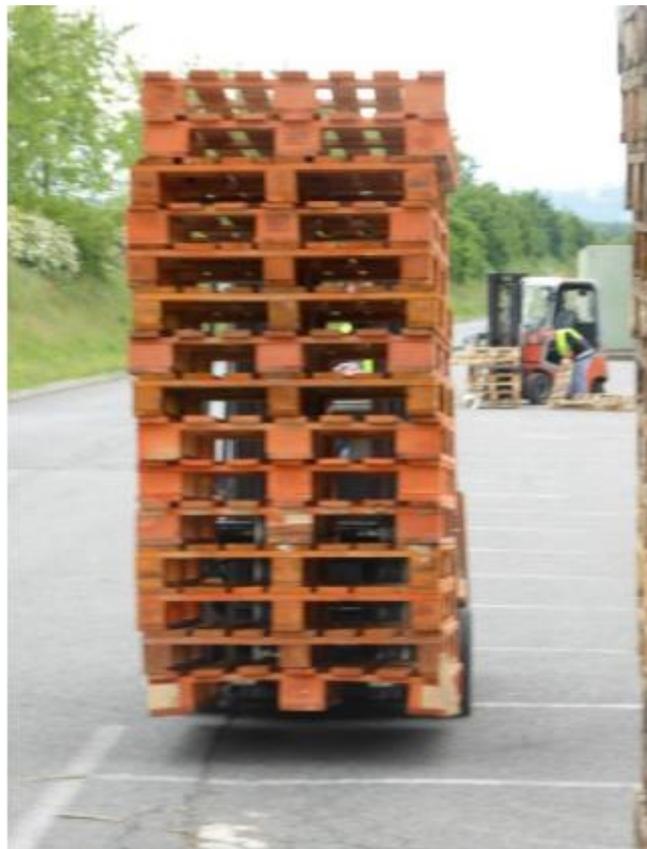
Handling a stack of 15 pallets with a forklift (© BARPI)

Pushing pallets with a forklift is not authorised. Instructions are given in this regard when passing the CACES (Certificate of Aptitude for Safe Driving). The driver involved in the event is also an experienced driver (17 years experience) and has the CACES 1-3-5 certificate. He also had a forklift permit, issued by his employer, and was up to date with his CACES training. Two specialised trainers/evaluators are present at the facility. At the site, the forklift operators are not paid by the number of tasks accomplished and are covered by the collective agreement for the logistics and supermarkets and supermarkets sector.

- Oral training of the site's forklift operators to take into account the feedback from the event. No formal written report was compiled to avoid alienating the forklift driver involved in the event;

Finally, regarding the handling of goods, it should be pointed out that, according to the "official occupational prevention, health and safety" journal, numerous deadly or significant accidents occur every year. On average, the operators of self-propelled forklifts rack up 8,000 lost-time accidents per year with approximately ten or so fatalities. The risks induced by the handling goods must, therefore, be analysed upstream in order to avoid any adverse consequences in terms of both environmental and human safety. Poor handling practices, even if they would appear to save time, should be avoided.
