The Rhine polluted by pesticides

November 1st, 1986

Schweizerhalle

Switzerland

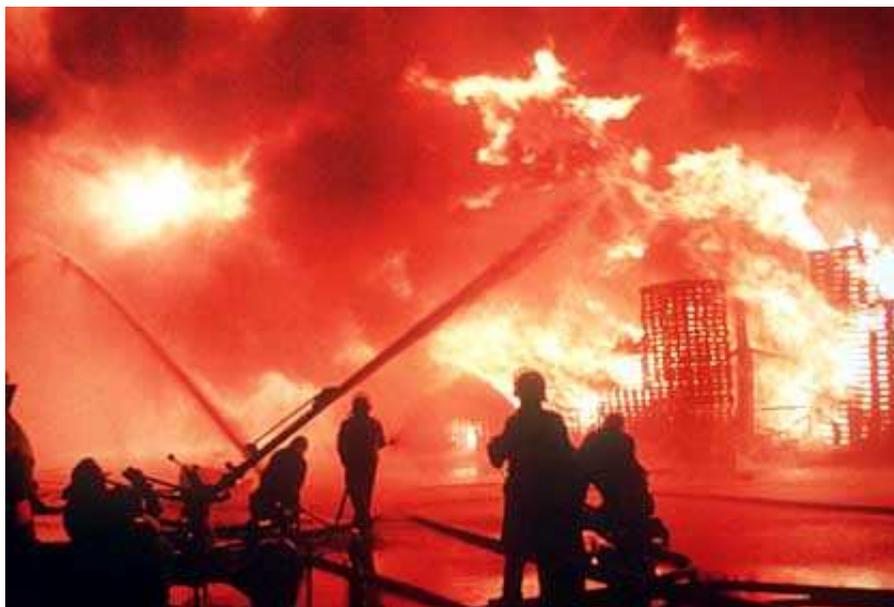
Figure 1 – Firemen fought the blaze for several hours

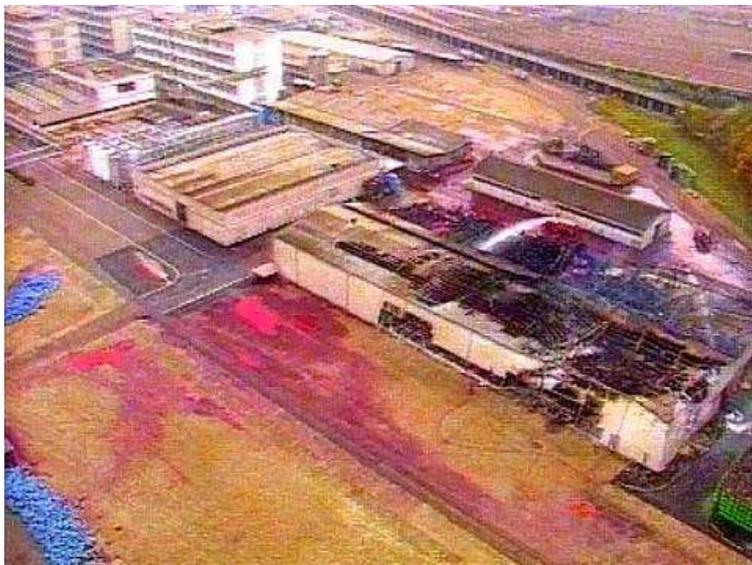
The Rhine river and the atmosphere were seriously polluted. According to certain sources, the 50 m³ catchpit built on the site was unable to contain the 10,000 to 15,000 m³ of firefighting water resulting from the millions of litres of water sprayed

Figure 2 – Overall view: burned warehouse and pink firefighting water <http://www.wissen.swr.de/sf/begleit/bg0016/nm15h.htm>

to put out the fire flowed for 28 hours via the rainwater drainage system into the river which took on a pinkish tint. According to certain sources, this water transported approximately 30 tonnes of toxic products (decomposition products produced in the fire, agro-pharmaceutical products...), including 150 kg to 2.6 tonnes of mercury incorporated in organic mercury compounds. The cocktail of substances which made its way down the river at 4 kph completely wiped out all aquatic life over more than 250 km, then reached Rotterdam more than 1,000 km downstream and slightly contaminated a few water tables. Upon seeing the river's pinkish-red colour, the guard of the Huningue canal's water inlet decided to close the valve and inform a civil employee of the Departmental Agriculture Department who decided to lock the outlets of the Hardt, from the Rhône to the Rhine, Blodelsheim and Chalampé canals. A few days later, the Rhine's ecosystem, including fauna and flora, was destroyed despite the high level of dilution (approximately 1:2,000,000). Thousands of dead fish were collected: 190 tonnes of eels died in a few hours. The

In 1989 and 1990, 17% of group investments were dedicated to the construction of catchpits at all of its sites throughout the world. At Schweizerhalle, one of the measures announced was the construction of 2 water catchpits of 15,000 and 2,500 m³ for a cost of 15 M Swiss francs.

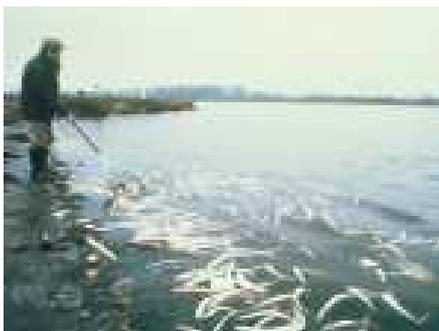
According to the sources, the underdimensioning or total lack of catchpits directly led to the spillage of polluted water into the Rhine and the destruction of its ecosystem. Several tons of dead fish were collected over the following days.

Figure 3- Thousands of dead fish in the Rhine
<http://www.ethlife.ethz.ch/articles/tages/EAWAGInfotag.html>

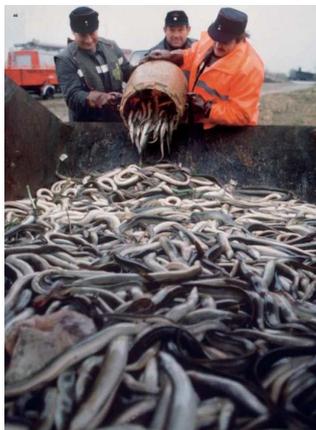
Figure 4 - Swiss firemen recovering tons of dead eels

- Level 5 of parameter Env10 characterises the 190 t dead eels (50 t ≤ Env10 < 200 t).
- Parameter Env11 reached level 1 by default: no quantitative information is available regarding the animal or rare or protected vegetal species that were destroyed.
- Parameter Env12 is 1 by default: the volume of water polluted is unknown.
- Level 1 of parameter Env13 is reached: a few water tables were contaminated.
- Level 6 of parameter Env14 is reached: the Rhine was polluted over more than 1,000 km.

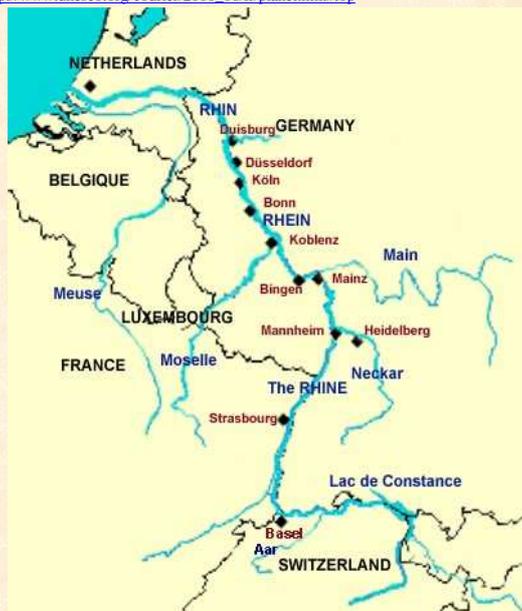
The Rhine originates from several sources located in the Swiss Grisons and extends 1,320 km between Reichenau and the North Sea. One of them supplies the anterior Rhine (Vorderrhein), and another the posterior Rhine (Hinterrhein): they come together at the Swiss village of Reichenau forming the Alpine Rhine, the natural border between Switzerland and Austria. It then crosses the Lake Constance. Following the famous 25-meter Schaffhouse falls, the High Rhine (Hochrhein) flows to the west and forms the border between Germany and Switzerland. Downstream from Bâle, it turns northward: the Upper Rhine (Oberrhein) flows more than 300 km. It then forms the border between the Switzerland and France, then that between France and Germany along 180 km. It then limits several German Länder. At Mayence, the river again flows west but at Bingen, it turns northward. The Middle Rhine (Mittelrhein) crosses the Rhine Schist Massif over 110 km. From Bonn, it is called the Low Rhine (Niederrhein). Arriving at the Dutch border near Emmerich, is subdivides to form the Rhine Delta, where it meets the Meuse. The Rhine hydrographic basin covers roughly 250,000 km².

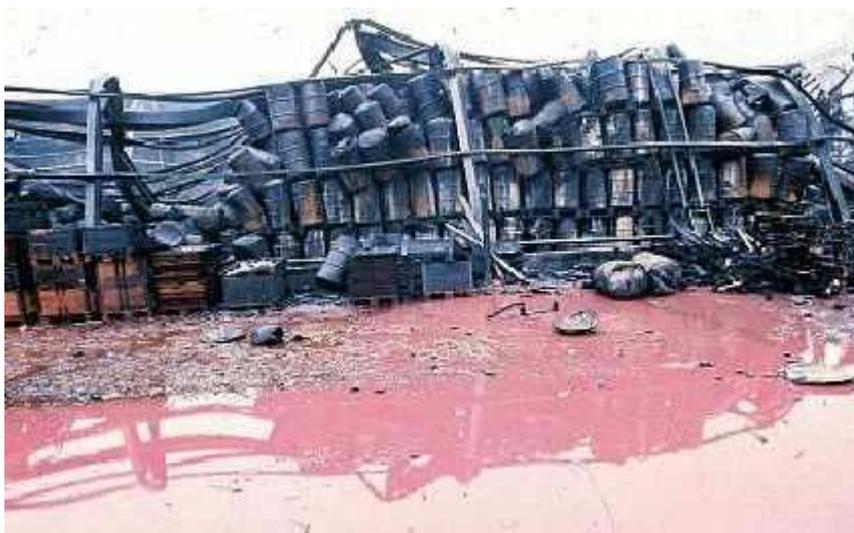
Figure 5 – Burned drums of pesticides and pink-coloured firefighting water
http://www.alsapresse.com/dossiers_classes/60ans/pdfs/alsace_1986.pdf

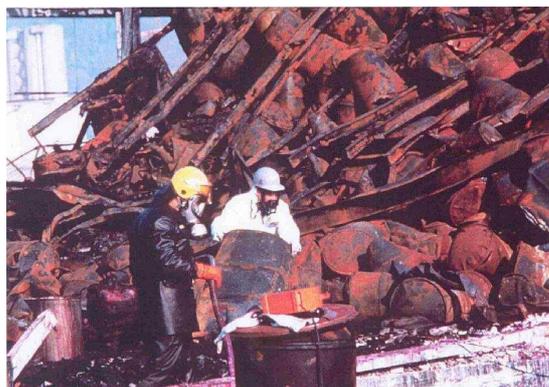
Figure 6 - Elimination of wastes

Initially, in order to limit chronic pollution, a specialised company cleaned the sediments over several hundred square meter around the plant. The authorities concerned required that the waste and rubble from the hangar be decontaminated and insulated. The site was protected from the rain by an immense tent, then cleaned. The water used for this operation was recovered and processed in the complex's treatment plant. The highly toxic wastes were loaded into : 20 rail cars, 200 bins and 6,000 hermetically closed drums.

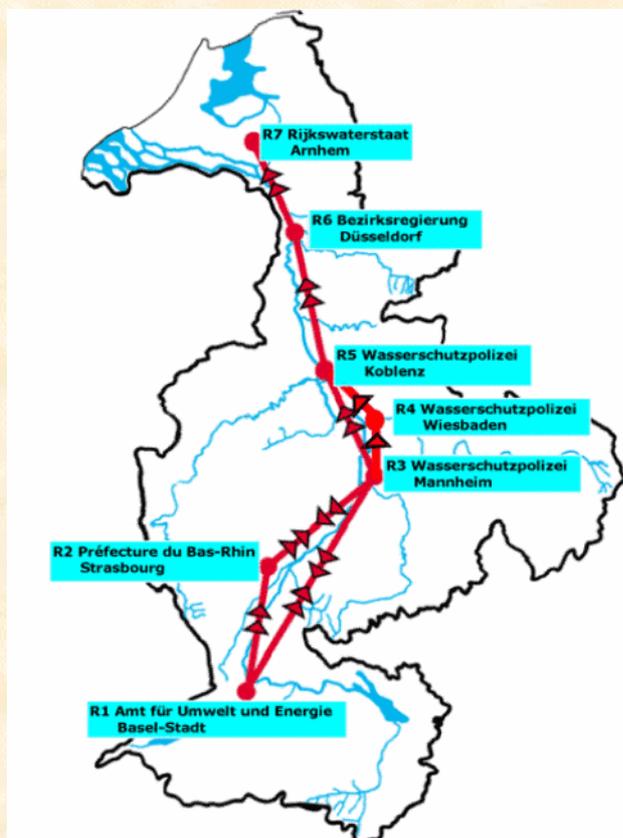
The **International Commission for the Protection of the Rhine (CIPR)** operates a warning and alert system for the Rhine: 6 international warning centres located between Bâle and the German-Dutch border share river monitoring operations and 2 others are installed on the Moselle. Each of these centres supervise a specific section of the Rhine or several tributaries. In the event of an accident, the centre concerned transmits an initial message to all the centres downstream and the secretariat of the CIPR in Coblenz. Most often it is just an informative bulletin. In the event of serious pollution, a warning is sent. The residents located downstream may intervene to ward off or limit possible damages.

Currently, the services linked with the alert model can monitor changes in the pollution wave and rapidly forecast concentrations in the substances transported.
