Fire in a plant specialising in processing recycled elastomer waste

02 February 2022

JOUÉ-SUR-ERDRE (Loire-Atlantique)

Fire
Miscellaneous equipment
(Heater)
Oil
Storage

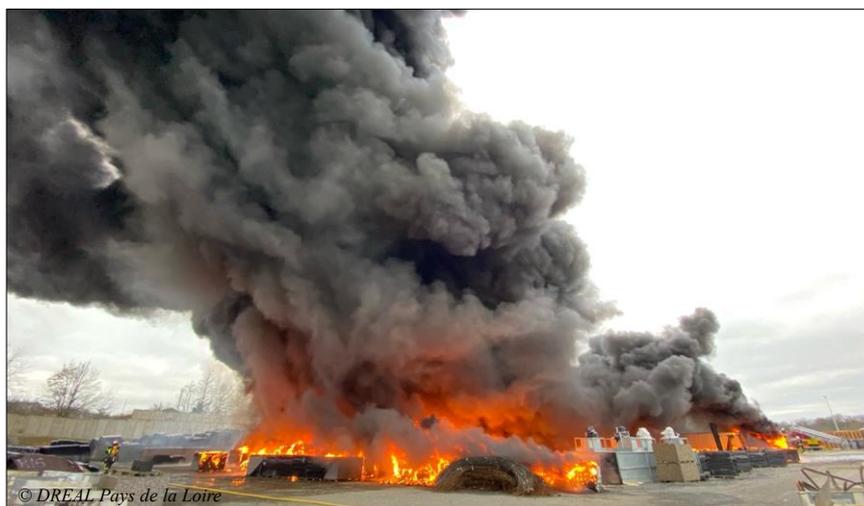
The site suffered significant damage:

- the stock of finished products (approximately 13,500 sheets of elastomer, i.e. 345 t) and machines pending assembly were destroyed by the fire, generating more than 316 t of waste disposed of in a non-hazardous waste storage facility;
- loss of the 10 t travelling crane;
- the vulcanisation line remained out of operation for 10 months;
- part of the structure and the building's entire roof and cladding were destroyed;
- the adjoining building was damaged (the partition between the two buildings and the roof were affected).

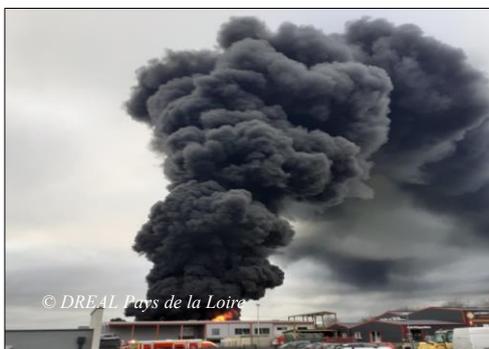
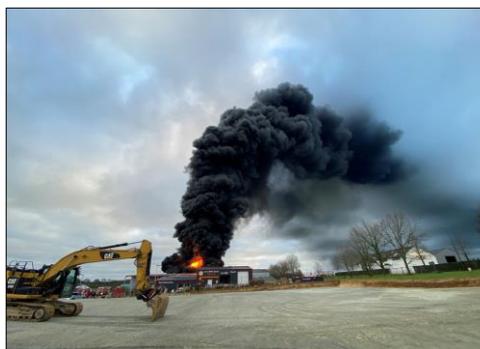
The origin of the accident, as determined by the experts, was a rupture of the heater's oil supply hose. This was due to the flexible part of the hose "coming loose" from the rigid part which includes the rotating fastening nut (see the picture below for illustration).

The oil used is a special high-quality oil for heat transfer and thermal regulation. The oil ignited between 7:45 and 8 a.m., as the first employees did not notice any fire beforehand. To obtain CE certification, the regulations of the Machinery Directive require that the fire risk be reduced while taking the three principles of the fire triangle into account. This means implementing preventive and protective measures to prevent the fire from breaking out or spreading. If these actions are not feasible, confinement, fire detection and extinguishing measures must be taken. In this case, this new heater did not have a retention tank or fire detection. The firefighting means were ill-adapted to the stock of oil, which played a significant role in the development of this incident.

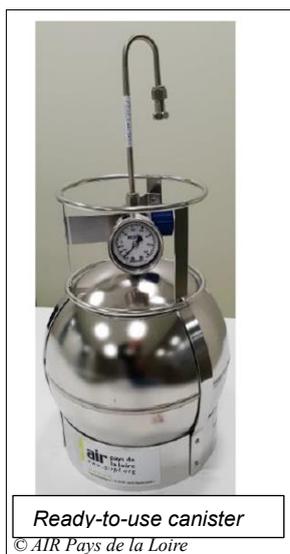
The measurements were carried out over periods ranging from 30 minutes to 4 hours based on the following scheme:

- a control site (an ‘EPHAD’ assisted living facility) located 200 m to the south-west not impacted by the smoke;
- eight measurement sites located downwind between 0 and 6 km to the east of the establishment near inhabited areas.

The pollutants analysed were mainly Chlorinated Volatile Organic Compounds (Cl-VOCs) and BTEX (Benzene, Toluene, Ethylbenzene and Xylene). 55 gaseous species were also identified. Canister sampling does not allow for the analysis of particulate matter on which certain pollutants such as PAHs (Polycyclic Aromatic Hydrocarbons), dioxins and furans can be attached.

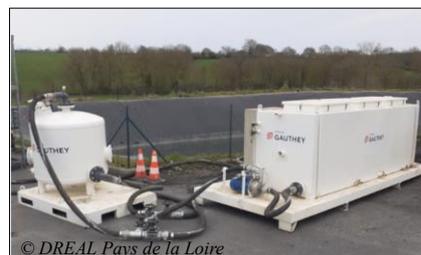
At the same time, the operator studied the possibility of treating the firefighting water contained in the retention pond before discharging it into the natural environment. A mobile pre-treatment installation was therefore set up on site (with a decanter, sand filter and activated carbon filter). The first test was conducted on 16 March to determine whether the pre-treated effluents were compatible with discharge into the natural environment. In light of the results obtained, it was decided to authorise the discharge of the water contained in the 240 m³ temporary storage bladder and the pond (i.e. approximately 500 m³ in all).

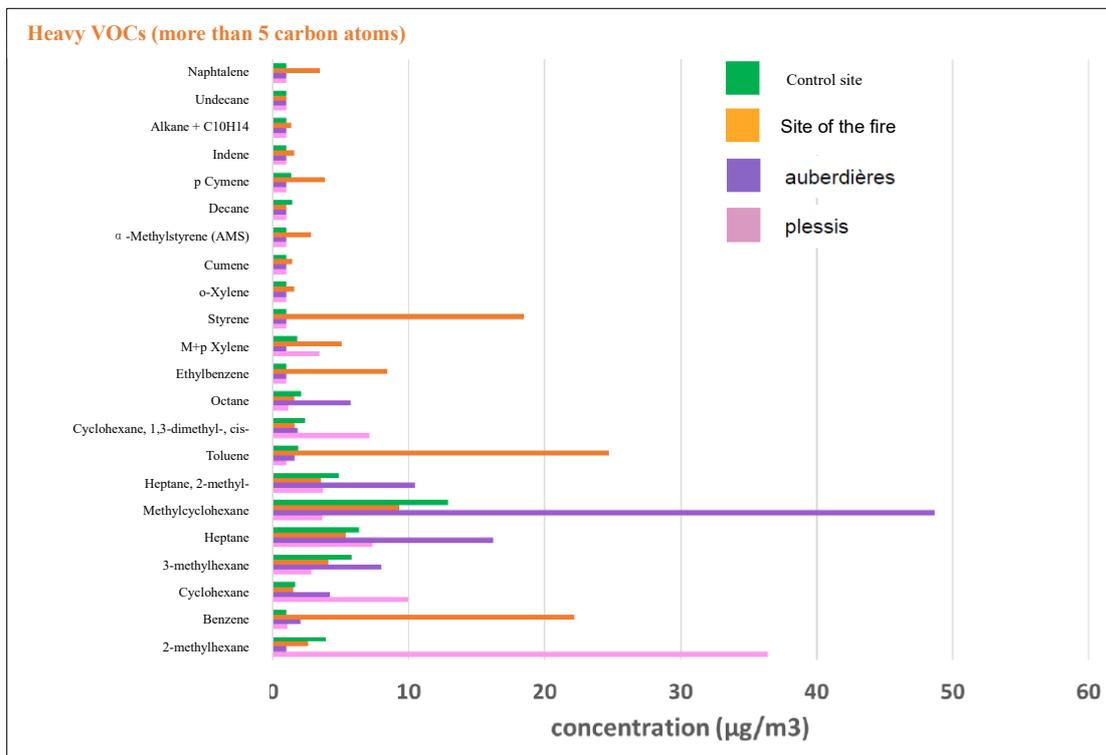
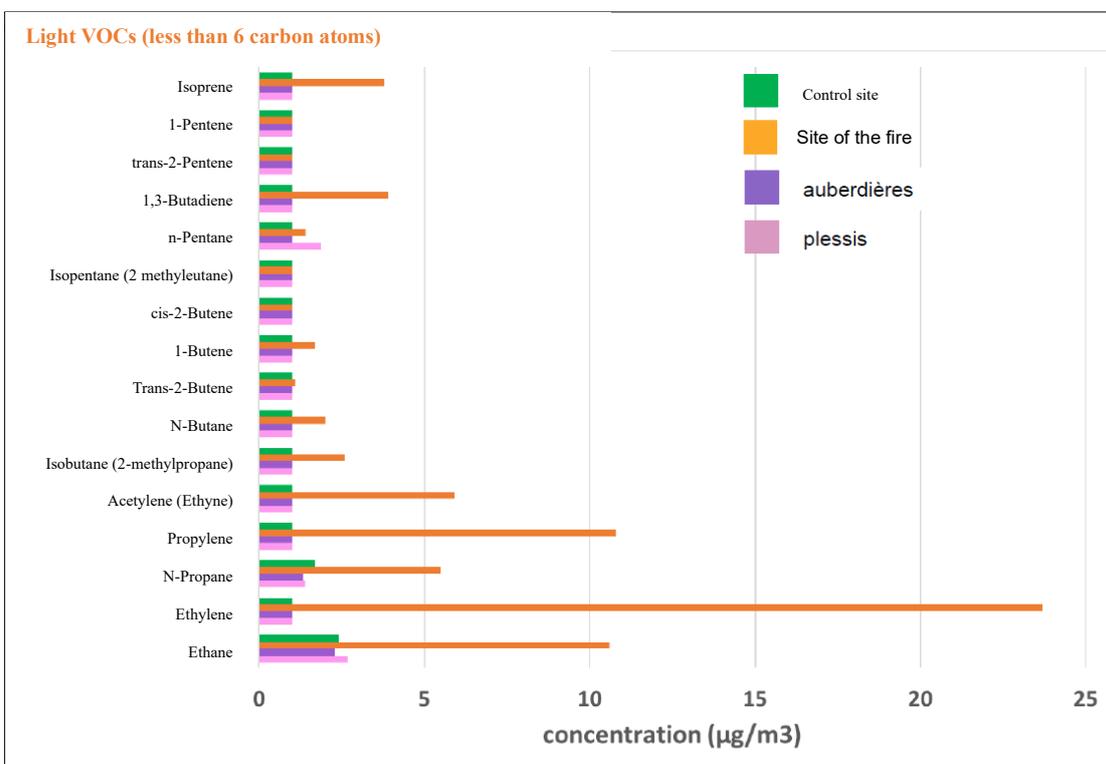
1-Results of the air analysis

- chlorinated VOCs were not identified as their concentrations were below the detection threshold ($< 1 \mu\text{g}/\text{m}^3$);
- a decrease by a factor of 2 to 20 in BTEX on the sites at 900 m and 1,900 m away, respectively (see Appendix 1);
- environmental matrix analysis (firefighting water, foodstuffs, plants, soils and soot) confirmed there was no impact of fumes on the environment. No concentration exceeded the limit values for discharge into the natural environment.
