Ammonia leakage in a fertiliser production plant 1st December 1994 Ribecourt-Dreslincourt (60) France

Chemistry
Ammonia /fertiliser
Leak of dangerous material
Inspection / Organisation
Manual operation
Piping / valve
Victim
Operations / shut down

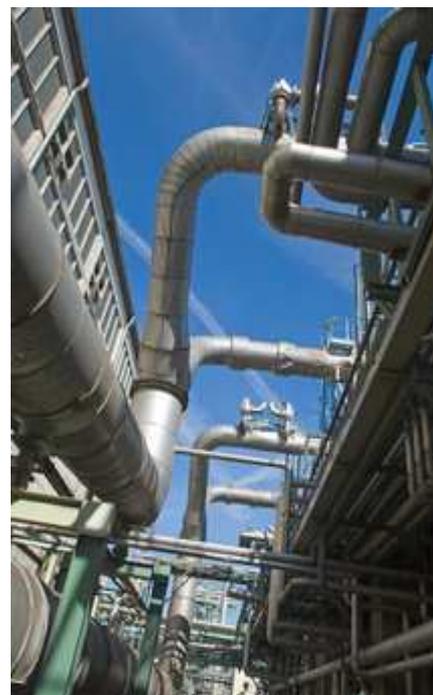
All production methods of the granulated three element fertiliser use the same procedure:

- a) Weighing of solid raw material
- b) Measuring of liquid raw material
- c) Granulation
- d) Drying
- e) Screening and crushing
- f) Coating and cooling
- g) Gas scrubbing

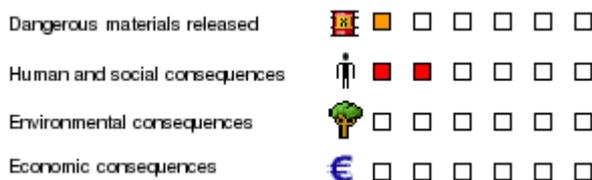
By applying the rating rules of the 18 parameters of the scale made official in February 1994 by the Committee of Competent Authorities of the Member States which oversees the application of the 'SEVESO' directive, the accident can be characterised by the following 4 indices, based on the information available:

The quantity of liquid NH₃ contained in the pipes and released in the dryer in form of a spray is estimated to be 5 kg. Since the Seveso threshold of this substance is 200 t, the quantity released corresponds to 0.0025% of the threshold. Level 1 is attributed to the dangerous materials released index for this percentage (see Q1 parameter). One of the poisoned victims died in hours following the accident, resulting in level 2 being attributed for the human and social consequences index (see H3 parameter).
