Explosion in a nitrogenous fertiliser plant

21 September 1921

Oppau – [Rhénanie]
Germany

Chemical industry
Disaster
Ammonium Sulphonitrate
Victims
Material damage
Modifications

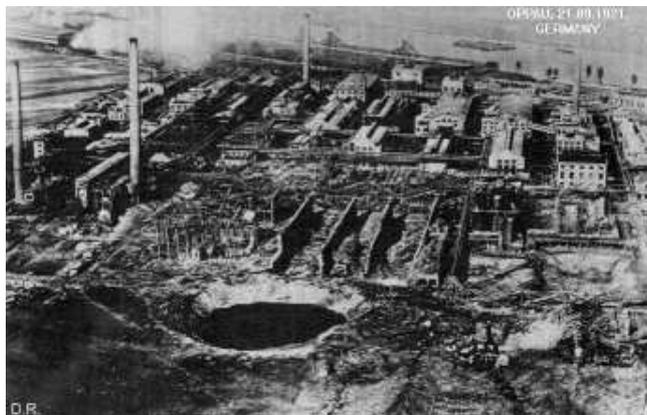
On 21 September 2001, when the technician was preparing the holes for the firings in the "silo 110" at 7.00 am, a very powerful explosion took place in the silo at 7.32 am, creating a 90m X 125m crater and 20m deep!

According to witnesses, there were two successive explosions, the first one being weak and the second one devastating. Seismographic readings from Stuttgart, at 150 km from Oppau also showed two distinctive explosions that occurred at an interval of half a second.

Soon after the explosion, there were multiple fires on the facility and other less intense explosions occurred on the site and the air was heavy with ammonia vapours.

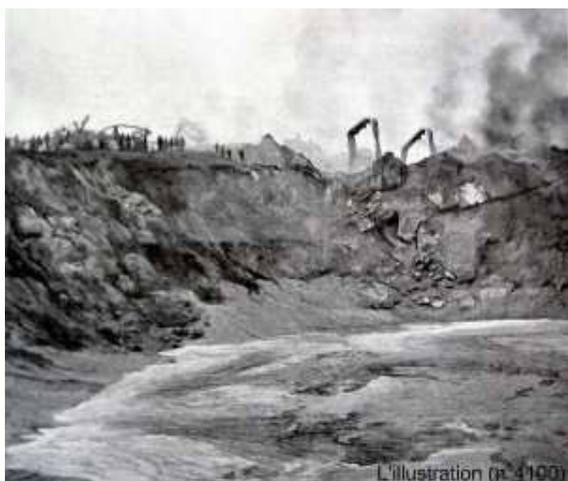
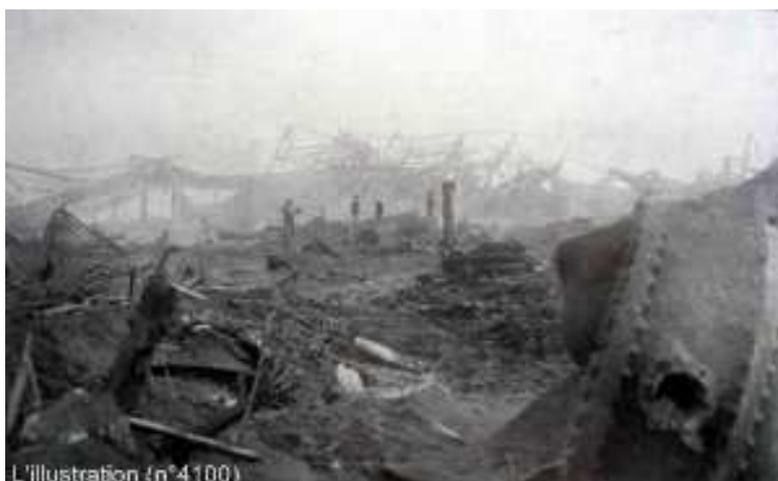
The official human casualty reported included 561 deaths, 1,952 injured and 7,500 people left homeless. Among the victims include passengers from three worker trains arriving on site for change of shift. Several children on their way to school were injured, boats on the Rhine river sustained damage with numerous sailors also injured. Eye injury was observed in several cases.

Around 80% of the buildings in Oppau were destroyed. Substantial damage was also reported in Ludwigschafen and Mannheim. Massive glass debris on the roads of Heidelberg (30 km from Oppau), interrupted traffic in the city.

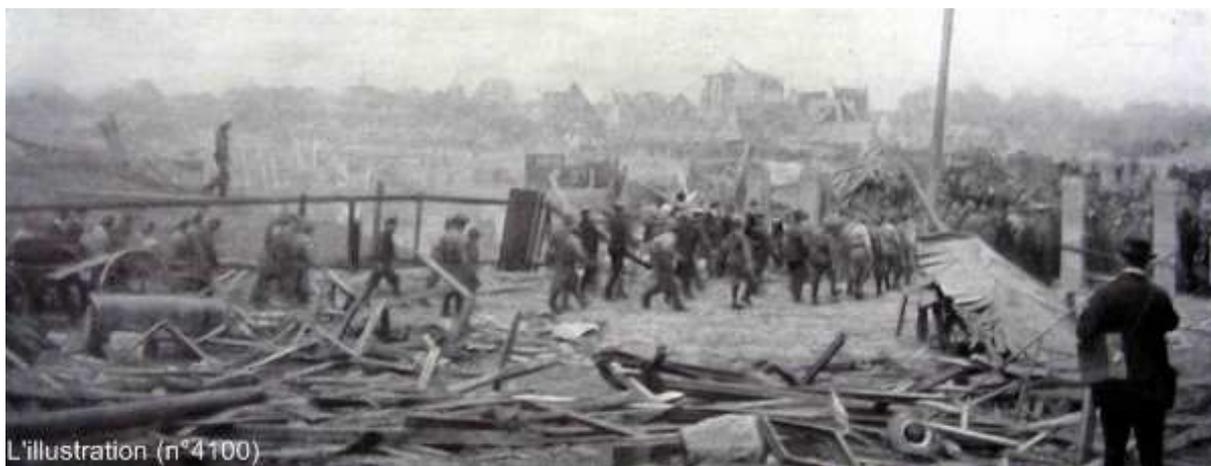
The extent of material damage and casualties made rescue operations particularly hard.

The emergency services that were rapidly alerted could not arrive on the site before 9.00 am out of the fear of new explosions. The French army based in Ludwigshafen and Mannheim created a safety line around the site. Emergency services (doctors, fire fighters, ambulances, French and German red cross volunteers, army, etc.) arrived from the neighbouring cities. Private and public vehicles were requisitioned.
