Release of 50 million m³ of water at the Vajont Dam

October 9, 1963

Erto e Casso (PN)

Arch dam
Rockfall / landslide
Water wave
Precursors
Geology

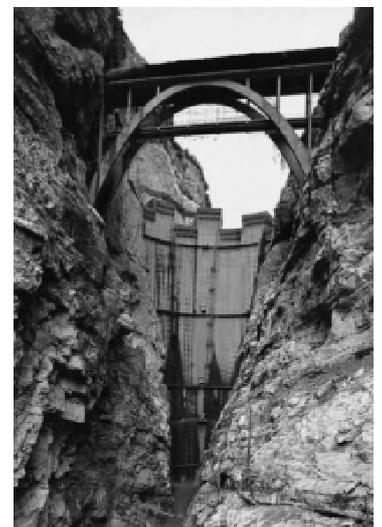
During construction [7]

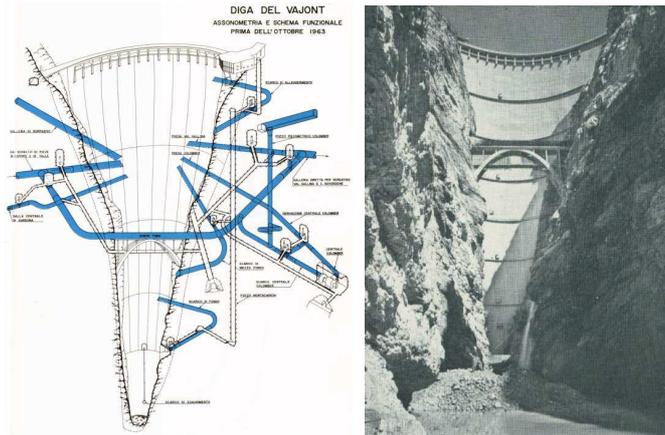
The dam project and once completed [1]

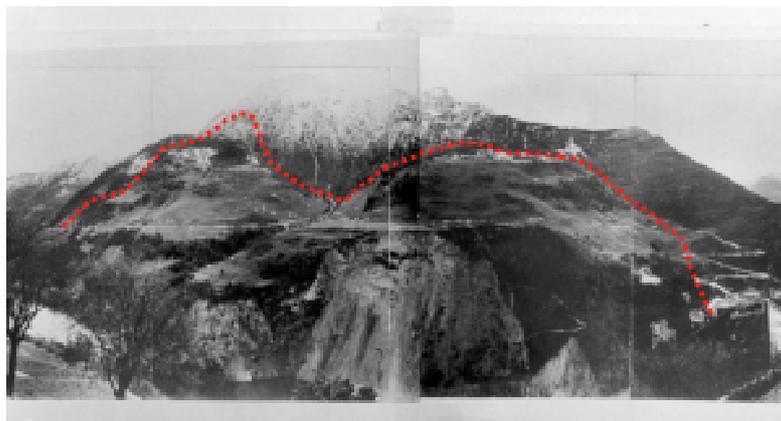
The vulnerable zone identified by geological experts as of 1960 [3,7]

In August 1957, a German geologist identified a vulnerable zone on Mount Toc. In July 1959, he proposed then conducted, in collaboration with an Italian geologist, a geological and technical assessment of this zone. At the end of August 1959, they discovered a fault and identified the risk of landslide along a plane shaped like a "chair". The two geologists submitted their results on instability around the dam banks to the project sponsors. The father of the Italian geologist, who himself was an architect and involved in the project, asked his son to moderate some of the report conclusions by impressing upon him the notion that such hypotheses need to be confirmed by another round of studies. On October 10, 1959, the pair of geologists proposed a complementary study programme. According to the Italian geologist who helped discover the fault, the concern over fault exposure that has become widespread today simply did not exist at the time [3].

Around the end of July and beginning of August 1960, the Italian geologist was pursuing his investigations and detailing the fault's potential shape. According to his estimations, the fault line was 2 km long and close to 600 m deep. He indicated moreover that due to its presence, nearly 200 million m³ of materials were at risk of collapsing at any time into the retention basin. In October 1960, ground movement exceeded the 3 cm/day threshold and led to a landslide of some 700,000 m³ on November 4, 1960 (see Section below entitled "*Initial filling of the reservoir*").

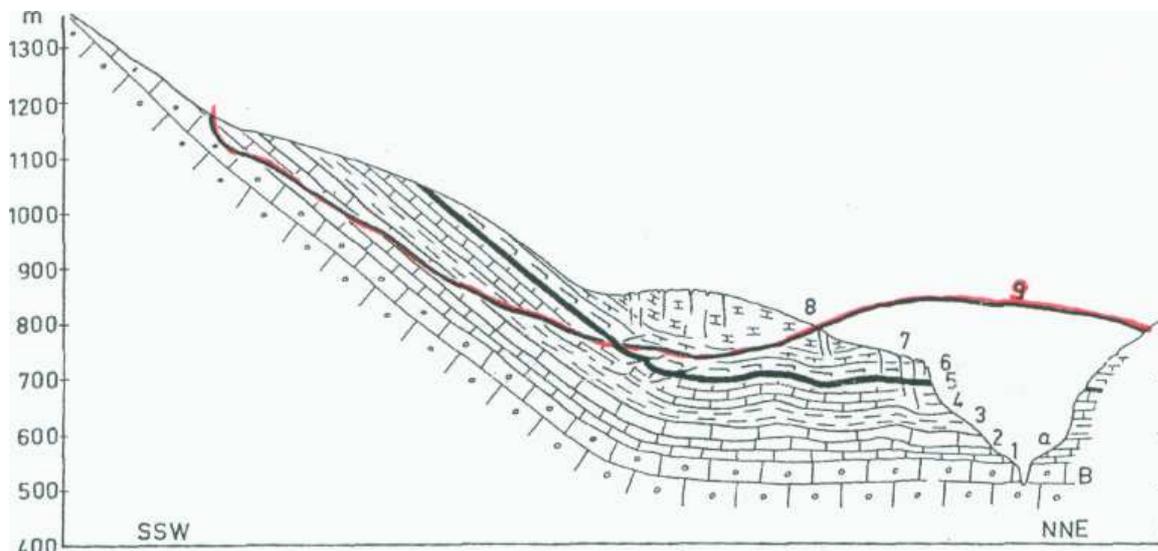
Geological section (about B-B), BROILI, 1967.
Idealised reconstruction of a geological section through the banks of the Vajont reservoir.

| (a) Vajont gorge. | (5) Lower-Cretaceous-(Albian-) formation. |
| (B) Dogger-Malm formation (oolitic limestone formation). | (6) Upper-Cretaceous-(Cenoman-) formation. |
| (1) Malm in general formation. | (7) Upper-Cretaceous-(Cenoman-) formation. |
| (2) Upper-Malm-Lower-Cretaceous-formation. | (8) Upper-Cretaceous-(Tur, Senon)-formation. |
| (3) Lower-Cretaceous-formation. | (9) Rock escarpment after the rock slide. |
| (4) Lower-Cretaceous-formation. | |

- the site's complex geological configuration, with the north-facing slope of Mount Toc featuring a "chair"-shaped sliding surface along a curved bedding plane,
- water level variations in the retention basin,
- rainfall characteristics: heavy rains during the week preceding the accident made the ground heavier and partially lubricated the sliding plane [1,3,14].

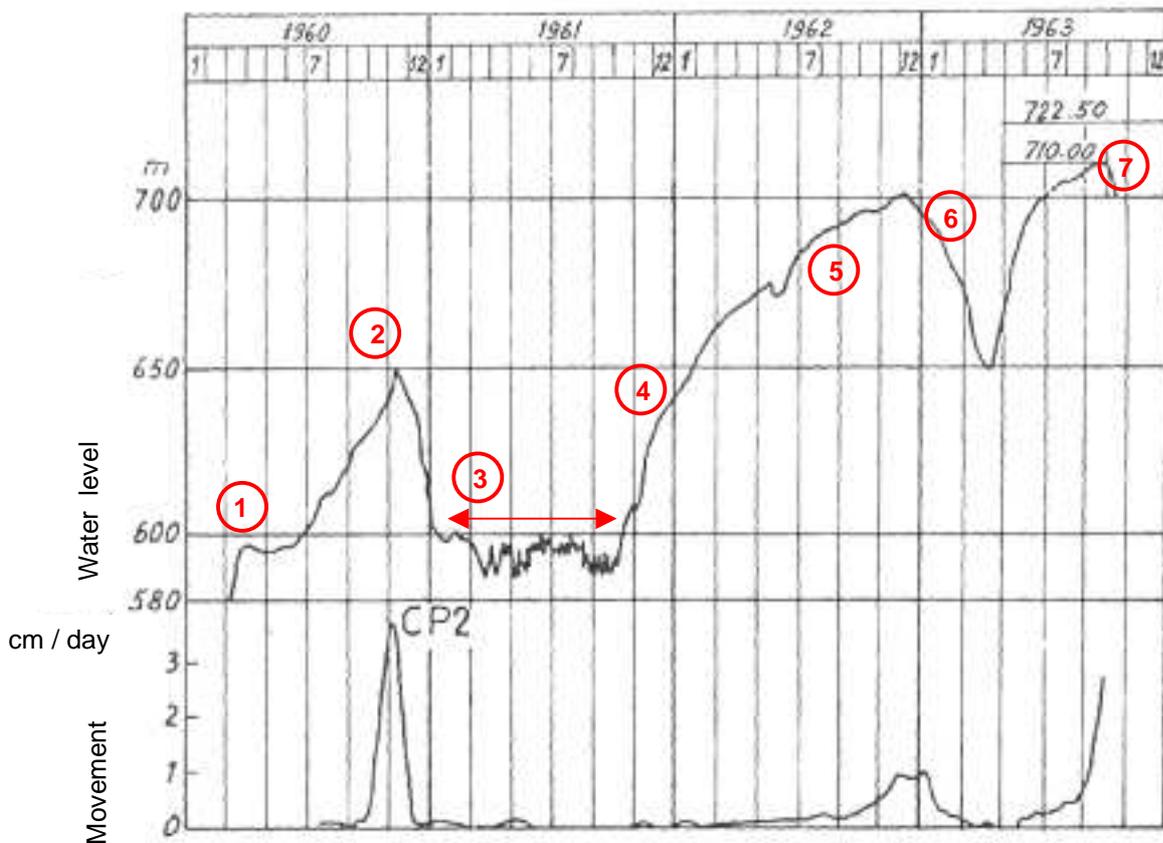
Lake level and ground movement speed [2,3]

1 - First appearance of the surface crack in March 1960.

2 - On November 4, 1960, after a week of heavy rains, an initial 700,000 m³ rockslide occurred. Though limited in magnitude, this slide further opened the crack into an "M" shape, making it easily visible. In spite of these developments, the hypothesis of a "surface" fault was still given priority.

3 - Following the slide, the operator decided to excavate a bypass channel connecting both parts of the lake on either side of the potential slide zone, in order to ensure the dam's water supply should a rockslide split the lake into two. The operator allocated 1 billion lire to building this 4.5-m diameter bypass, with construction completed in October 1961.

4 - During the extremely cold 1961-62 winter period, conditions began to stabilise. The fracture expanded by 6 m, yet the mountainside remained intact without any slide activity.

5 - With summer 1962 approaching, the dam operator undertook a second dam filling. Reports mentioned the presence of disturbing seismic activity throughout the first part of the year, and the number of cracks detected on homes in the valley had increased multi-fold, raising serious concerns on the part of local residents. Measured ground movement reached 1.5 cm a day once the reservoir height had climbed to 700 m during winter 1962-63.

6 - At this point, the operator decided to lower the reservoir level, and seismic activity ceased.

7 - The dam was filled to its limit of 715 m during 1963. According to some sources [1,12], the operator was seeking to maximise output from the facility prior to its transfer to Italian Government control, by virtue of the December 1962 creation of the national electric company.

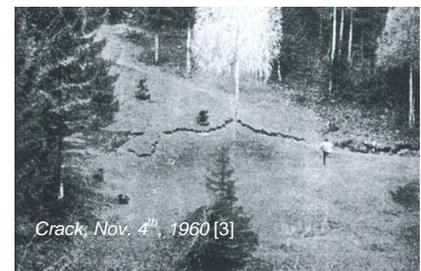
Crack, Nov. 4th, 1960 [3]

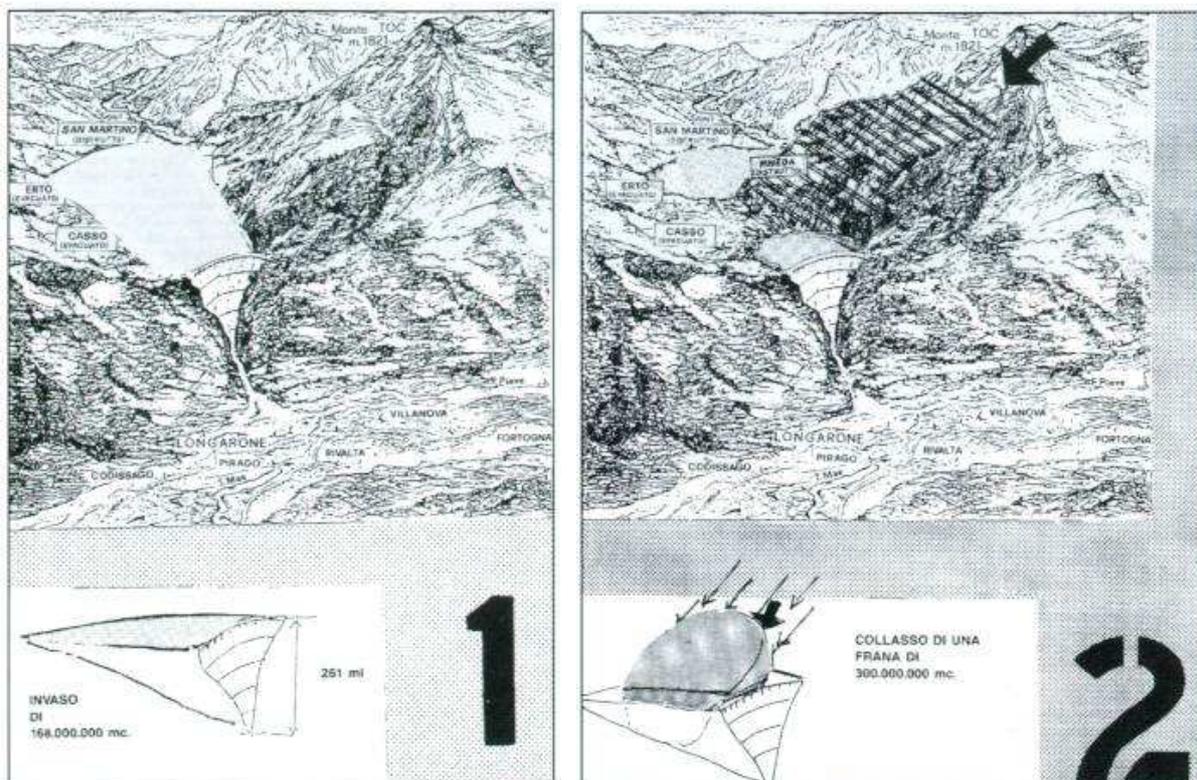
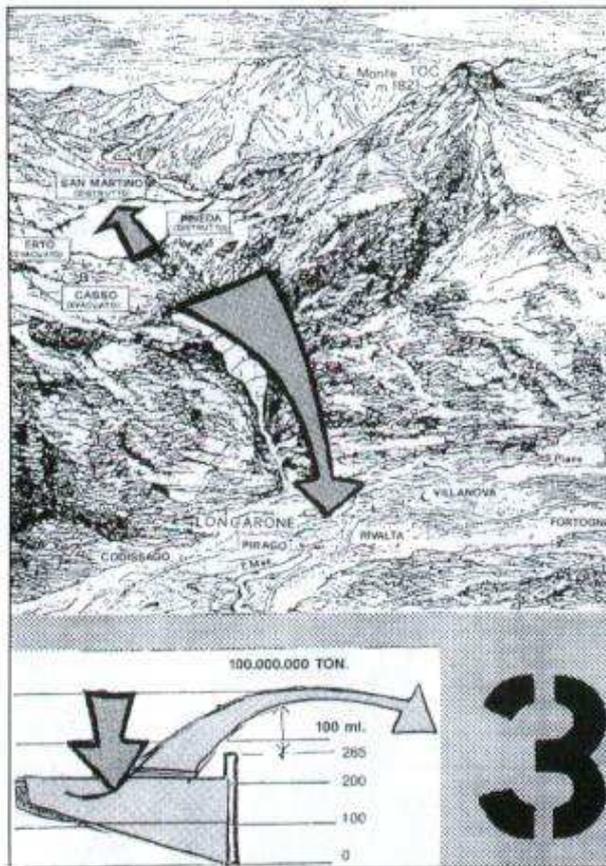
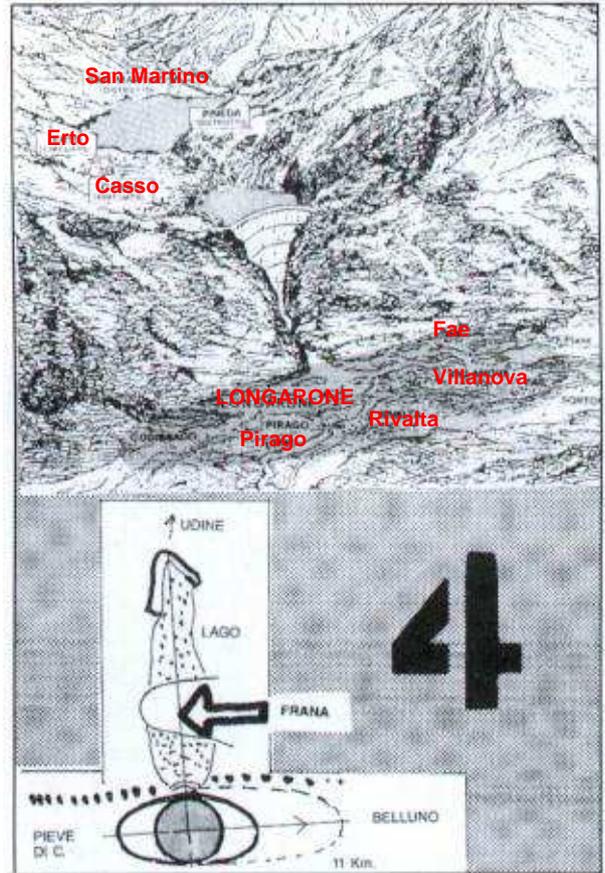
Accident dynamics [1] (see also the video in ref. [14])

On October 9, 1963 at 10:39 pm, the landslide occurred; over 260 million m³ of earth and rock rushed down the mountain at speeds upwards of 90 km/hr and into the retention dam. The roar of this event was deafening, as the rockslide carried with it electric supply lines, plunging Longarone into total darkness.

In a matter of moments, landslide material filled the lake. Two waves of 25 million m³ of water each washed over the land both upstream and downstream of the retention zone. Another wave over 150 meters high topped the dam and raced into the narrow valley in the direction of Longarone.

The thrust of this water mass into the valley caused a series of incredibly violent phenomena: powerful air streams suddenly propelled by the water formed a pressure wave that began to destroy the town, then came the water mass carrying loads of debris levelling many structures in its wake.

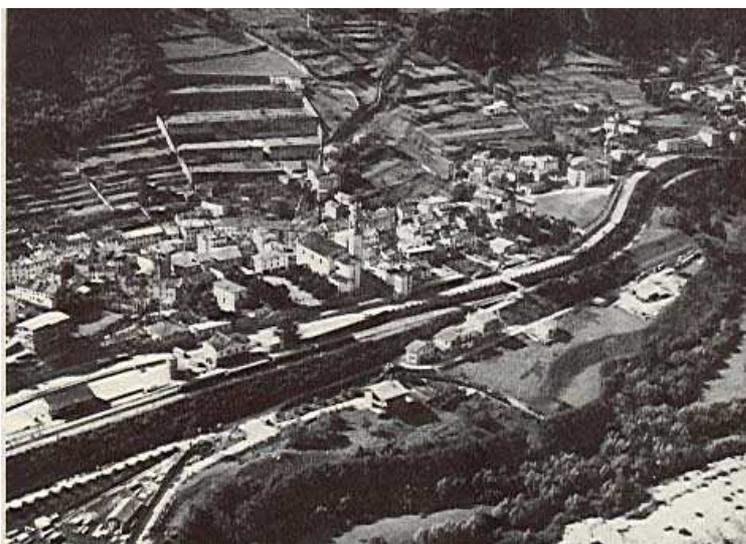
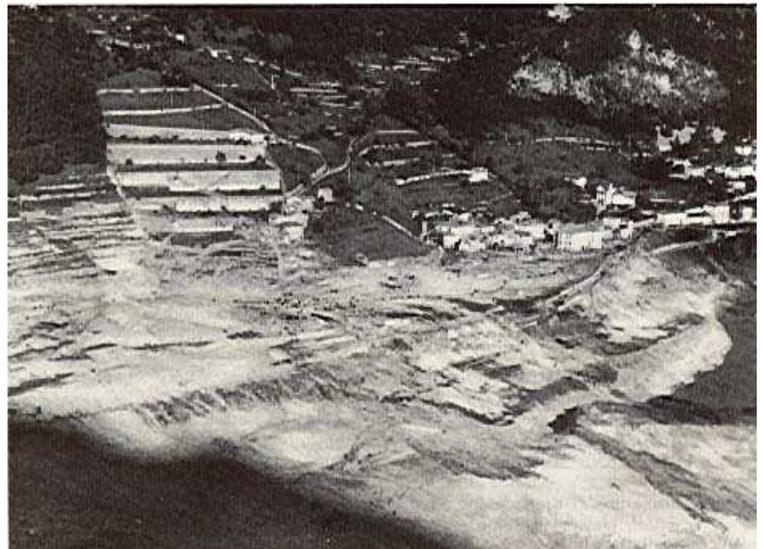
The town of Longarone before and after the wave's passage [1]

The "downstream" water mass submerged the towns of Longarone, Pirago, Rivalta, Villanova and Faè. Many small neighbouring villages lay along the trajectory of the "upstream" wave reaching elevations above the lake. The human consequences were of catastrophic proportions: depending on estimations, between 1,900 and 2,100 people lost their lives. The social impacts would also be devastating. The total destruction of these towns and villages was tragic for the region: families and activities disappeared, social ties were shattered, and an entire community history was washed away.

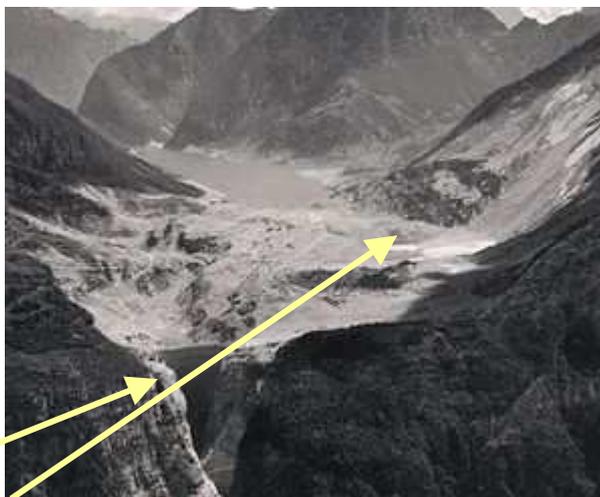
The dam and rockslide zone after the disaster [1], as seen from the same angle as the initial view on page 1

The dam remained for the most part intact; only the outlying installations (control room, technical facilities, etc.) were destroyed.

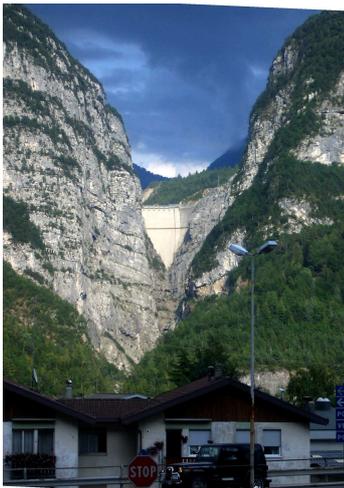
The dam, as seen from Longarone [5]

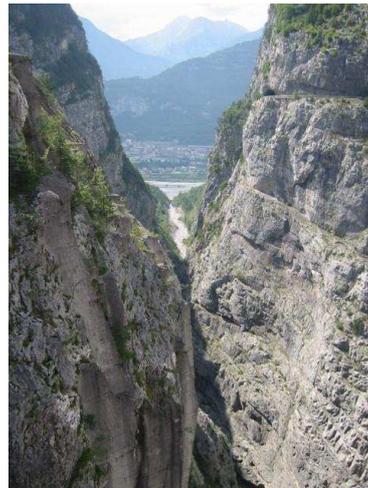
View from the dam arch. In the background, the rebuilt town of Longarone [1]
