Fire inside a barn and explosion of fertiliser

2 October 2003

Saint Romain-en-Jarez (Loire)

Fire
Explosion
Farmer
Ammonium nitrate /
fertiliser
Victims
Property damage
Emergency response
(difficulties of)

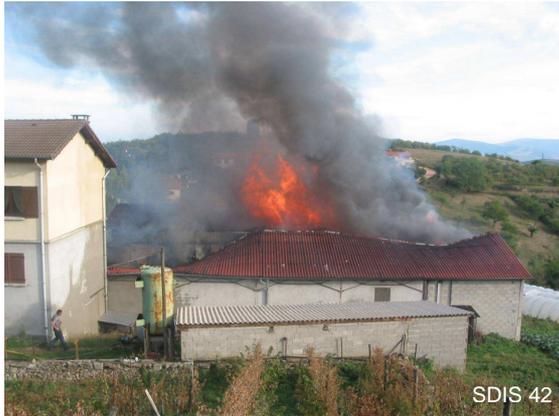
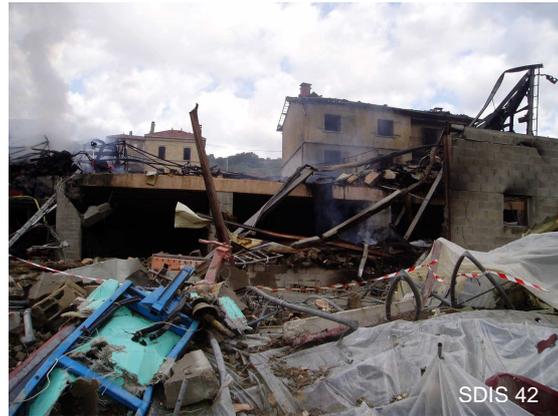
The fire-fighting strategy adopted had to be adapted to both the amount of water resources and the fire's progression. Once the house was out of danger, fire-fighters turned to two variable-rate nozzles in order to protect the flat that was still intact on the barn's first floor.

At 5:12 pm, with a large portion of the barn roof already collapsed and the fire source having lost intensity, a hissing sound was heard followed by a powerful explosion, without the fire-fighters having taken note of any preliminary signs or indications. Debris rained down all around the point of explosion. Heavy pieces of the structure's steel frame would be found hundreds of metres away. The toll from this disaster: 26 people injured; the barn totally destroyed; and many neighbouring village buildings, within a radius extending several hundreds of metres, sustained varying degrees of damage.

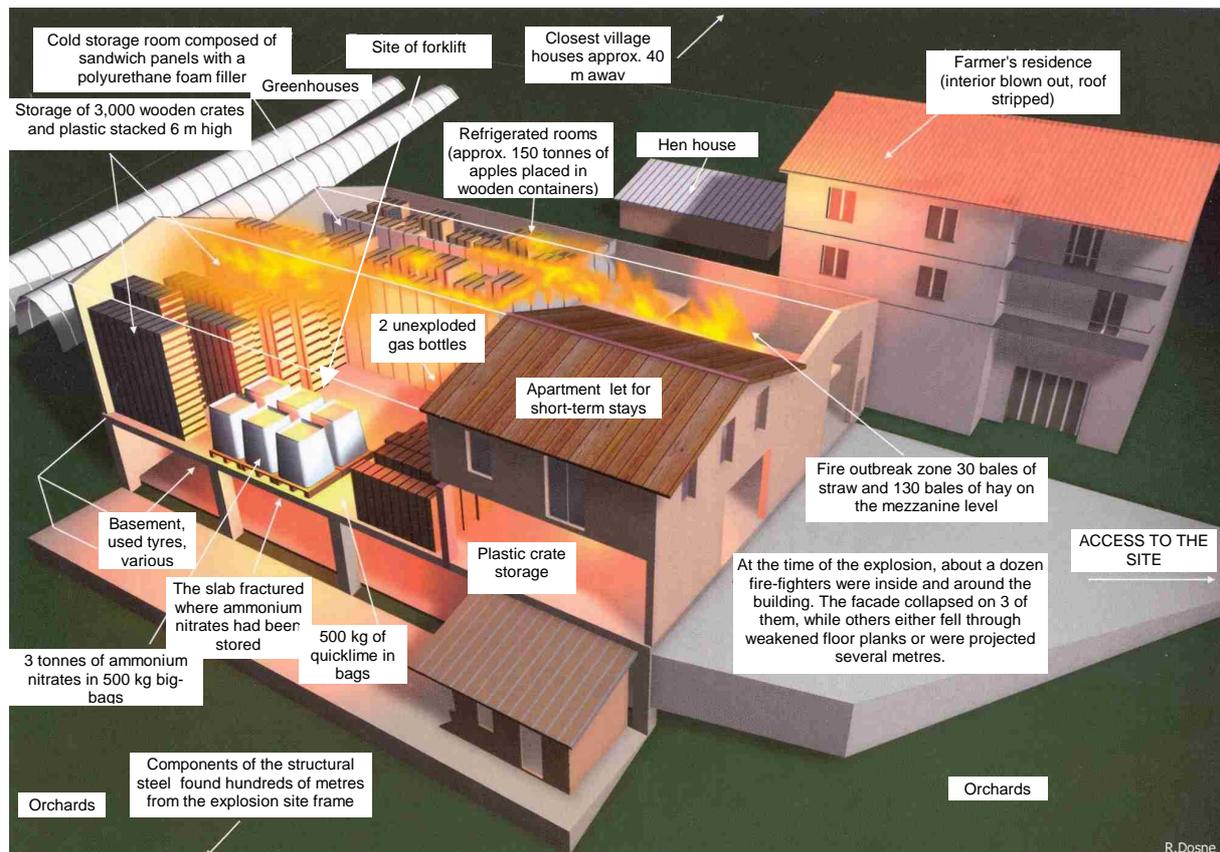
Explosion of ammonium nitrate solution inside the barn (drawing by René Dosne, "Face au Risque", issue 399, January 2004)

This explosion would have been caused by the detonation of a portion of the 3 to 5 tonnes of ammonium nitrate solution present inside the barn. The explosion epicentre was actually located in the southern quadrant of the building, corresponding to the assumed fertiliser storage zone. At this particular spot, the ground floor concrete slab was cracked. During 2003, fertiliser inventories among local farmers were running especially high since much had gone unused following a late freeze in April 2003 that destroyed nearly all of the stone fruit crop.

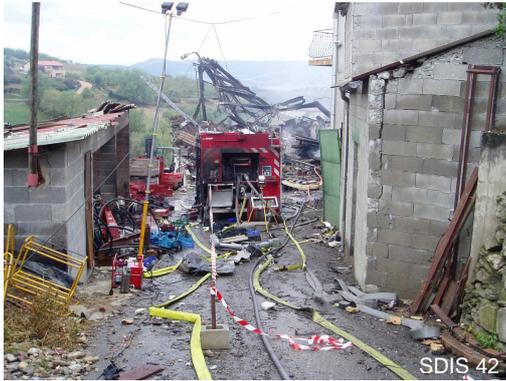
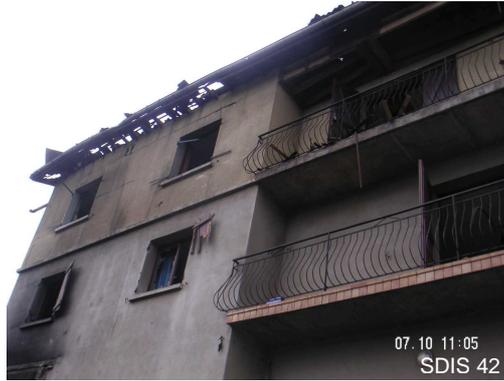
Experts appointed by the Environment Ministry were assigned to: collect all information necessary to understand the sequence of events, record the damage to structures, and identify the locations of various types of projected debris. The upper limits of the damage radius recorded onsite are listed in the following table:

Maximum radius of lightweight damage (broken glass panes, tile dislocation)	650 metres
Maximum radius of major damage (cracked walls, chassis degradation)	350 to 580 metres
Maximum radius of serious damage (structural deterioration, displaced partition walls)	150 metres
Maximum radius of fragment projections	800 metres

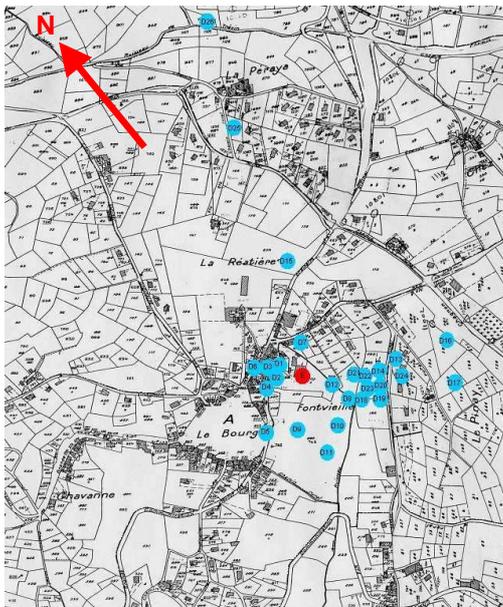
Locations of identified debris

The fragment projected the furthest ignited a fire in a prairie 800 m from the explosion site, yet it remains entirely possible that other fragments were projected even greater distances.

Hazardous effects could be observed beyond distances of 600 m, given the characteristics (velocity, mass, shape) of the fragments recovered during the investigation.

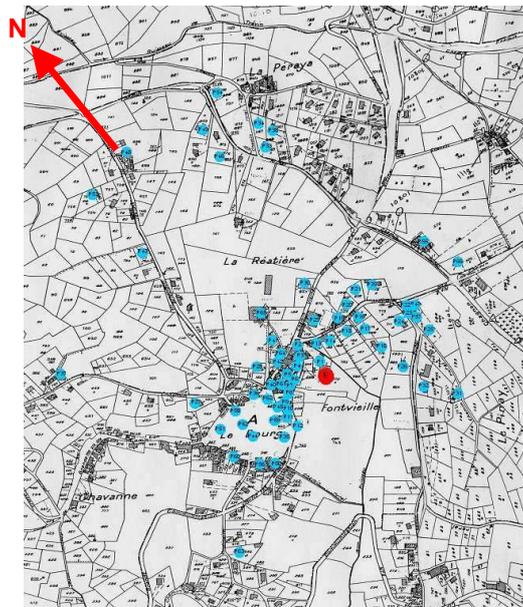
Locations of actual damage recorded

A rather pronounced directional effect heading northwards could be noticed at distances of up to several hundreds of metres. Conclusions drawn by the panel of experts cited a number of possible causes of this phenomenon, including:

The innermost ring of houses around the explosion epicentre, along with several houses in the central part of the village (for a total of some twenty dwellings within a 150-m radius), were heavily damaged.
