Fire and explosion in an industrial chemical plant

18th October 1981

Villeurbanne – [Rhône]
France

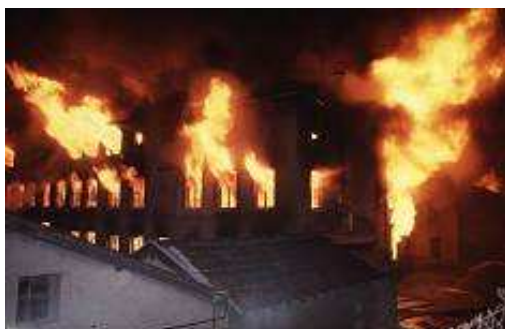
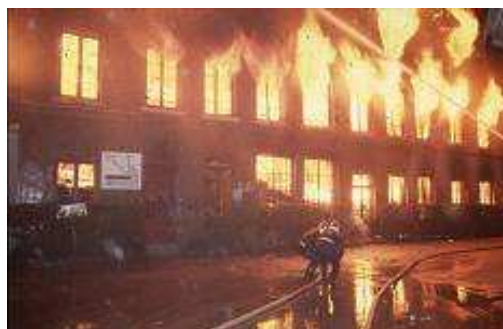
The alert was given towards 1h20 in the morning. The fire was then visible from outside the buildings. The fire services arrived within the following minutes. Around 1h30, a first explosion occurred while the police and safety services were commencing the evacuation of the neighbouring buildings,. This incited the inhabitants of the quarter to evacuate their residences spontaneously. At 2h10 a second, very powerful explosion occurred, accompanied by numerous projections of stored products and materials, in particular of the metal beams which supported the roofing of the buildings. Around 2h15,

two further explosions of lesser importance occurred. Around 3A.M. the fire-fighting services had the fire, which now extended to most of the buildings, under control.

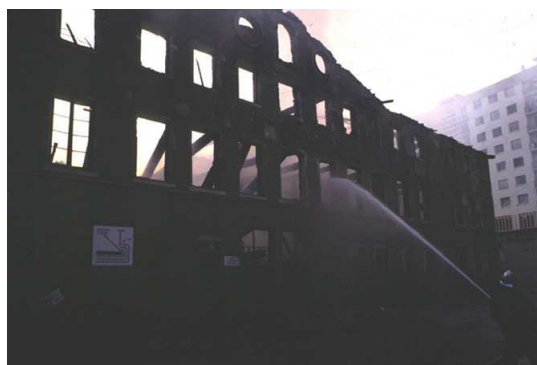
The buildings of the industrial chemical plant were almost completely destroyed by the fire and the explosions. There remains nothing on the presumed site of the chlorate depot and the ground has been indented by 50 cm. There only remains skeleton walls and a mass of metal profiles (roof beams and shelving)

The respect of obligations prescribed by the decrees applicable to installations classified as being subject to declaration would doubtless made it possible to reduce the consequences to the environment. The enquiry held by the inspectorate of classified installations will demonstrate major shortcomings as regards respect for elementary safety rules contained in the "standard" decrees and, in particular:

- For chlorate depots "the space designated for the storage of chlorates will contain no flammable liquids, compressed gases, concentrated mineral acids or finely powdered combustible materials"
- For depots of flammable liquids « flammable liquids must be stored in non-flammable recipients"
- For the battery charging workshop: « The workshop should be put to no other use. In particular is forbidden to store there a depot for combustible materials »

In the absence of any watchman's rounds, of any fire or smoke detection systems, alarms or automatic extinguishers, the fire easily spread throughout the warehouse, fed by the combustible materials present. (cardboard packaging, palettes...).
