## Accidentology associated with the ageing of industrial installations

This document focuses on the two main mechanisms of ageing: corrosion and fatigue.

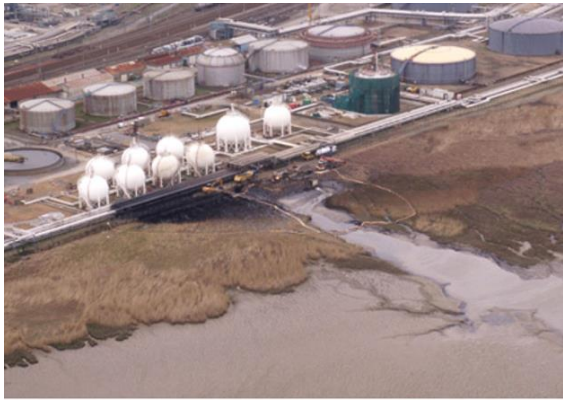
Of the 200 corrosion-related accidents which occurred in France over the last 10 years, **more than half involve pipelines and piping.**

- frequent **difficulties in accessing the pipes for inspection purposes** (pipes that are buried or in sleeves, pipes located overhead on racks, insulated pipes, etc.);
- their **extensive length** (on or between sites), which **makes monitoring difficult.**

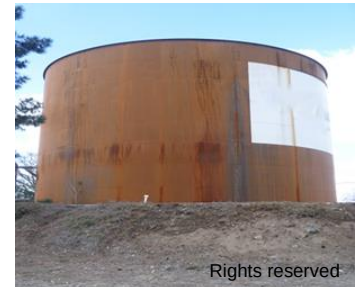
ARIA 42401 - 05/07/2012 - 33 - BIGANOS

At a paper manufacturing plant located 5 km to the east of the Bay of Arcachon, a 5,000 m<sup>3</sup> tank of black liquor ruptured during a filling operation at 2:30 pm. [...]

The tank showed signs of obsolescence, and corrosion. Additional inspections were scheduled to take place on tank in late July 2012 to ensure its ability to remain in service. [...]
