# Runaway reactions, case studies, lessons learned

Véronique Pasquet, CNRS, Ministry of Sustainable Development, Office for the Analysis of Industrial Risks and Pollution (BARPI), France

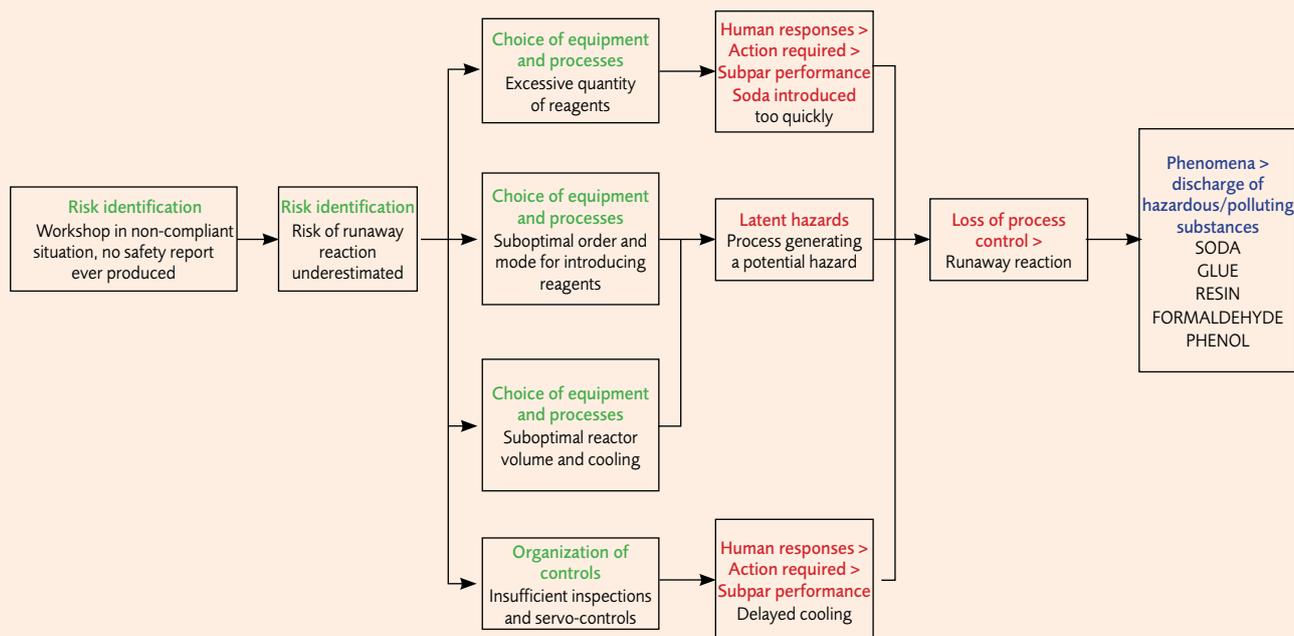
Modelling of the accident (tool developed in the ARIA database)

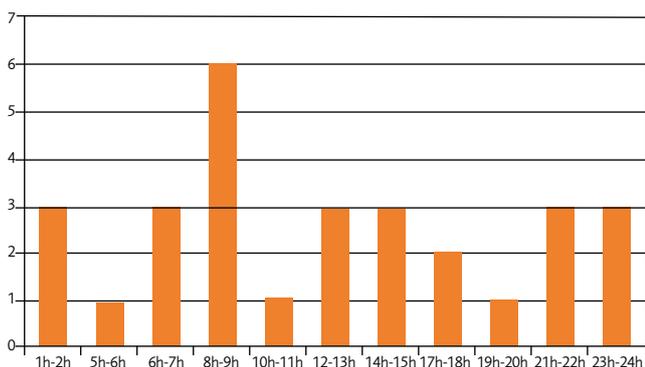
Number of accidents at different times of the day

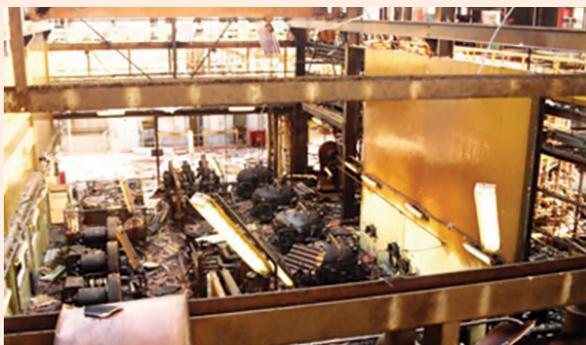
Control room

An explosion and fire occurred at night in a workshop set up to synthesise toluene diamine (TDA), by means of hydrogenating dinitrotoluene (DNT) in the presence of Raney nickel, during a scheduled maintenance downtime. In-house fire-fighters brought the fire under control within 35 min; in the meantime, four employees required hospitalisation. One of them, who was handling the valves to wash the hydrogenation reactors with isopropanol, sustained burns over 40%-50% of his body and died 15 days later. The workshop was completely destroyed. The reactor burst; the bunker housing the workshop was deformed due to the combined action of the blast wave and sprayed fragments; the reinforced concrete wall was ripped open, with rebar twisted; and the control room was heavily damaged. Glass panes were broken over a 50- to 100-m radius, while the distillation unit juxtaposing the bunker was damaged and allowed isopropanol and TDA to escape, adding fuel to the fire. Buildings belonging to the neighbouring industrial facility located 150 m away suffered deformations to their lightweight structures. Wind dispersed the gaseous pollutants released ( $\text{CO}_2$ , CO, NO<sub>x</sub> and unburnt organic matter). The environmental impact remained limited.
