Conveyor belt fires: Are the standards being met?

Conveyor belt fires - cereal, wood and fertilizer

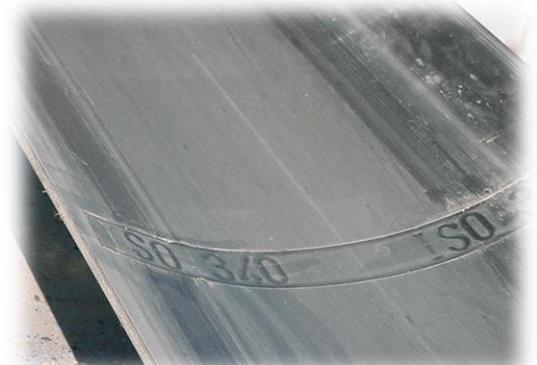
ISO 340-compliant conveyor belt
© DRIRE

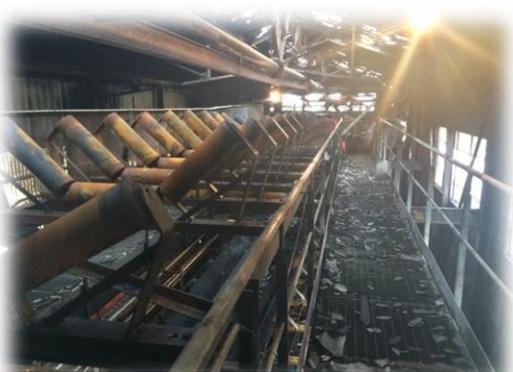
At around 9 p.m., a fire broke out at a paper mill on a rubber conveyor belt feeding a silo containing 1,000 tonnes of wood chips. The zone's fire alarm was triggered. Three employees, suffering from smoke inhalation, were taken to the hospital. The internal emergency plan was activated and the plant was shut down for two days. The fire was finally extinguished at around 3:50 a.m. A large portion of the fibrocement roof had collapsed. The fire had damaged 150 m² of conveyor belt.

Burning conveyor belt (© Operator)

As the fire may have been caused by an electrical malfunction, the installations could not be put back into service until the facility had been secured. Underground water and soil samples were prescribed. An electrical verification report must also be submitted to the Classified Facilities Inspection Authorities.
